BULLET-IN-BORE STUDY
OF
5.56MM, BALL, M193 CARTRIDGE AND M16A1 RIFLE

FRANK E. BRAUN, JR.
AND
ROMAN FEDYNA

Ammunition Development and Engineering Laboratories
FRANKFORD ARSENAL
Philadelphia, Pa. 19137

October 1969

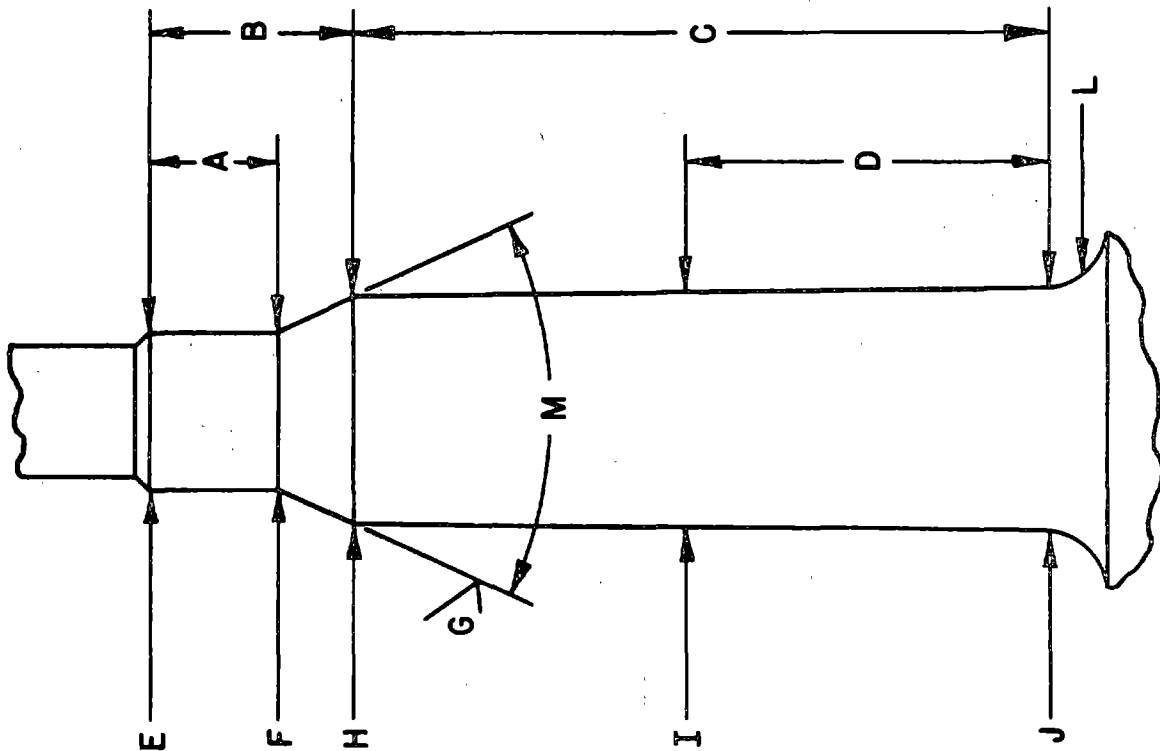
FIGURE 1

CHAMBER CASTS OF WEAPONS

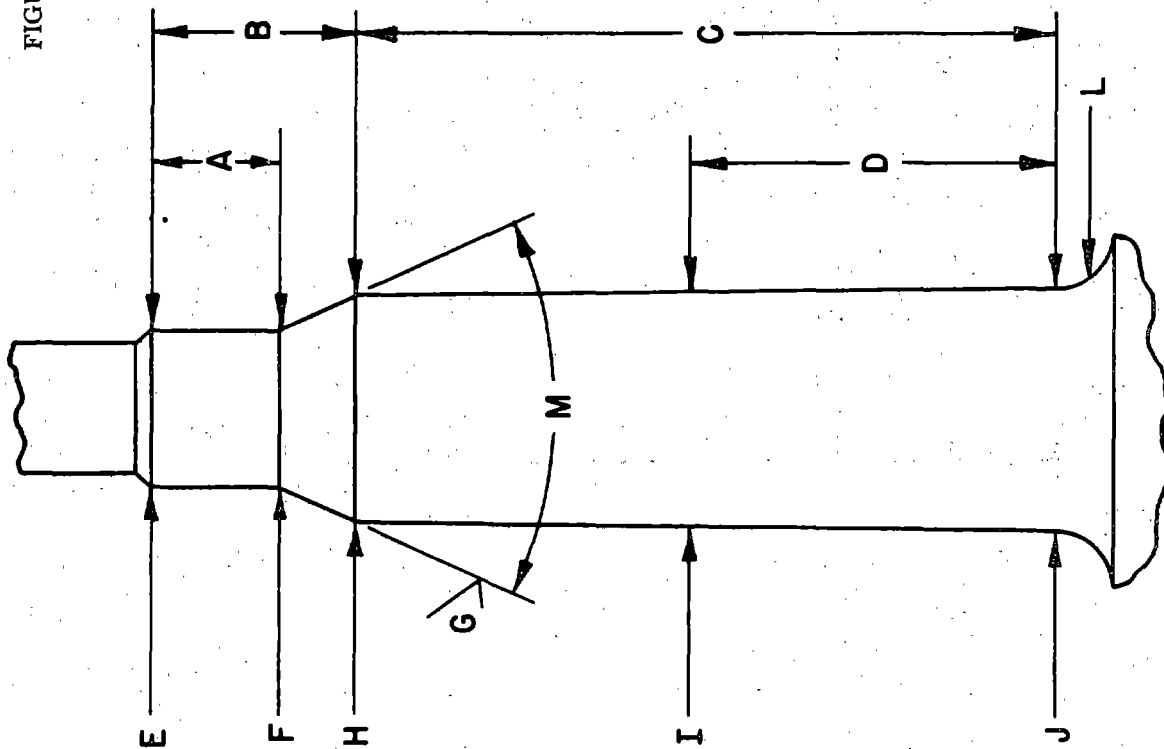
FIGURE 2

(3) A chamber cast of the damaged Fort Huachuca Rifle was also made (refer to Figure 2).

CHAMBER CAST OF DAMAGED HUACHUCA WEAPON

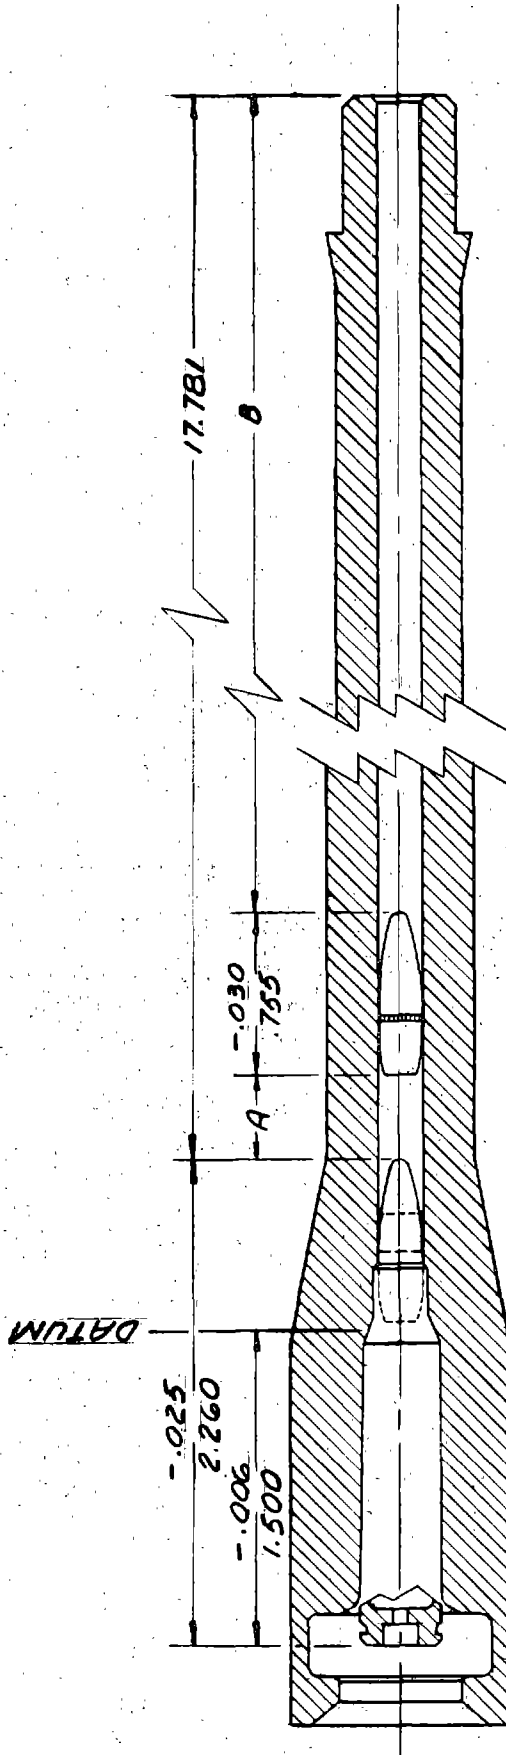
Figure 4

(1) For all modified cartridges, the bullet lodged farthest down the bore from the chamber in the Fort Huachuca rifle and travelled the shortest distance from the chamber in the new rifle. The position of bullets-in-bore for any given weapon and for any related bullet pull was consistent (see Figure 4).

⊗ ZERO CLEARANCE - ROUND COULD NOT BE CHAMBERED BEHIND BULLET LODGED IN BORE WITHOUT FORCE, RESULTING IN EITHER INDENTING BASE OF LODGED BULLET OR PUSHING BULLET OF CHAMBERED CARTRIDGE INTO CARTRIDGE CASE OR BOTH.

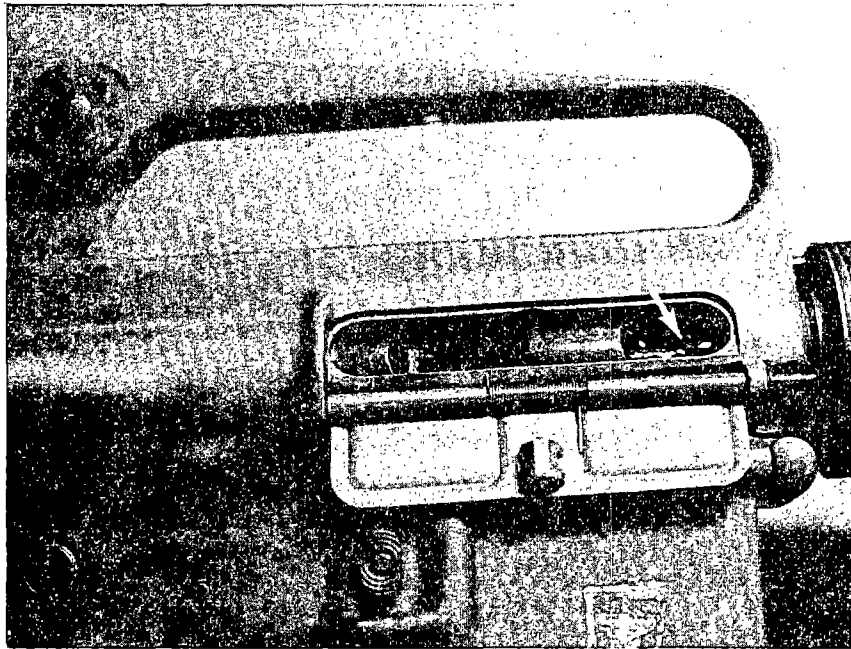
Figure 5. Side view of New Rifle (Serial No. 1326633) with a bullet lodged in the bore, preventing complete chambering of the succeeding round.

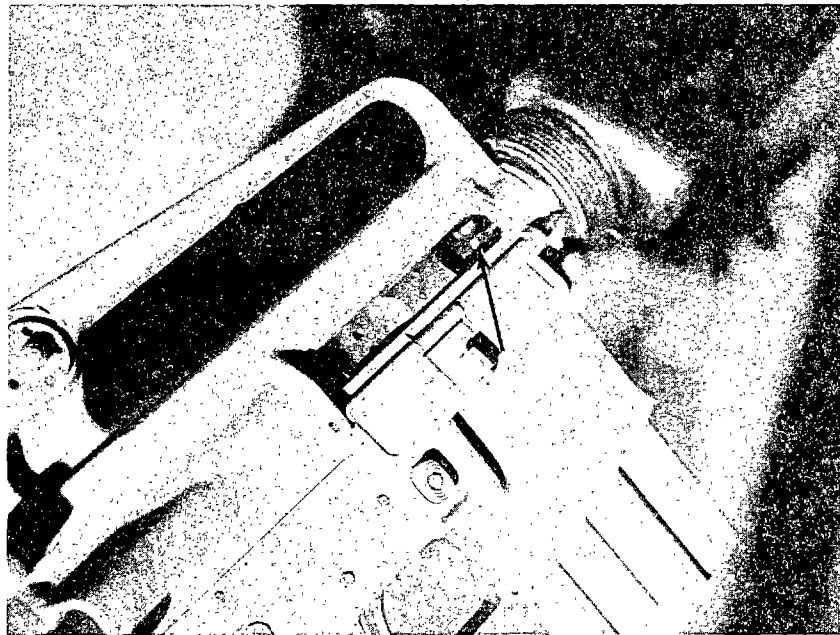
Figure 6. Rear view of same condition described in Figure 5.

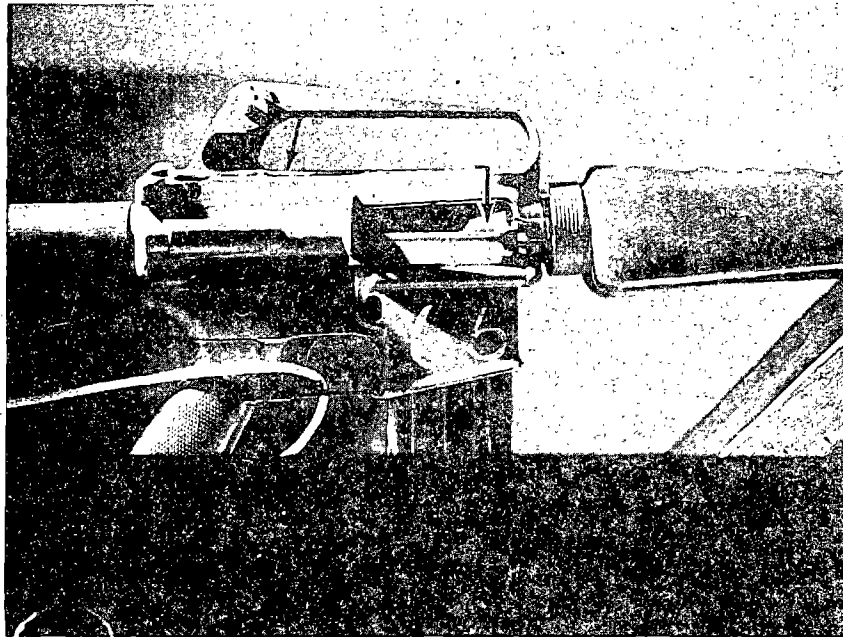
Figure 8. Side view of damaged Fort Huachuca Rifle (Serial No. 598656) showing cracked upper receiver housing.

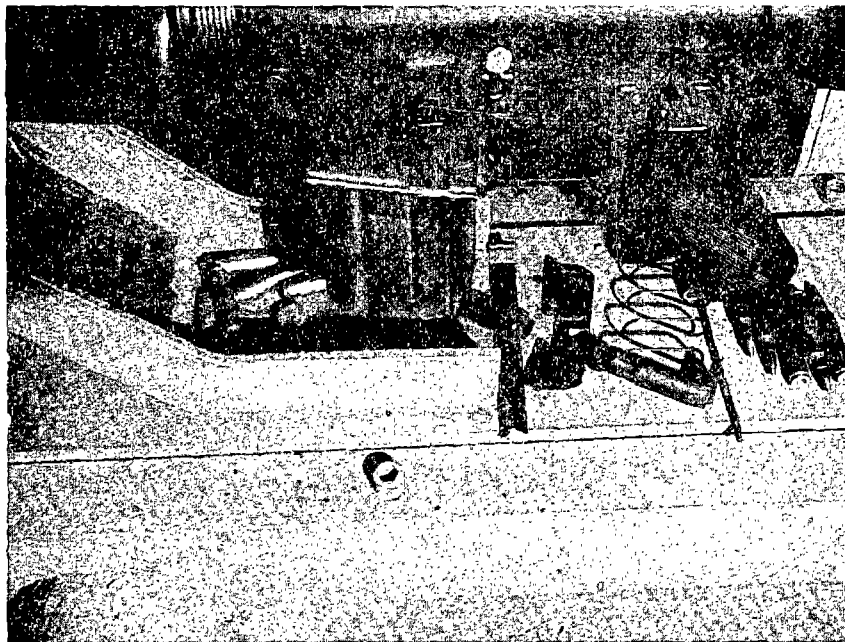
Figure 9. Side view of lower receiver showing auxiliary parts of damaged magazine, cartridges, dust cover and dust cover pin.

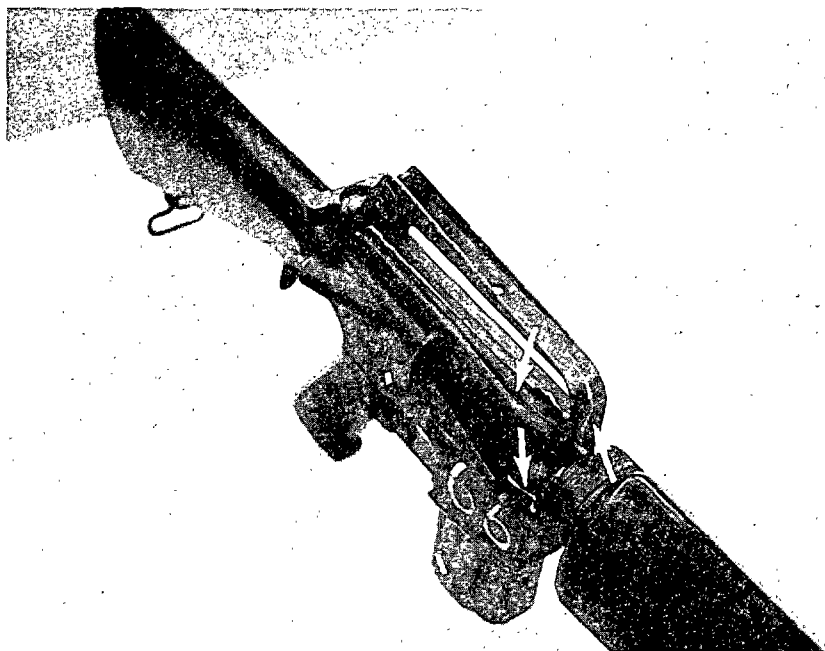
Figure 10. Top view showing fractured upper receiver housing and cracked carrying handle.

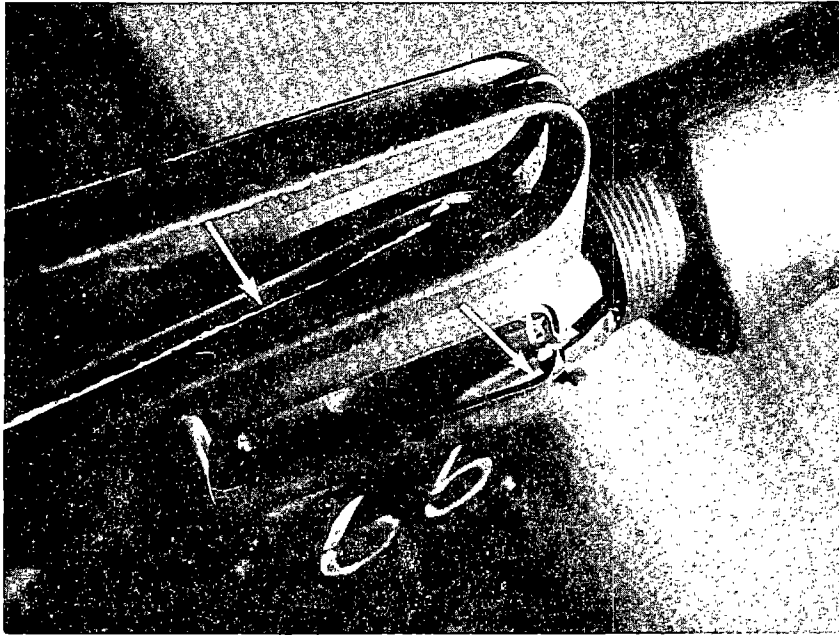
Figure 11. Side view showing fractured upper receiver housing, cracked carrying handle and closed bolt.

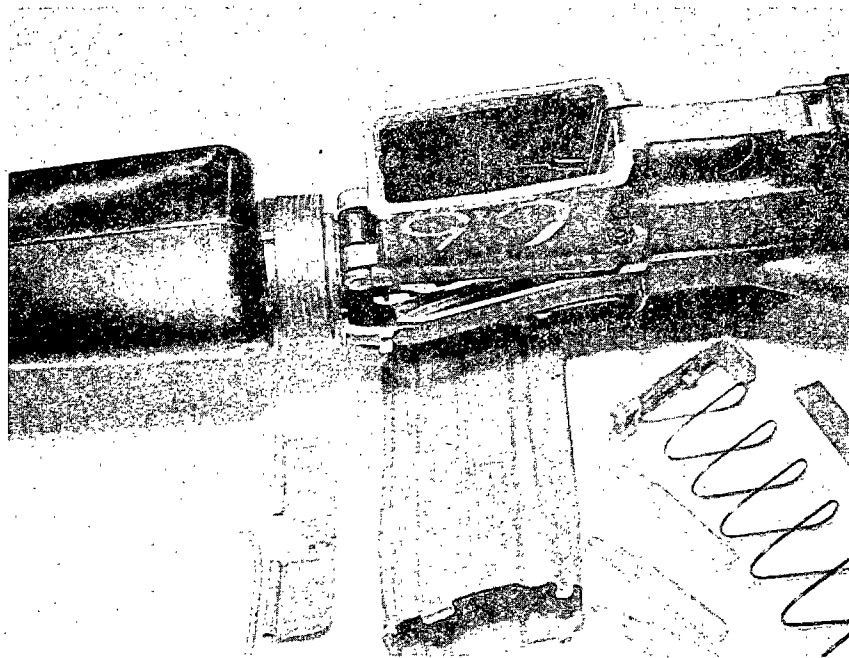
Figure 12. Bottom view showing bulged magazine housing, damaged magazine and auxiliary parts.

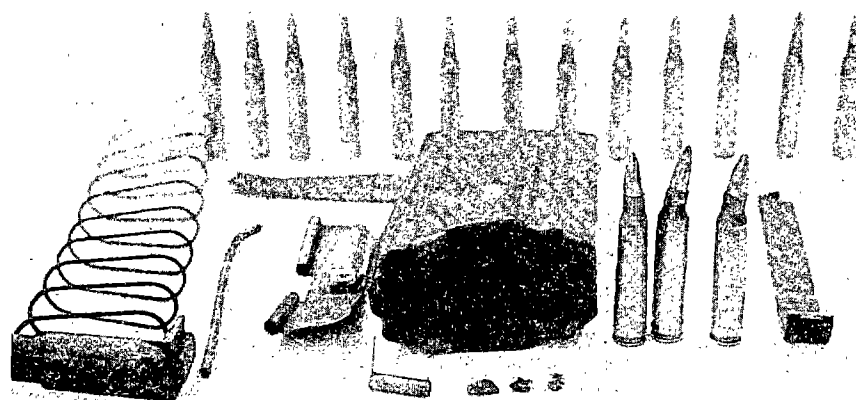
which were blown from the magazine and found on the floor of the gun-mounting fixture (see Figure 13), a fractured bolt carrier (see Figure 18), a bent and broken extractor (see Figure 17), a crack in the wall of the barrel through the locking lugs (see Figure 20), a ruptured cartridge caseⁱ which was lodged in the chamber, and a bullet jacketⁱⁱ found in the bullet seat when removing the ruptured cartridge case. The recovered bullet jacket weighed 13.557 grains. The nominal weight of a normal bullet jacket is 17.000 grains.

Figure 13. View showing recovered magazine, auxiliary parts and cartridges. Note three damaged cartridges.

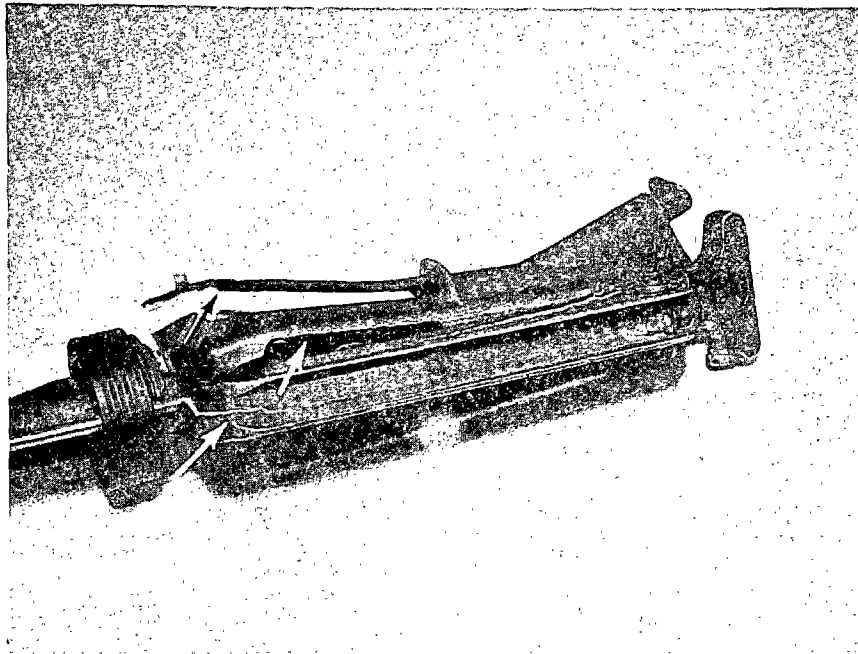
Figure 14. Top view showing fractured upper receiver housing.

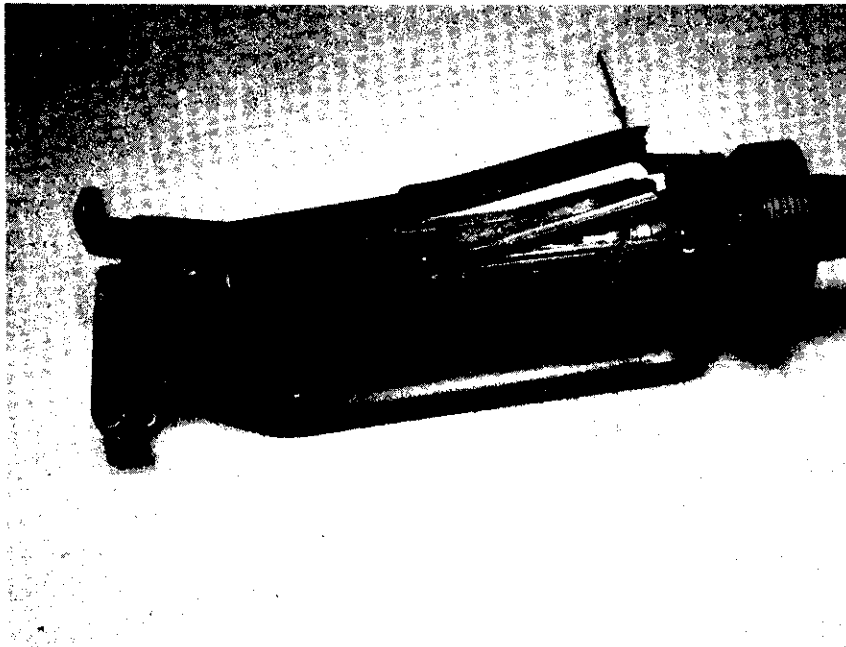
Figure 15. View showing fractured upper receiver housing and bolt carrier.

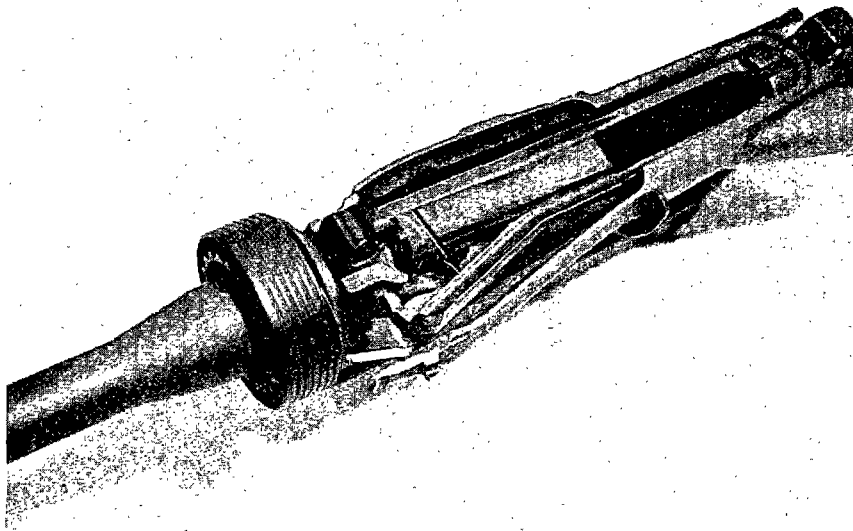
Figure 16. Bottom view of same condition described in Figure 15.

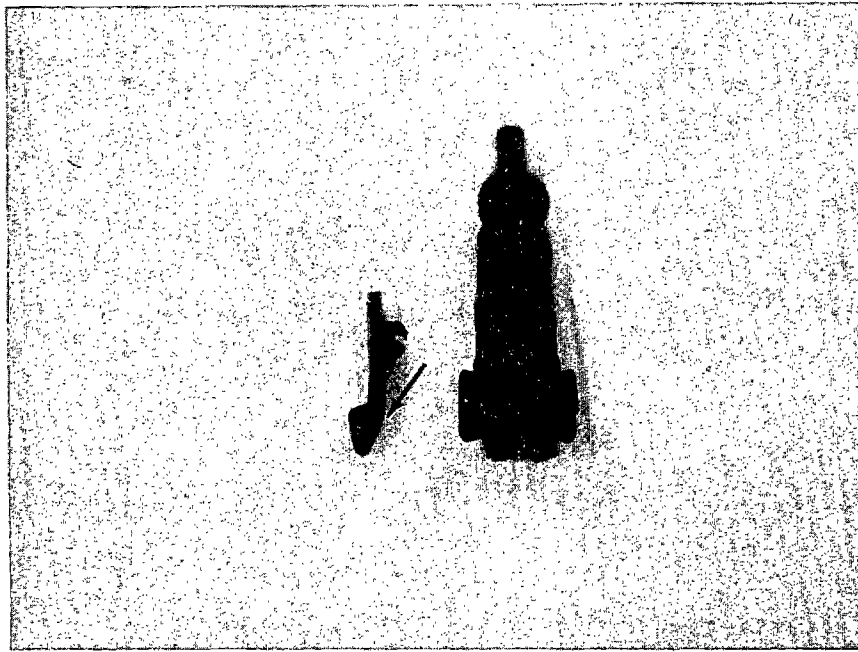
Figure 17. View showing undamaged bolt and bent extractor.

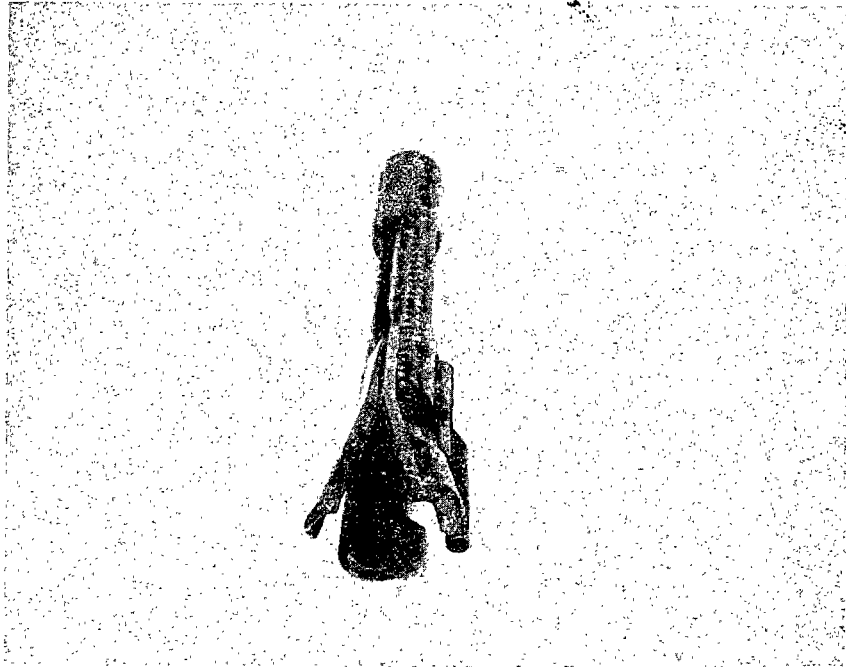
Figure 18. View showing fractured bolt carrier.

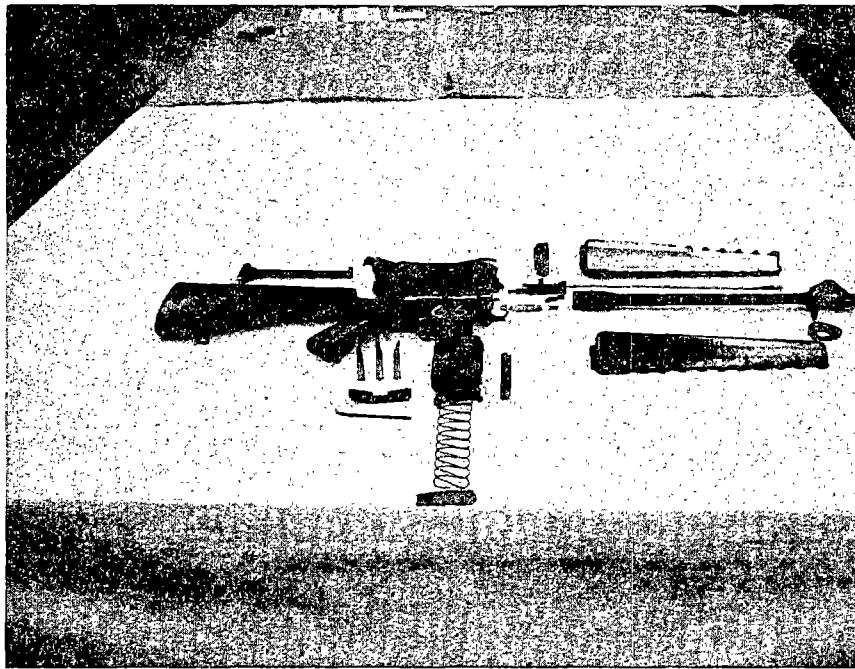
Figure 19. View showing disassembled parts of damaged weapon.

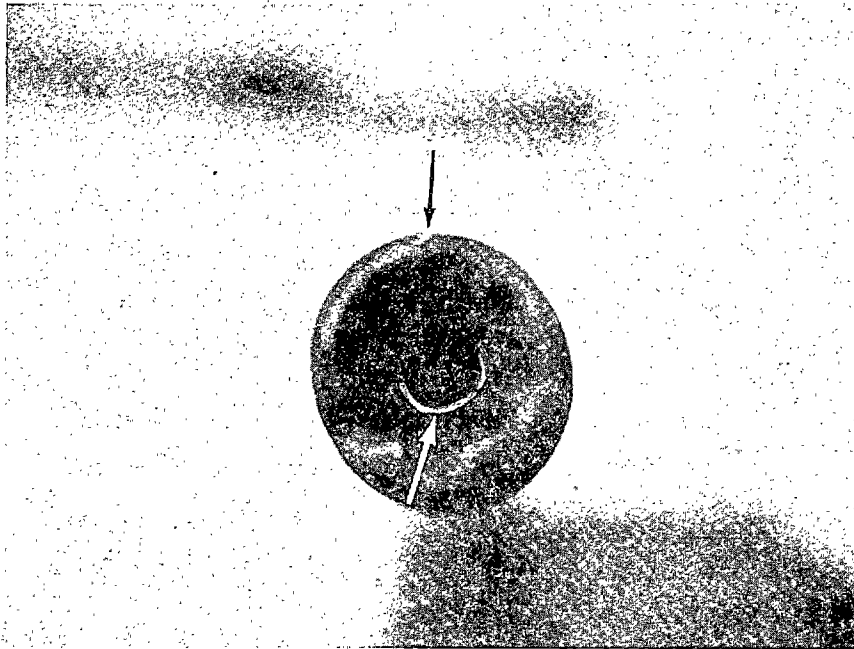
ⁱ The ruptured cartridge case was that of the succeeding cartridge that was chambered completely and fired into the lodged bullet in the bore (see Figures 20 and 21).

Figure 20. View showing crack in wall of barrel extending through locking lugs and body of a cartridge case. (Case head was sheared off during weapon disassembly.)

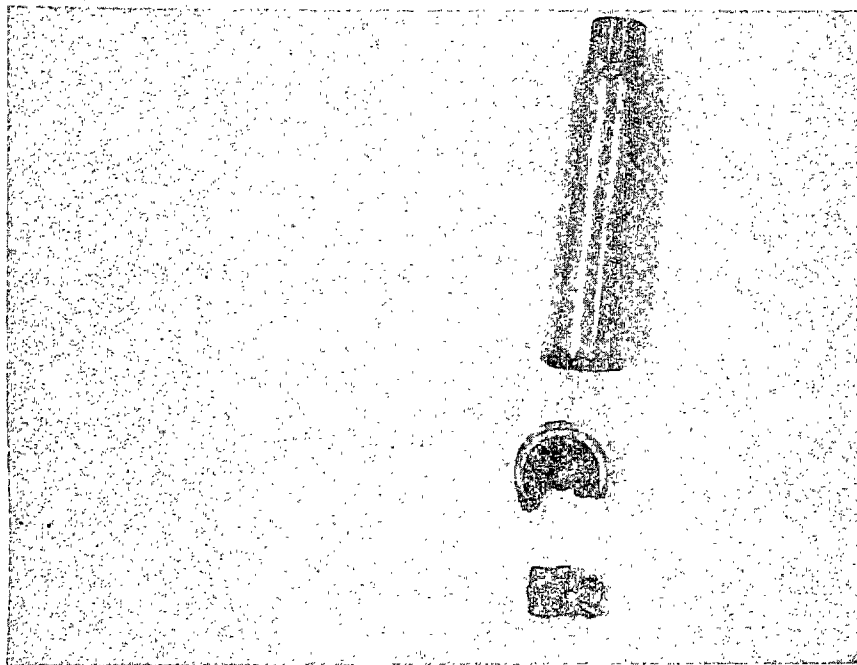
Figure 21. View showing body of cartridge case after removal from the chamber. The smaller portion of the case head was pulled off by the extractor when the weapon was fired.

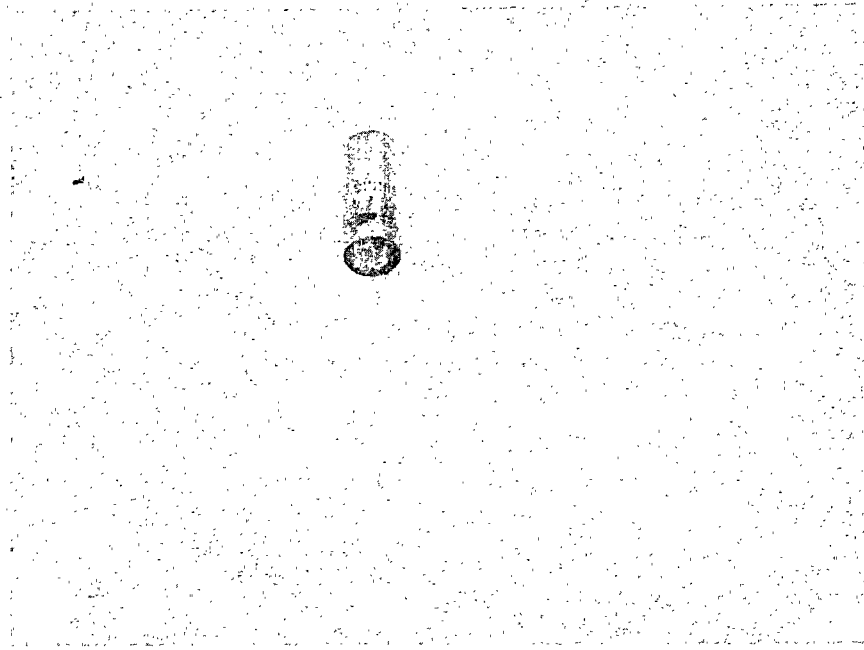
Figure 22. View of partial bullet jacket removed from bullet seat.

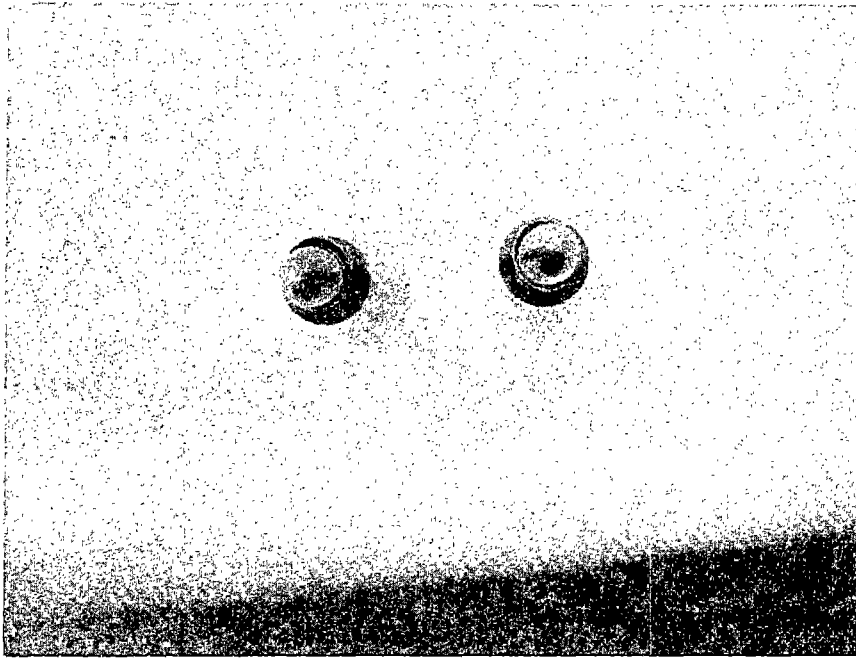
Figure 23. View showing two uncrimped cartridges.

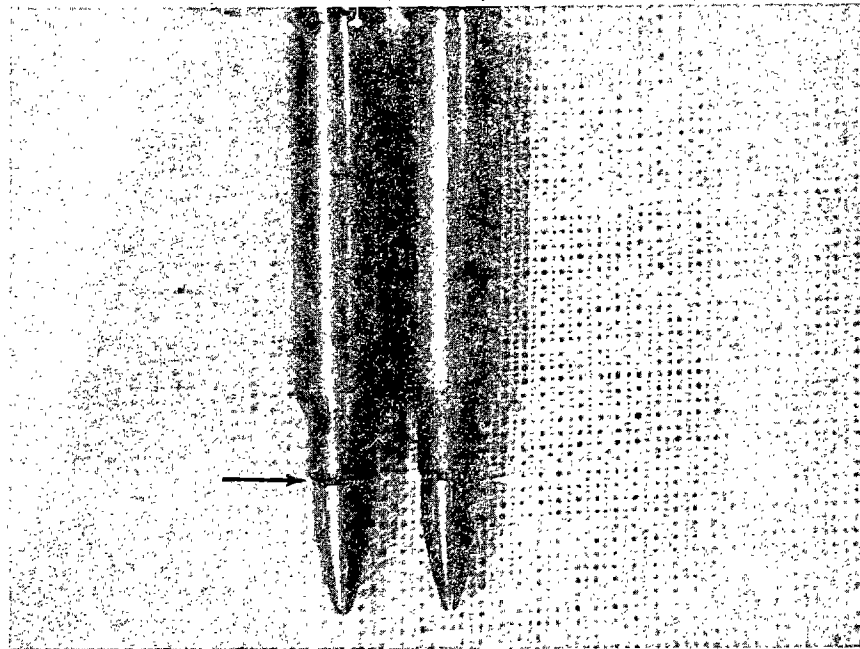
Where modified cartridges failed to produce bullet-in-bore type malfunctions, chambered cartridges elongated as much as .012" beyond the maximum allowable cartridge length due to pressure from the primer (see Figure 24). Exact original lengths of cartridges were not determined although the lengths after hand crimping were gaged for acceptability with a "Go/No-Go" gage.

Figure 24. View showing two modified cartridges after extraction. An observation of the cannellures shows one cartridge which elongated upon firing and a second cartridge which did not elongate upon firing.
