REPORT ON USATECOM PROJECT NO. 8-3-0030-06F
PRODUCT IMPROVEMENT TEST OF BOLT ASSIST DEVICES
FOR RIFLE, CALIBER .223, AR15
REPORT NO. DPS-1120
NOVEMBER 1963

REPORT ON USATECOM PROJECT NO. 8-3-0030-06F
PRODUCT IMPROVEMENT TEST OF BOLT ASSIST DEVICES
FOR RIFLE, CALIBER .223, AR15
REPORT NO. DPS-1120

Test Director: A. Wilson
Infantry and Aircraft Weapons
Division
Development and Proof Services
Aberdeen Proving Ground, Md.

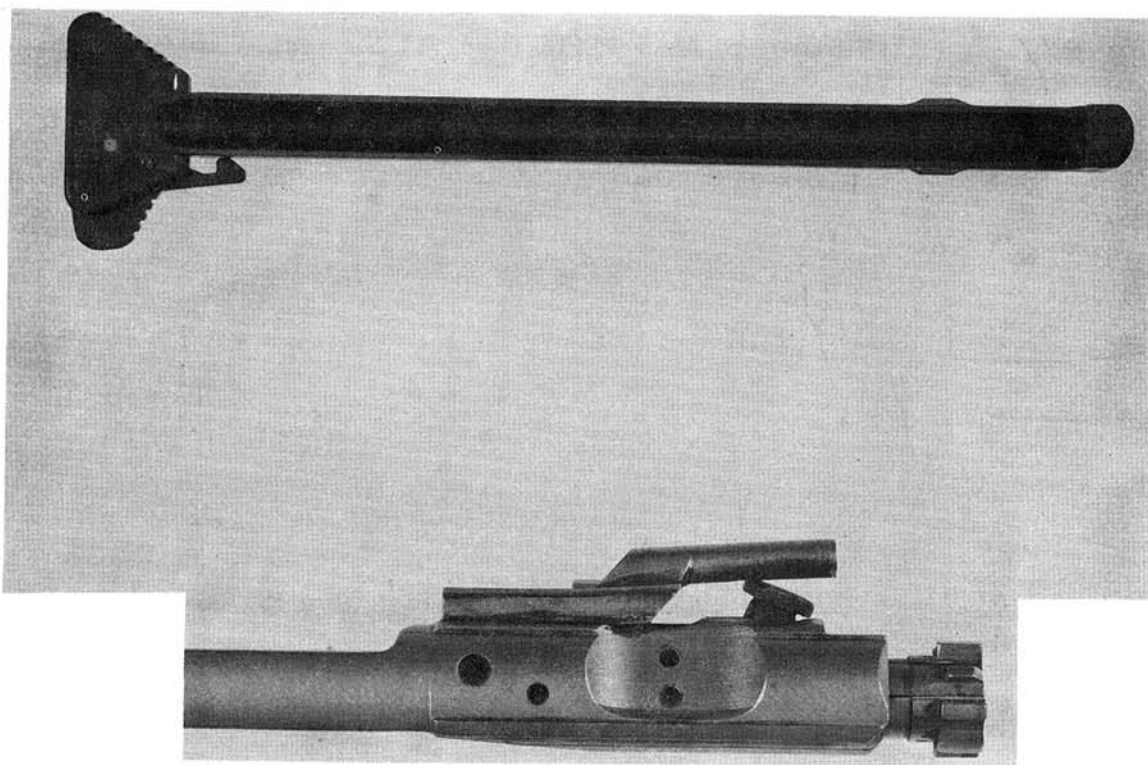
The standard AR15 rifle upper receiver did not crack in the area below the carrying handle. All the components of the magazine except the tube were blown downward and free of the rifle. No rounds were stored in the magazine at the time of the cook-off. Figures 9, 10, and 11 show the over-all view of the rifle, the damaged bolt and undamaged charging handle, and damaged receiver, respectively.

Figure 10: Damaged Bolt and Undamaged Charging Handle from Standard AR15 Rifle (008271) Subjected to Cook-Off.

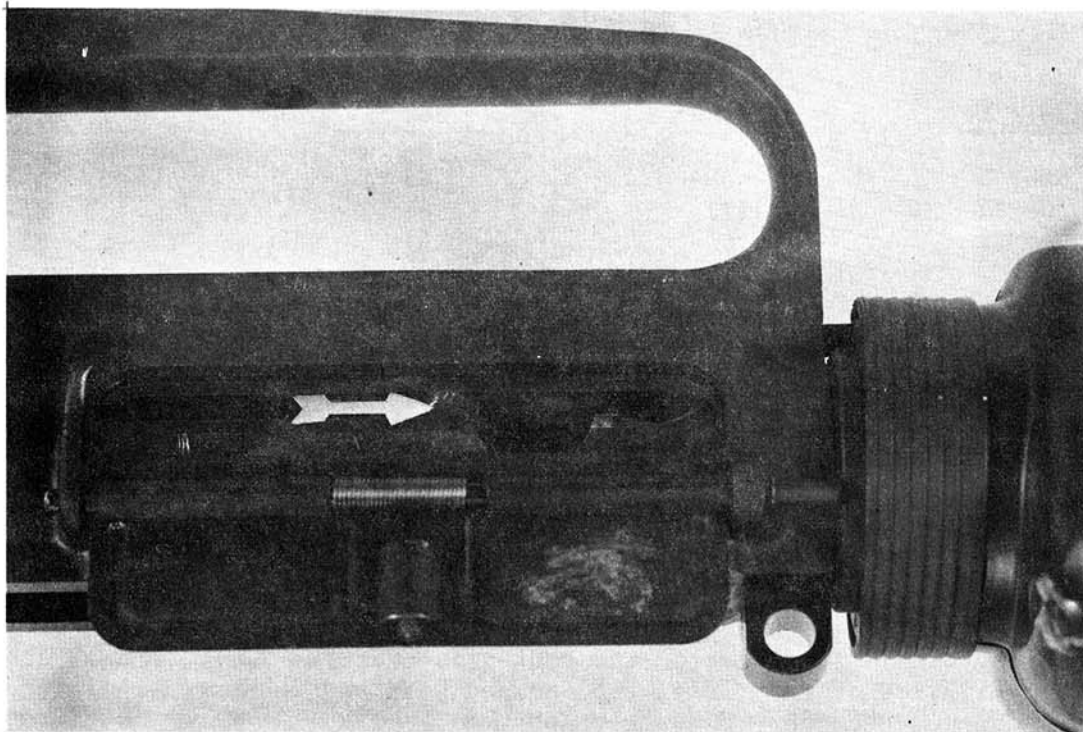
Figure 11: Standard AR15 Rifle (008271) Subjected to Cook-Off. Note Damaged Receiver.

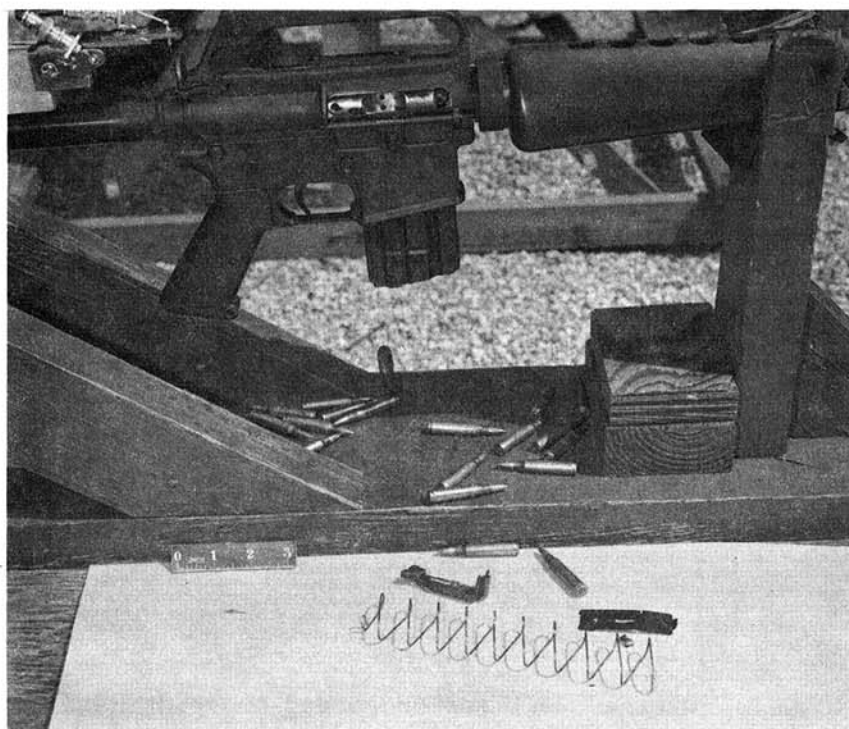
Figure 12: Rifle, AR15 (012548), with Bolt Assist Device Subjected to Cook-Off.

The receiver of the AR15 rifle with the modified charging handle was cracked forward and rearward of the riveted cam plate. All the components of the magazine, except the tube and 19 unfired rounds, were blown downward and free of the rifle. Other than slight damage at the mouth of the carrier key tube, the bolt group appeared undamaged as a result of the cook-off. Additional details on the damages are contained in Appendix C. The rifle is shown in Figure 12.

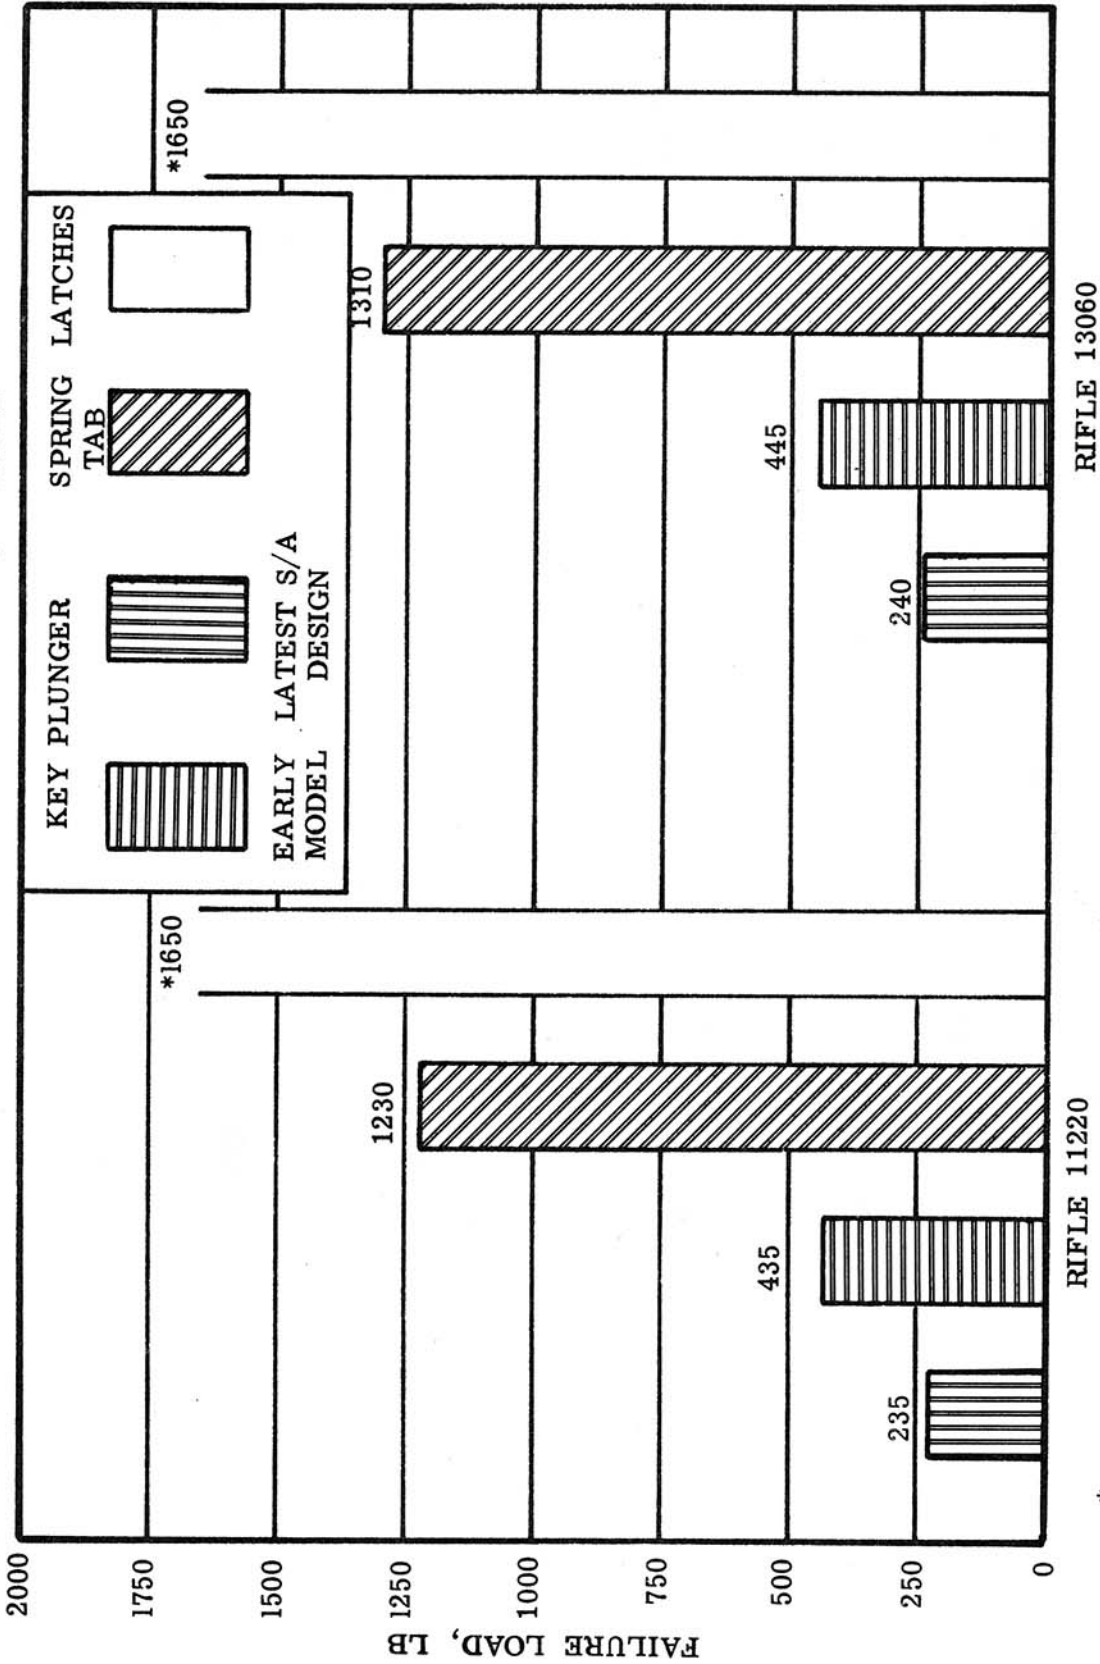
Figure 20: Test of Bolt Assist Device for AR15 Rifle.

- a. Two early model bolt carrier key plungers failed in shear at loads of 435 and 445 pounds; two of the latest plungers failed at loads of 235 and 240 pounds.
- b. Two charging handle spring tabs failed in tension under loads of 1230 and 1310 pounds.
- c. Each of two double-latch charging handles was subjected to a load of 1650 pounds without failure or disengagement of the latches occurring.

* NO FAILURE FOR AN APPLIED LOAD OF 1650 LB

2.6.3 Discussion. The destructive tests revealed that, in the event the charging handle spring is engaged with the carrier key plunger at the time of firing and the charging handle latches are engaged, the carrier key plunger will fail before the charging handle spring will fail, and the spring will fail before disengagement or failure of the charging handle latches will occur.

It is recommended that the charging handle bolt assist device tested not be adopted.

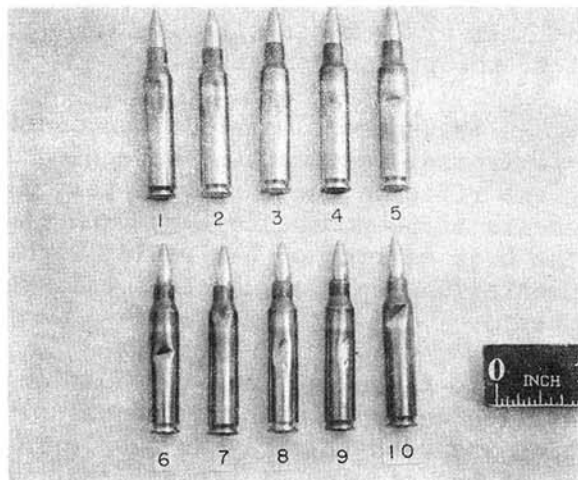
Figure 24: Typical Examples of Damaged Cartridge Cases Used in Extractive and Bolt Closure Force Measurements.

The results also revealed that individuals were capable of exerting far greater loads on the head of the plunger-type and charging-handle bolt-closing devices than is required to chamber cartridges damaged to the extent shown in Figure 24.

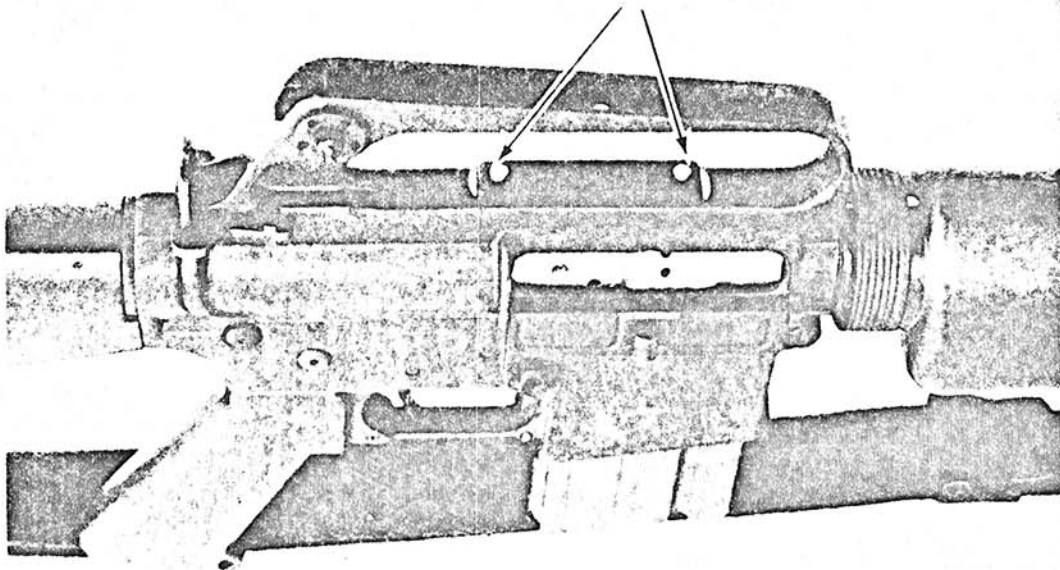
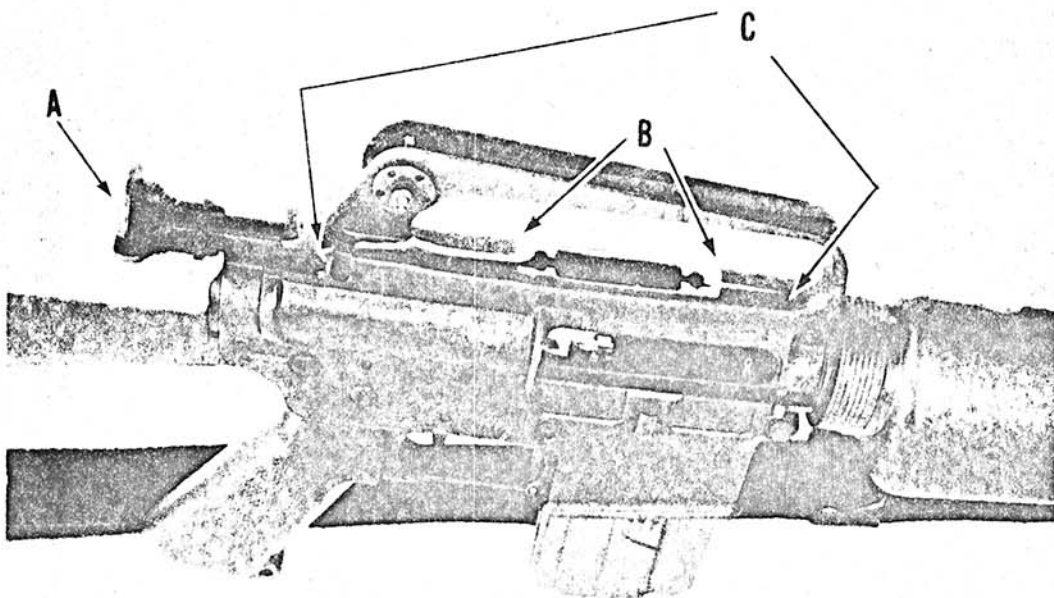
TOP: Modified AR-15 rifle. Note the arrows which point to the protective housing on the top of the receiver. This housing covers the aperture in the top of the receiver which allows the leaf spring in the top of the charging handle to move up when the bolt locks, thus releasing the spring-loaded pin on the bolt carrier.

BOTTOM: A. Darkened spot showing rearmost position reached by the charging handle.
B. Original location of housing for bolt assist device.
C. Ruptured receiver.
