SUBJECT: Final Letter Report of Military Potential Test of Subcaliber Training Device for M16A1 Rifle, TECOM Project No. 8-WE-623-016-001, Report No. APG-MT-4089

3. REPORT TITLE MILITARY POTENTIAL TEST OF SUBCALIBER TRAINING DEVICE FOR M16A1 RIFLE			
4. DESCRIPTIVE NOTES (Type of report and inclusive dates) Final Letter Report 25 April to 19 May 1972

5. AUTHOR(S) (First name, middle initial, last name) Hans H. Brundiek			
6. REPORT DATE June 1972		7a. TOTAL NO. OF PAGES 26	7b. NO. OF REFS 5
8a. CONTRACT OR GRANT NO. Not applicable.		9a. ORIGINATOR'S REPORT NUMBER(S) APG-MT-4089

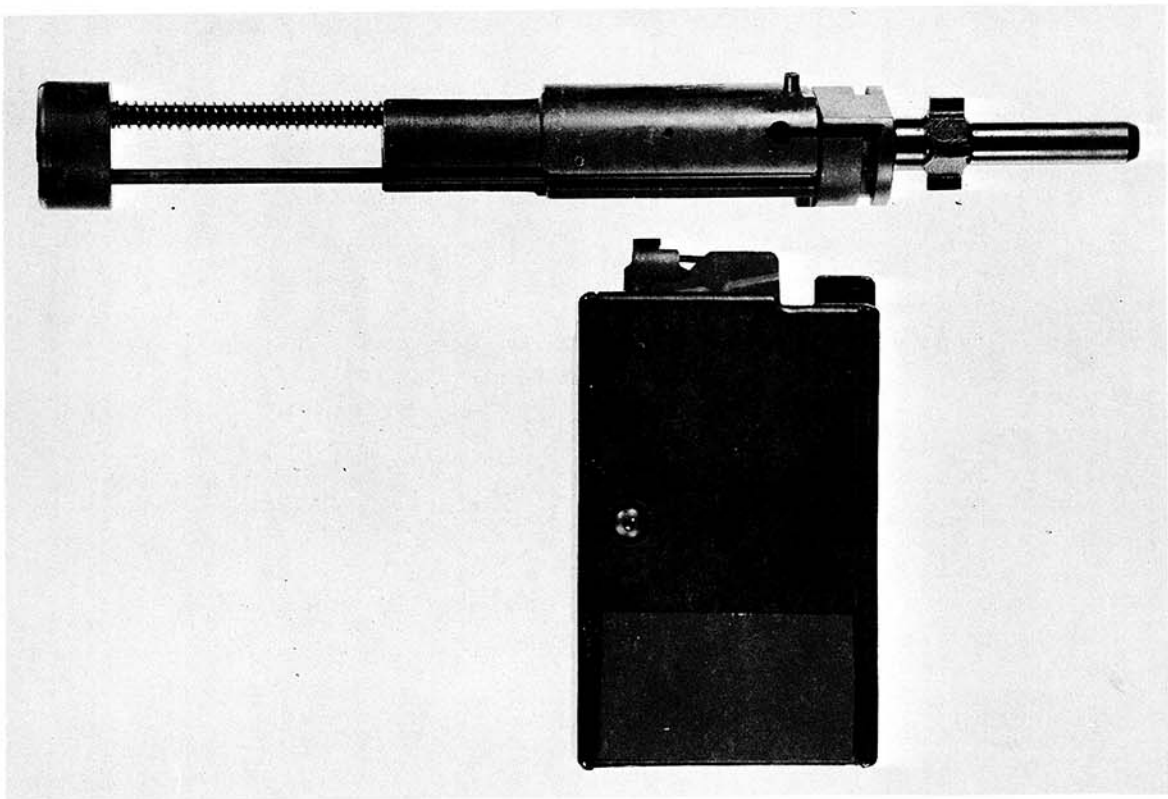
Figure 2.3-1: Code A Device with Magazine.

The visual inspection of the Code A devices showed the over-all appearance of the components to be highly satisfactory; however, the ejector is an integral part of the magazine of this device. Unloading requires hand-cycling with the magazine in the rifle. This is highly unusual and is considered to be potentially hazardous. If the magazine is removed and the bolt is pulled back to clear the weapon in the usual manner, a cartridge will be pulled out of the chamber (and held by the two extractors) but will not be ejected. If this is not observed and the bolt is released, the cartridge will be chambered again.

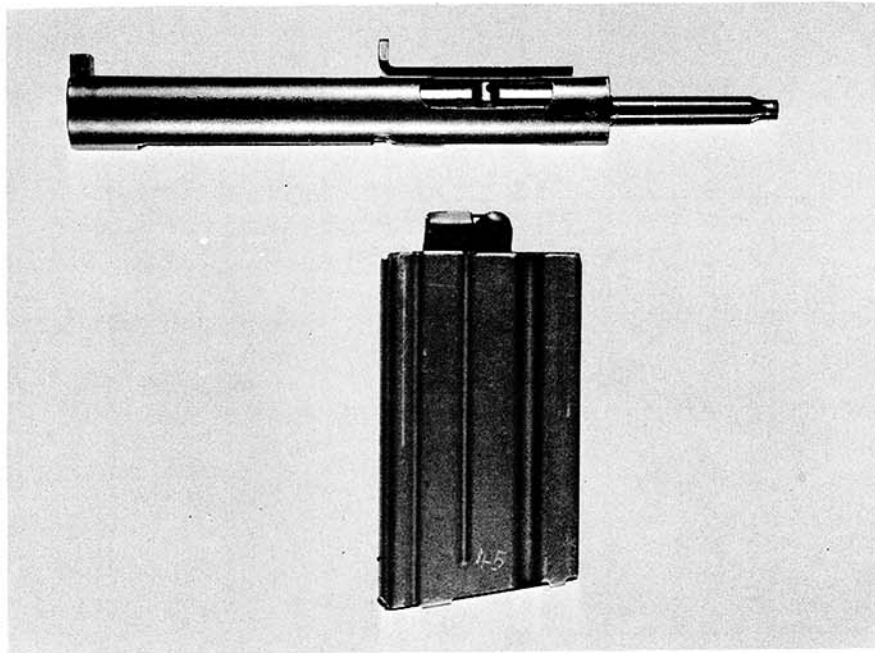
Figure 2.3-4: Code B Device with Magazine.

The Code B devices showed tool marks and a rough surface in the chamber and bore of the barrels. The barrels were also leaded and fouled from previous firings. Photographs were taken of the complete devices (with the magazines), of the field-stripped devices and the magazines, and of the devices completely disassembled (Figures 2.3-1 through 2.3-6).
