REPORT R-1946

ELIMINATION OF GAS TUBE FOULING IN THE
M16A1 RIFLE WHEN USING THE M200 BLANK CARTRIDGE

BRUCE W. BRODMAN
ANDREW J. GRANDY

February 1970

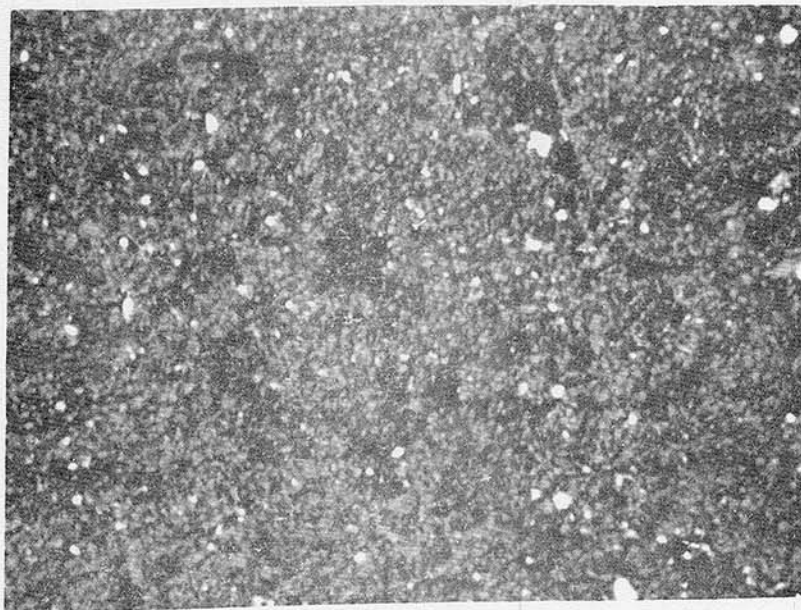
Figure 3. Microstructure, Contamination in M16A1 Rifle Gas Tube

In order to subject the gas tube to further studies, transverse sections 1/4-inch thick were taken at 1-inch intervals along the entire length (labeled A through J starting at the port end) of the gas tube. These sections were mounted and metallographically polished. Microscopic examination of the mounted tube sections showed that Section A (just forward of the port hole) was completely clogged, whereas the other sections contained a thin layer of contamination (5 to 25 mils in thickness) around the periphery of the stainless steel gas tube. Photomicrographs of the fouling residue present in Section A, are shown in Figure 3. A random distribution of shiny metallic particles (0.1 to 2 microns in size) can be seen throughout the specimen; the matrix consists of a slate gray phase containing several patches of a darker gray (or black) phase.

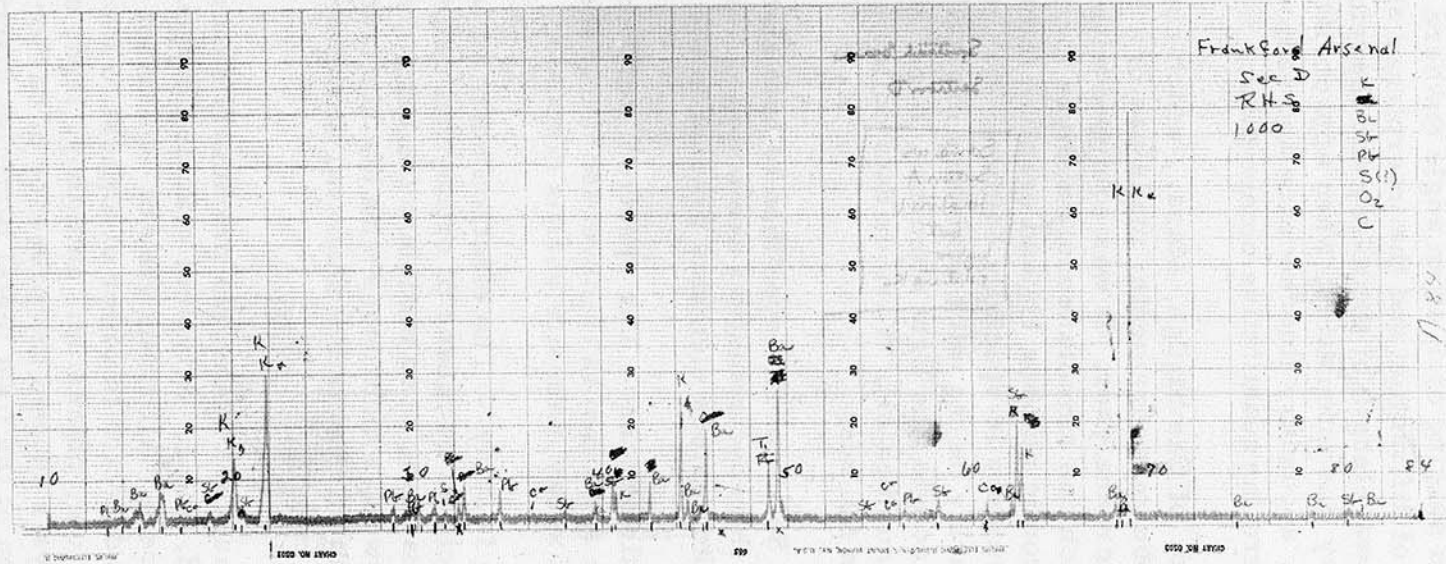
Figure 4. Spectral Scan Gas Tube Section "D"

Spectral scans were run on the previously described gas tube section A, D, G, H, and J. A typical scanning display for section D is shown in Figure 4. All scans yielded equivalent data. The elements that were detected in order of highest to lowest intensity were barium, titanium, potassium, antimony, lead, and sulfur. Light element analysis showed the presence of carbon and oxygen. Specific examination of the light metal particles distributed through the fouling matrix showed a large increase in antimony intensity accompanied by a decrease in all other elements. These particles were, therefore, identified as antimony metal.

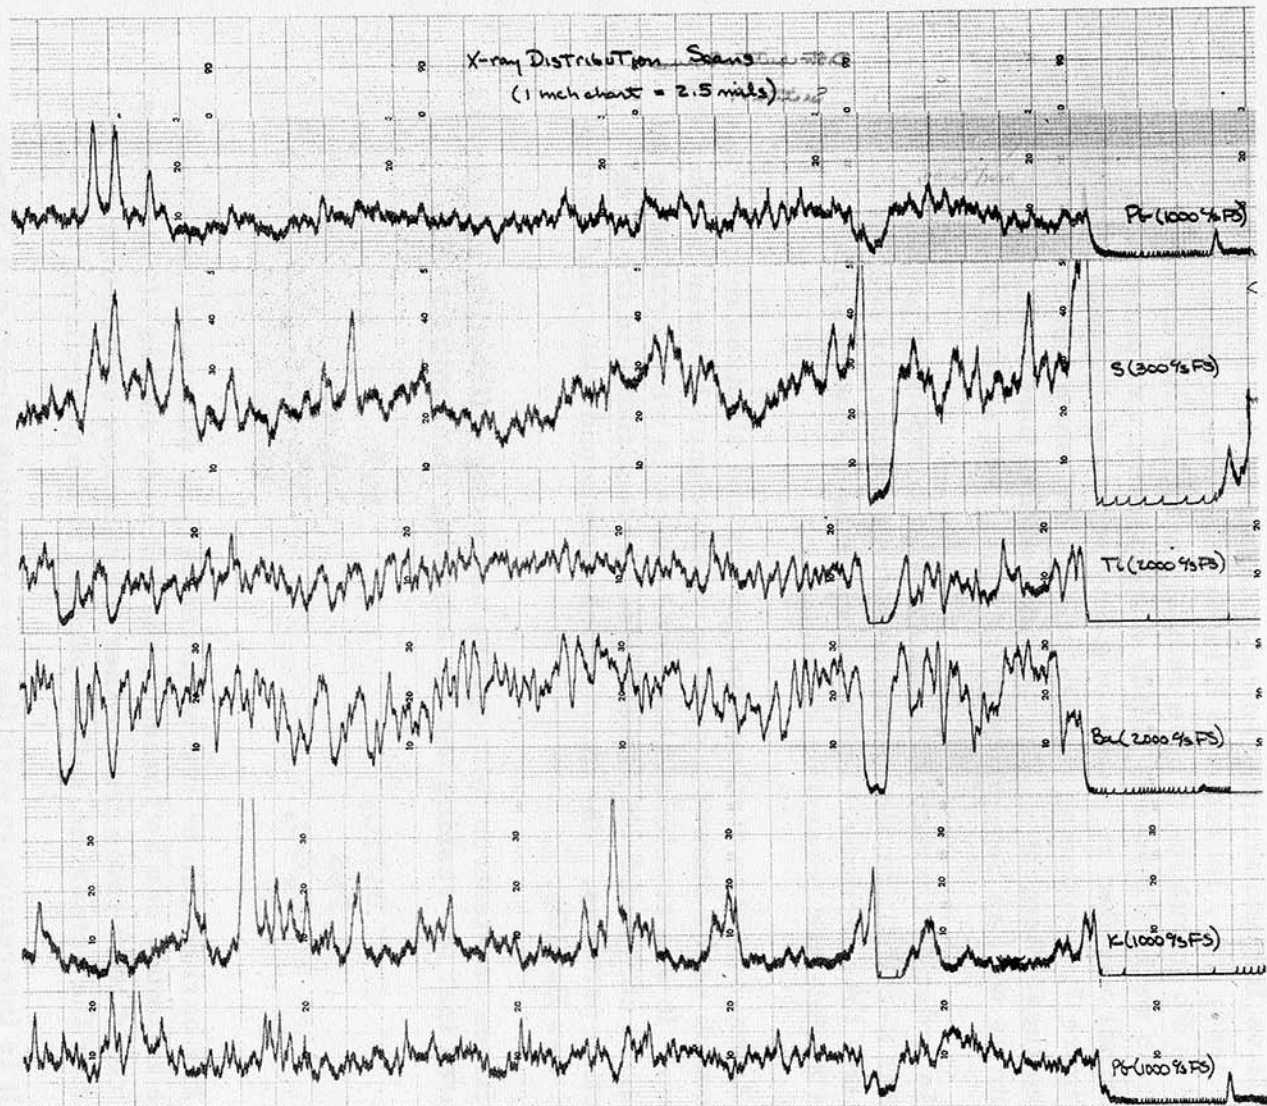
Figure 5. X-ray Distribution Scans (Pb vs S, Ti vs Ba, and K vs Pb)

In order to associate the detected elements with each other, x-ray distribution scans were carried out simultaneously on element pairs (see Figure 5) including lead versus sulfur, titanium versus barium and potassium versus lead. It can be seen in Figure 5 that there is a direct relationship for the first two element pairs (Pb vs S and Ti vs Ba) and an inverse relationship in the case of potassium versus lead; i. e., increase in K intensities are accompanied by a decrease in Pb intensity. These results indicated that titanium and barium as well as lead and sulfur were present as compounds. This was further verified by means of x-ray scanning displays (see Figure 6). Figure 7, a scanning display of K vs Sb, shows no correspondence between these elements. The correspondence between antimony and titanium as well as between lead and sulfur are especially well defined.

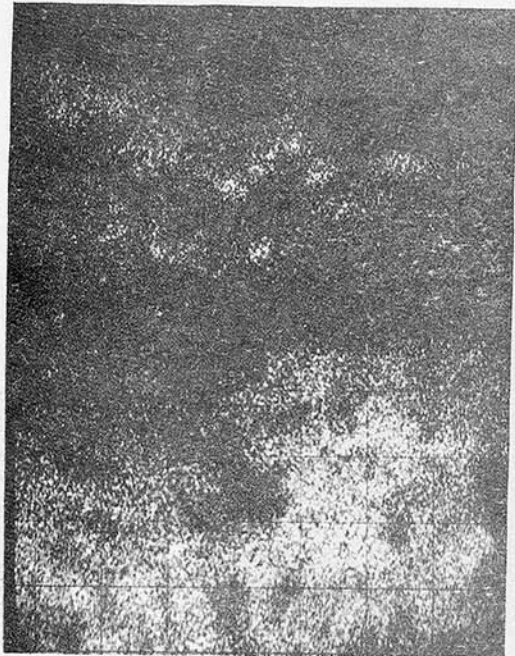
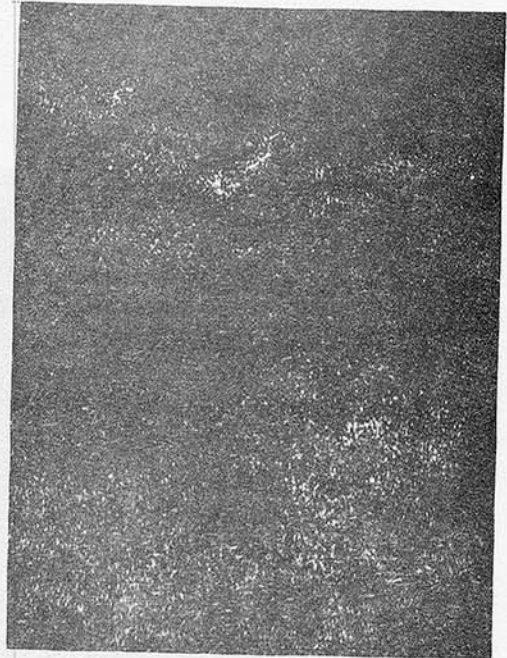
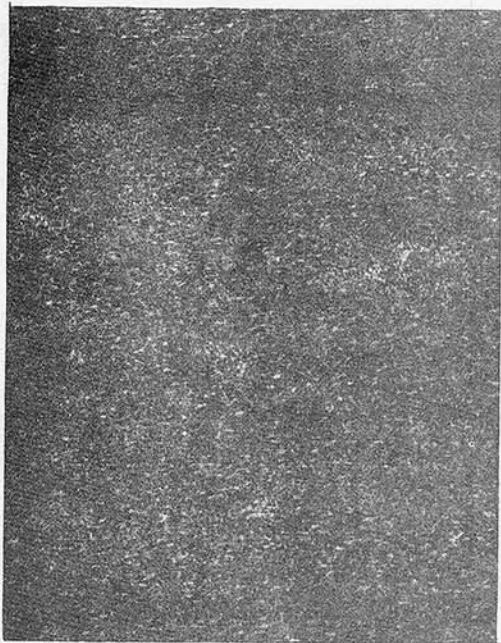
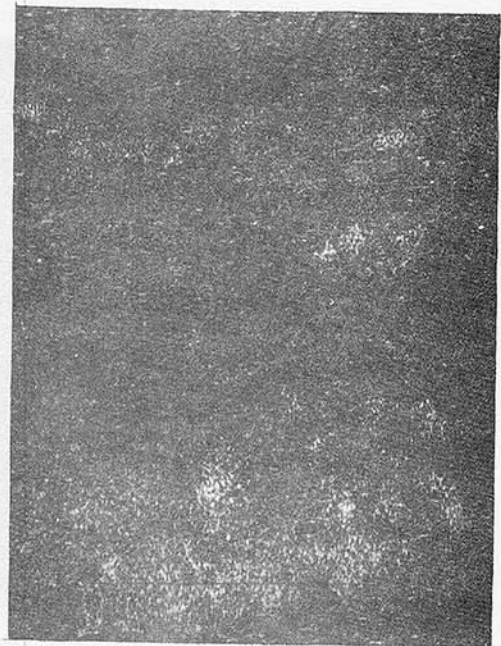
Figure 6. X-ray Scanning Display, Section A (Ba vs Ti and Pb vs S)

X-ray scanning display photographs and electron microprobe distribution scans showed a good correspondence between barium and titanium. It was concluded that these elements were present as an amorphous compound which would not be identifiable in the x-ray diffraction patterns. The most logical compound that could be postulated was $BaTiO_3$.

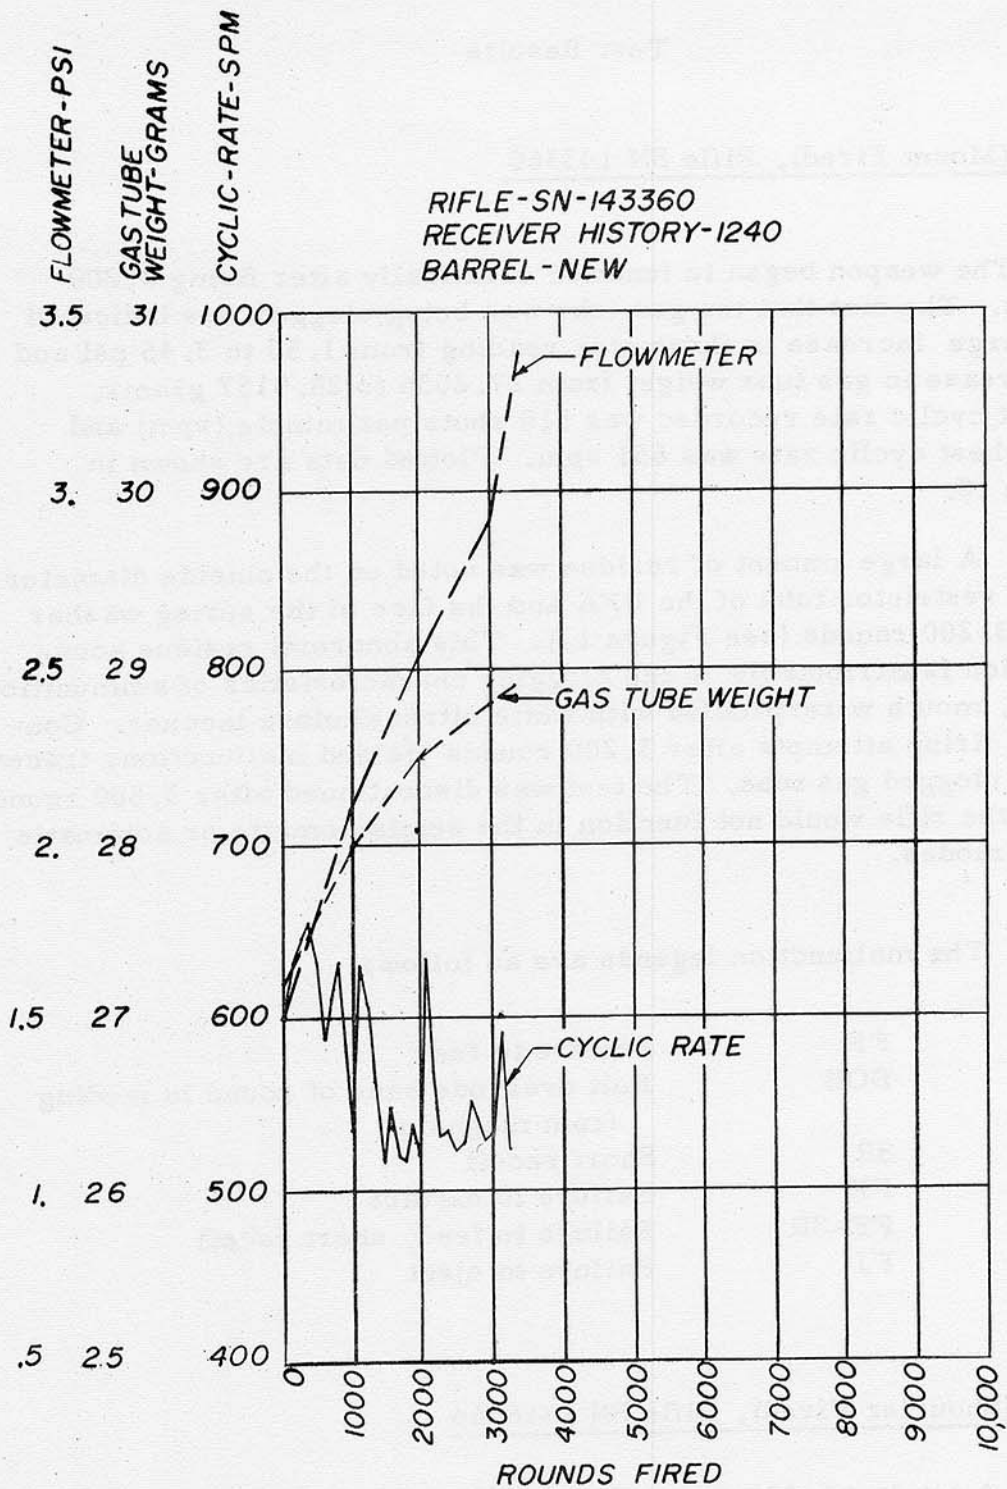
Figure 10. Test Data, Lot A, Mount Fired

The weapon began to function erratically after firing 3,200 rounds. The fact that the gas tube was being clogged was indicated by a large increase in flowmeter reading from 1.50 to 3.45 psi and an increase in gas tube weight from 27.2036 to 28.9157 grams. Lowest cyclic rate recorded was 519 shots per minute (spm) and the highest cyclic rate was 651 spm. Plotted data are shown in Figure 10.

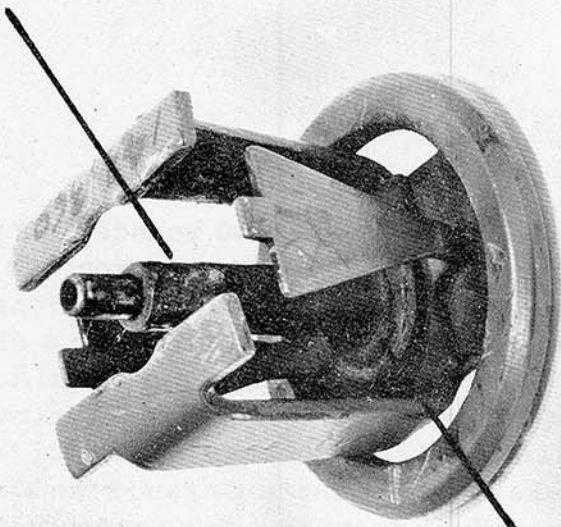
Figure 11. BFA, from Rifle SN 143360

A large amount of residue was noted on the outside diameter of the restrictor tube of the BFA and the face of the spring washer after 3,200 rounds (see Figure 11). This abnormal residue accumulation is attributable to the clogging characteristics of ammunition Lot A, mouth waterproofed with white nitrocellulose lacquer. Continued firing attempts after 3,200 rounds yielded malfunctions traceable to the clogged gas tube. The test was discontinued after 3,500 rounds since the rifle would not function in the semiautomatic or automatic firing modes.

**RESIDUE ACCUMU-
LATION ON SIDE OF
RESTRICTOR TUBE**

**RESIDUE ON FACE
OF SPRING WASHER**

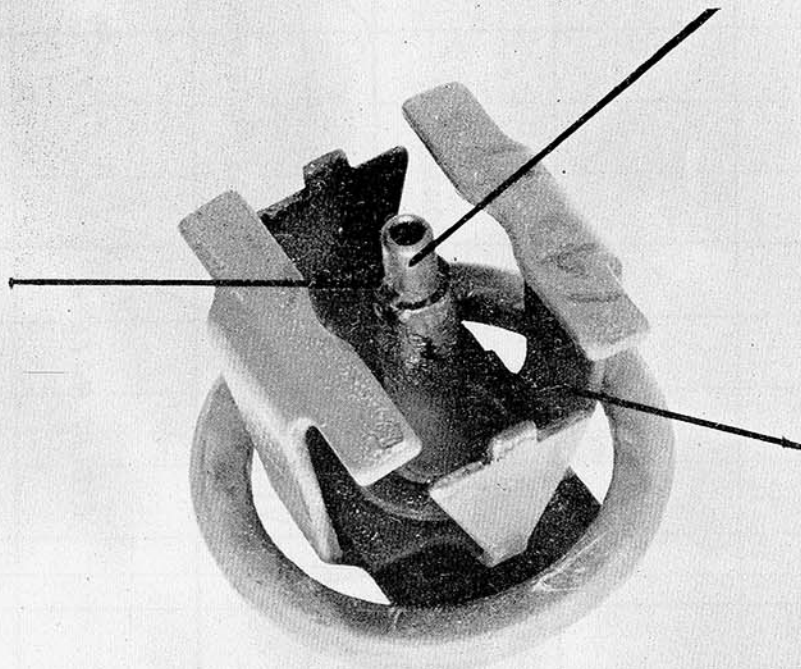
Figure 19. BFA from Rifle SN 143678

A steady decrease in cyclic rate noted after 4,000 rounds was traced to gas leakage on the BFA. Examination disclosed that a large amount of residue had collected on the face of the restrictor tube which mates with the muzzle face of the rifle. Figure 19 is an enlarged view of the BFA from rifle SN 143678 showing the degree of deposit. Note that the gas paths are provided by clearances in the rifling groove diameter of the barrel. Clearly defined is the residue at each groove termination on the restrictor tube face.

GAS PATHS PROVIDED
BY RIFLING IN BARREL

RESIDUE BUILD-UP
ON FACE OF
RESTRICTOR TUBE

RESIDUE ACCUMU-
LATION ON SIDE OF
RESTRICTOR TUBE

Residue buildup on the restrictor tube face ranged from 0.040 to 0.060 inch. Thus, as firing proceeded, the restrictor tube face became positioned progressively further from the muzzle face of the barrel. This allowed a progressive gas leakage with resultant loss of gas energy supplied through the gas tube. No malfunctions were encountered even at the low cyclic rate level. Testing was concluded at 10,000 rounds.
