NO. SWERR-S-2-72

EFFECT OF M193 BALL ROUND FIRED  
THROUGH M15A1 B.F.A. WHEN ATTACHED TO M16A1 RIFLE

## TECHNICAL NOTE

APRIL 1972

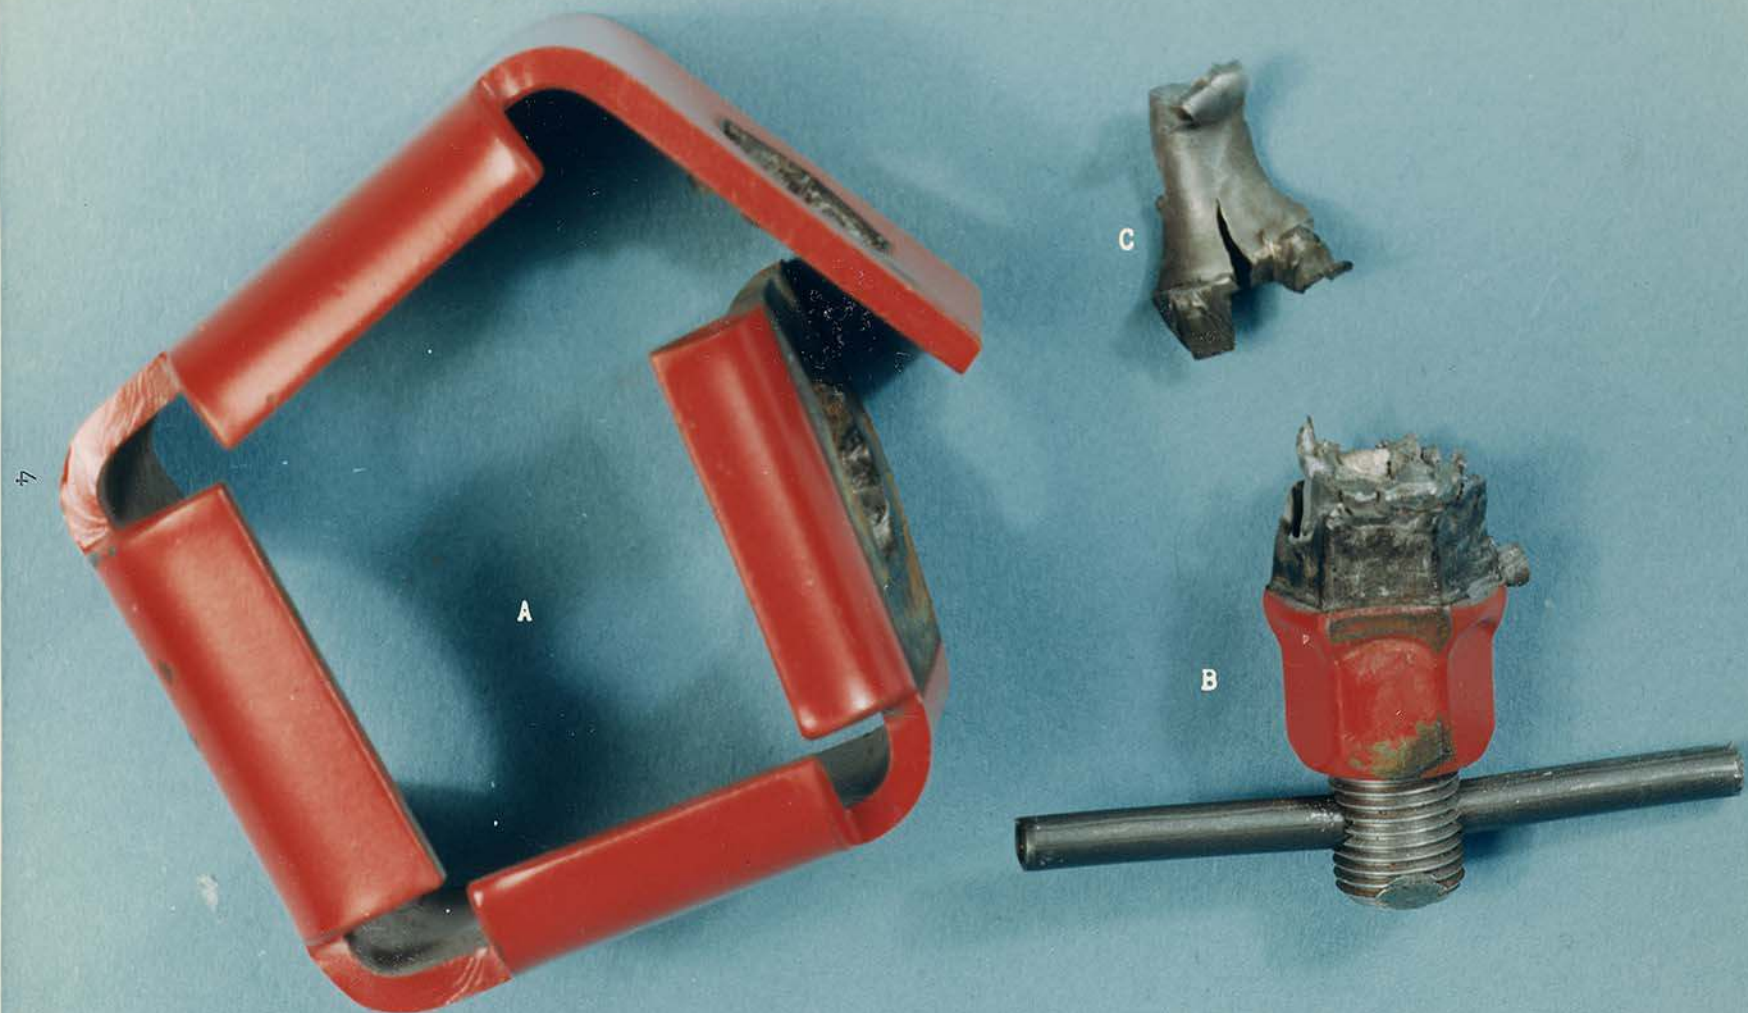
Figure 2

1. The "T" handle end of the restrictor tube with the rivnut (Figure 2-B) separated from the frame (Figure 2-A). This piece was found approximately 65 feet down range at an angle of approximately  $10^{\circ}$  right of the muzzle of the weapon.

3. The frame (Figure 2-A) dropped from the suppressor to the floor, directly below the muzzle.

RECOVERED PIECES OF B.F.A. AFTER FIRING.

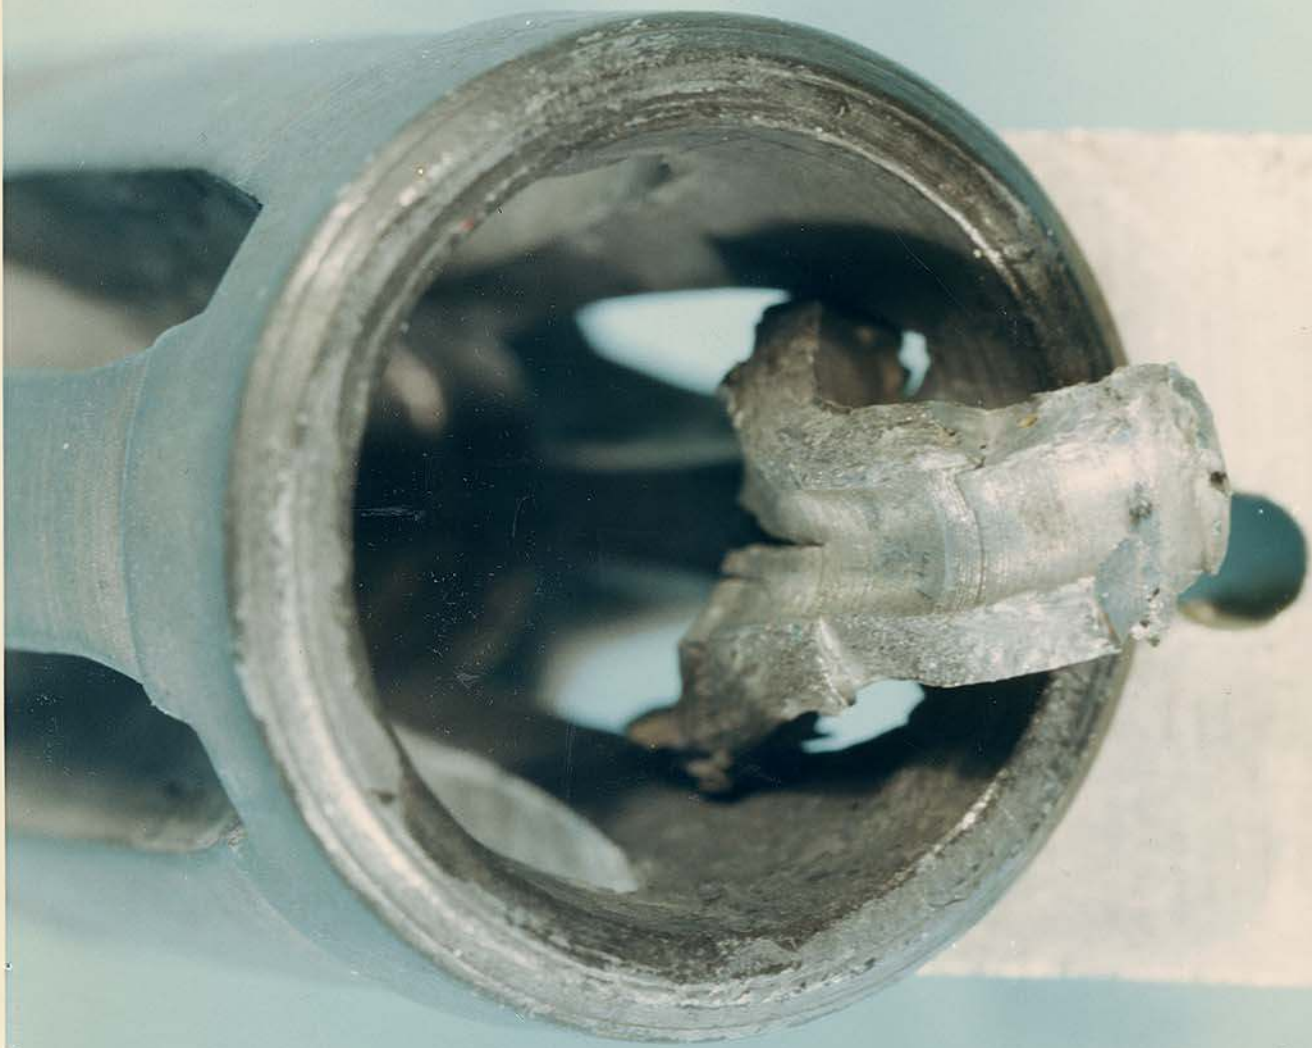
**Figure 3**

2. A piece of the restrictor tube (Figure 2-C) remained lodged in the flash suppressor flutes (Figure 3).

RESTRICTOR TUBE FRAGMENT RETAINED IN FLASH SUPPRESSOR FLUTES.

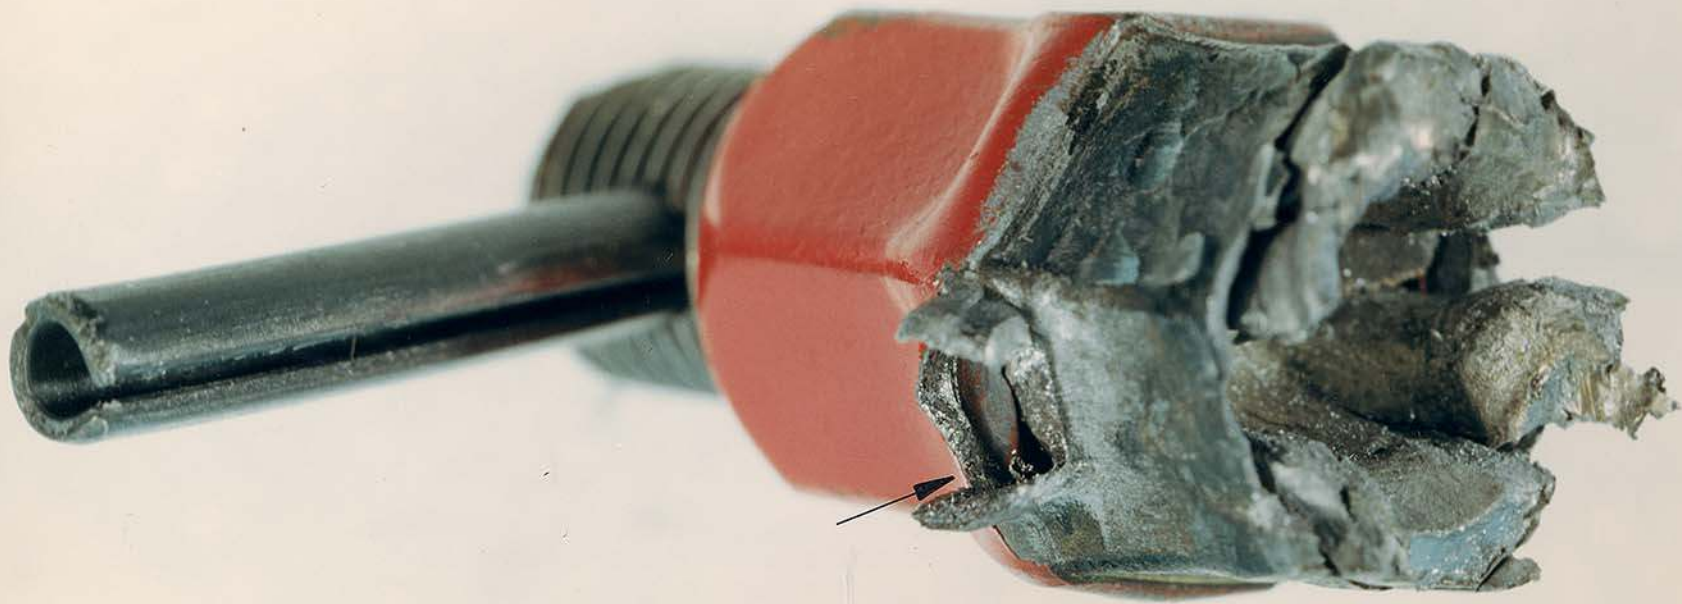
4. Examination of the "T" handle portion of the restrictor tube with nut (Figure 4) revealed that more than 1-1/8 inches of the restrictor tube was blown away. Also, evidence of gilding metal (bullet jacket) was found in the depression of the remaining portion of the restrictor tube. Further examination revealed the appearance of a right angle hole through the rivnut wall at the base of the depression. An arrow in Figure 4 indicates the location of this hole. It is assumed that the right angle hole was produced by projectile fragment exit, because of the presence of gilding metal at the beginning of the hole. The direction of flight that this fragment assumed is not known.

HANDLE END OF RESTRICTOR AND RIVNUT OF B.F.A.

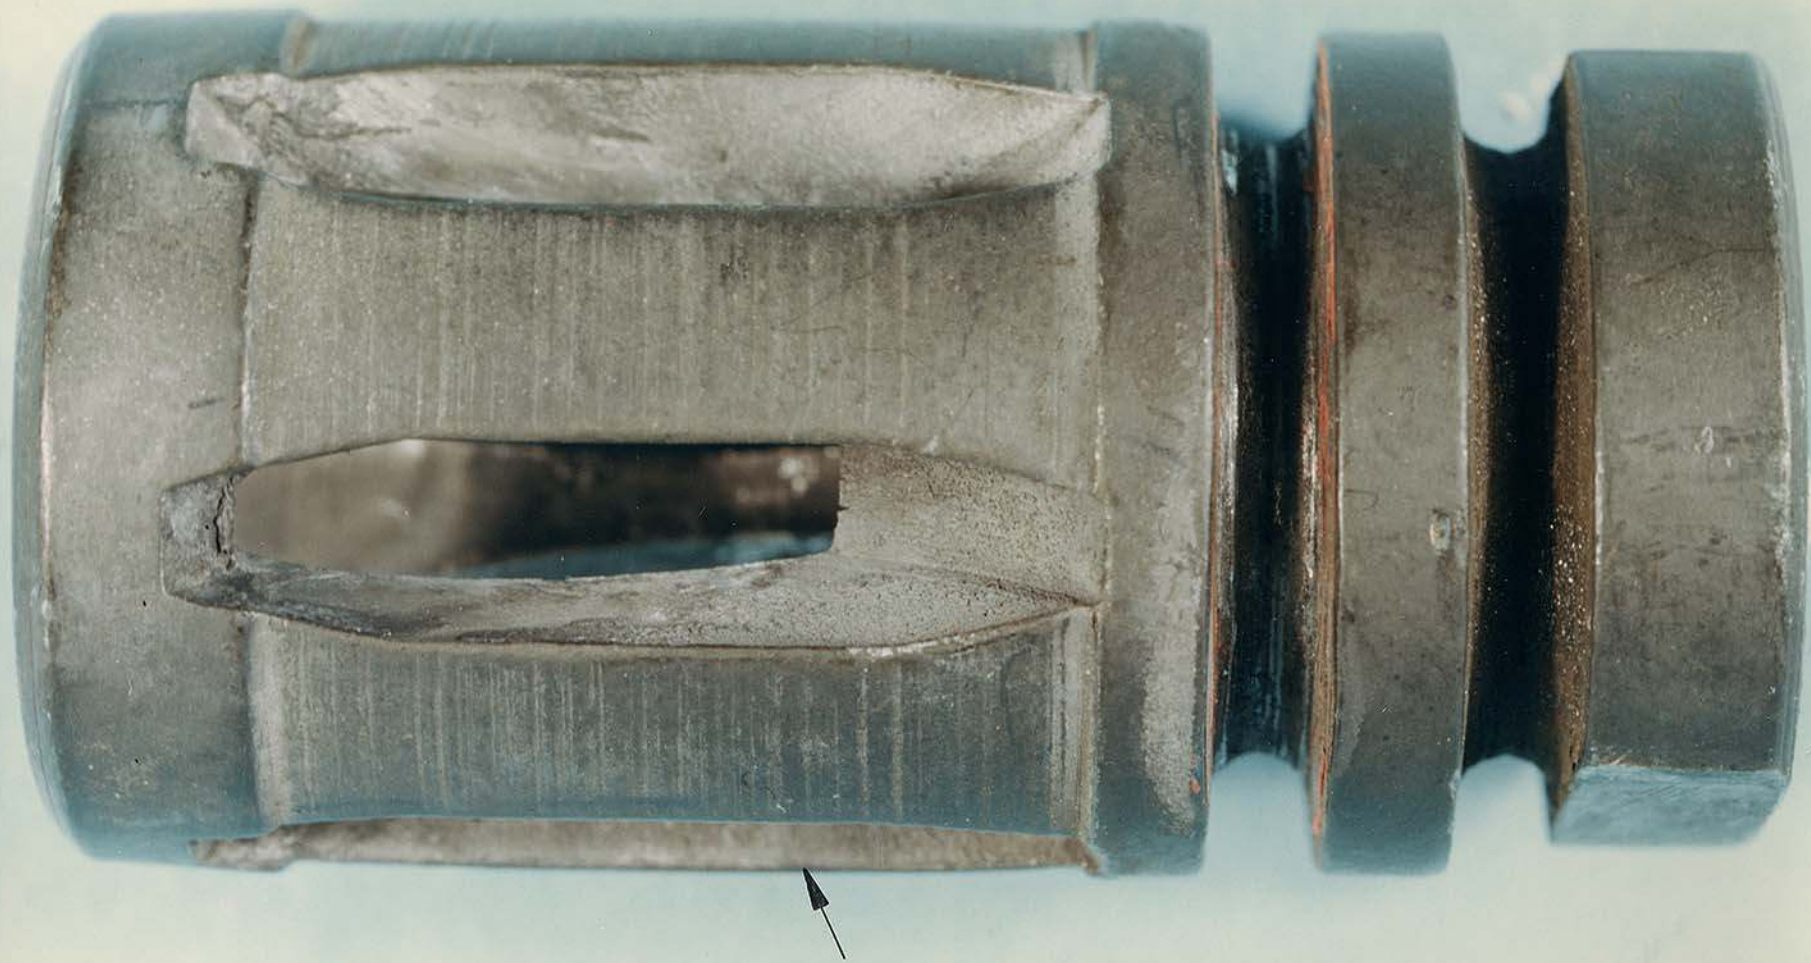
5. The sides of the flash suppressor, all six segments between flutes, exhibited slight expansion/deformation (see Figure 5). An arrow in Figure 5 helps point out a typical bowed segment.

EXPANDED FLASH SUPPRESSOR.
