REPORT ON USATECOM PROJECT NO. 8-3-0030-06F  
PRODUCT IMPROVEMENT TEST OF BOLT ASSIST DEVICES  
FOR RIFLE, CALIBER .223, AR15  
REPORT NO. DPS-1120  
NOVEMBER 1963

U. S. ARMY  
DEVELOPMENT AND PROOF SERVICES

Three models of charging handle bolt assist devices for the caliber .223 AR15 rifle were evaluated for effectiveness in manual extraction and bolt closure operations. A plunger-type bolt closure device was also evaluated. The devices were tested for operation under various adverse conditions, and other special tests were also conducted. Only the plunger-type bolt closing device provided an effective means for closing the bolt under adverse conditions. The modified charging handle did not provide adequate means for extraction operations under adverse conditions. It is recommended that the charging handle bolt assist device tested not be adopted.

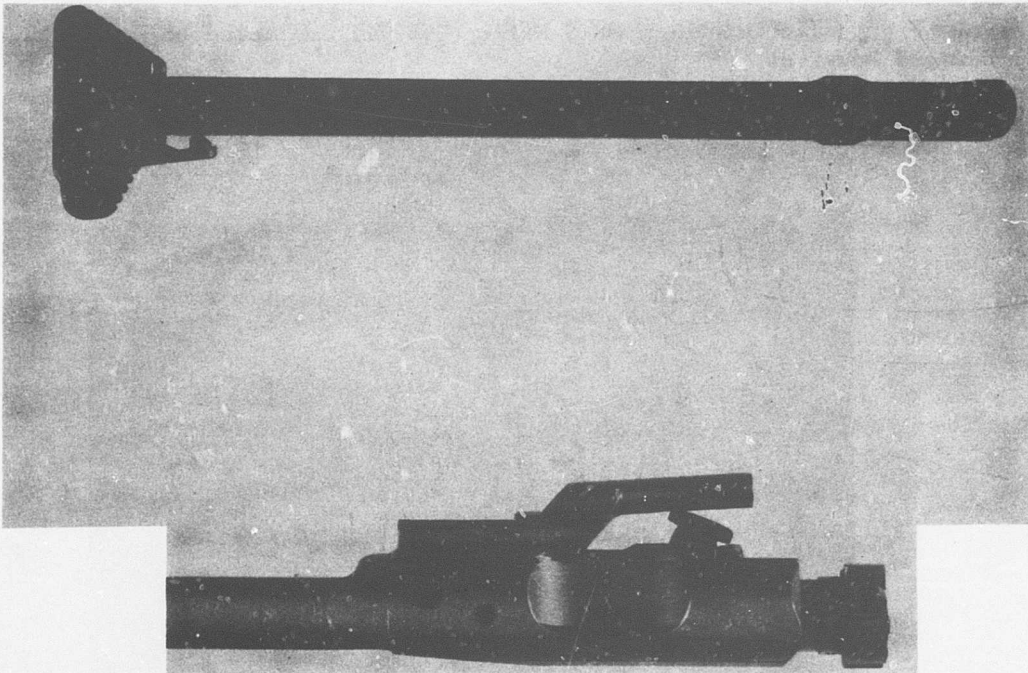
The standard AR15 rifle upper receiver did not crack in the area below the carrying handle. All the components of the magazine except the tube were blown downward and free of the rifle. No rounds were stored in the magazine at the time of the cook-off. Figures 9, 10, and 11 show the over-all view of the rifle, the damaged bolt and undamaged charging handle, and damaged receiver, respectively.

Figure 10: Damaged Bolt and Undamaged Charging Handle from Standard AR15 Rifle (008271) Subjected to Cook-Off.
