June 8, 2003 Rev 1

## TECHNICAL NOTE 56: EXTRACTOR RELIABILITY

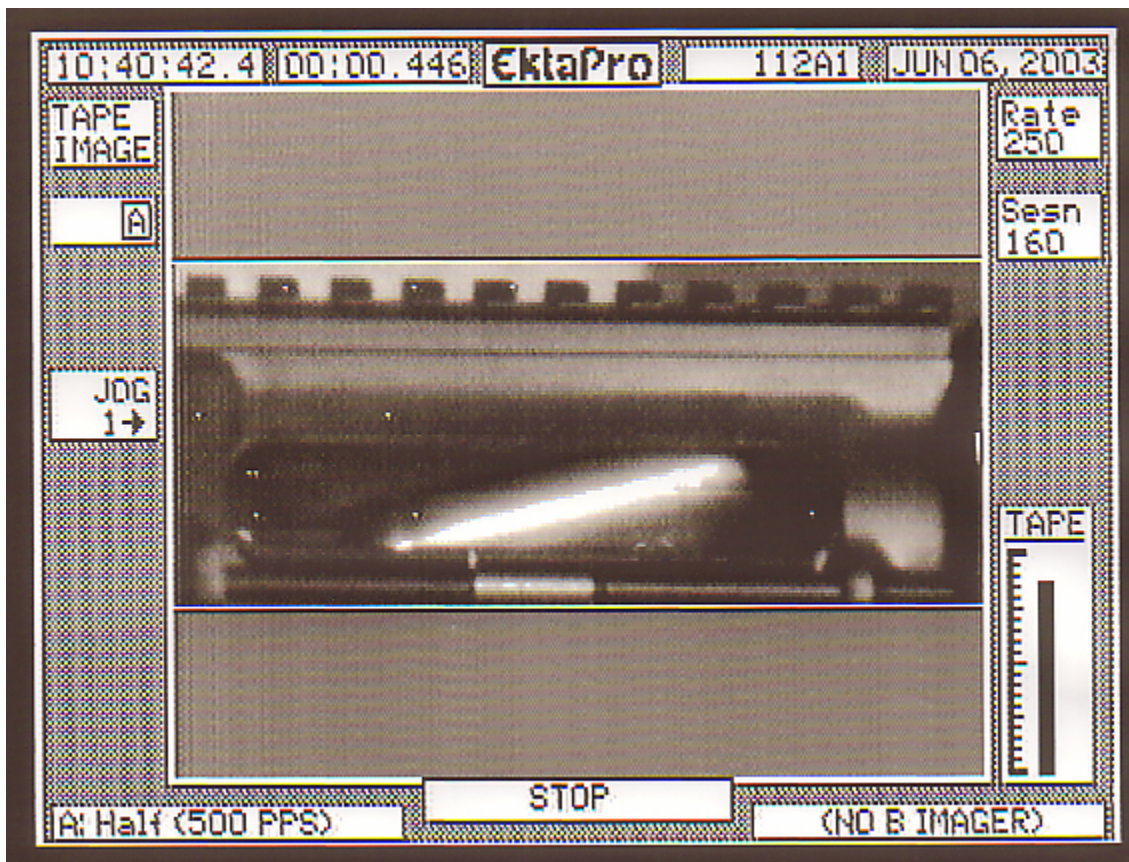
Instead, the case is not ejected from the action and the following round is fed to the chamber. Forward motion of the bolt stops when the fired round stubs between the barrel and bolt face and the next cartridge stops with the bullet tip just inside the chamber mouth (Figure 1). The problem has proved difficult to diagnose because it is infrequent, incorrectly described, and involves a number of subtle causes.

*Figure 1. Fired cartridge jammed between barrel extension and bolt. Following round (not visible) is feeding into the barrel extension.*

The condition is often labeled a “double feed” or a failure to eject. In fact, it is a complex failure to *extract*.

**WHAT TO DO:** Few shooters will ever see this problem, and they don’t need to do anything. Those without the O-ring extractor spring reinforcement should request one and it will be provided at no charge. Shooters suffering this problem should correct the fouling and heating problems noted above, use NATO standard ammunition, and contact ArmaLite for further instructions if the problem continues.

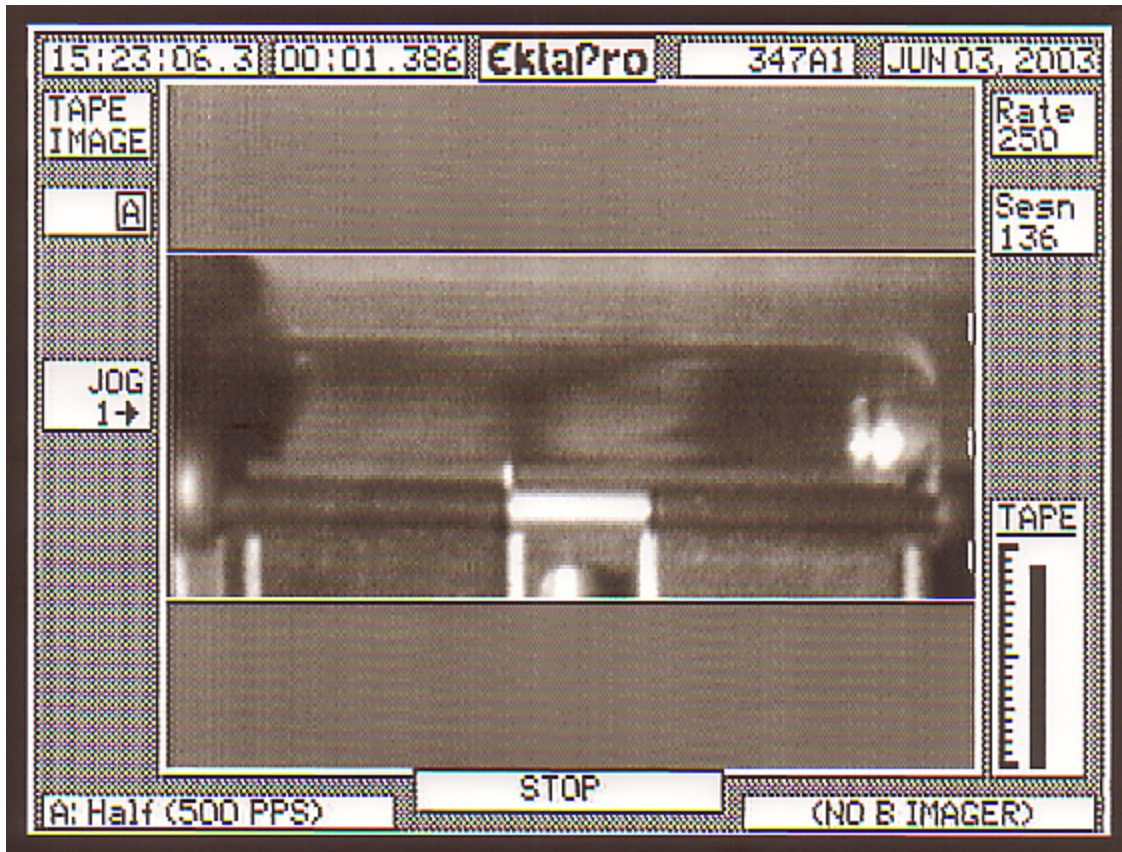
**FINDINGS:** Extensive testing was required to determine that the bolt loses control of the cartridge case very soon after pulling on it strongly enough to mark the rim, but well before the ejector can function. In other words, extraction starts, but doesn’t finish.

**Figure 2.** Bolt is moving to the rear followed by the fired cartridge. The fired cartridge is moving slower than the bolt, and cannot be ejected. Even at 500 frames per second, the bolt movement is blurred by its speed.

A number of elements conspire to create this malfunction and makes it very hard to diagnose. The issues include microscopic damage to the extractor claw caused during deburring at a supplier’s factory, extractor location and orientation, small case head diameters, chamber finish or cleanliness, overheating the rifle by excessive firing rates, and the absence of the extractor spring reinforcement (“O-ring”) in some early extractors.
