MAN: JOHNSON

~~FOR OFFICIAL USE ONLY~~

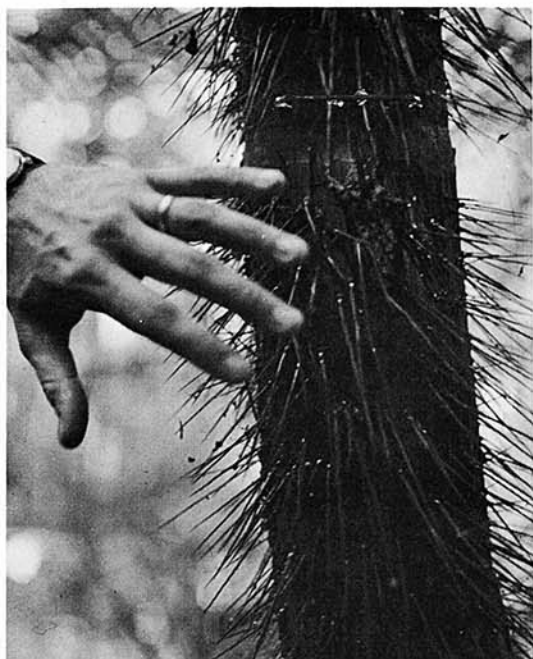
Numerous minor injuries were caused by the sharp spines of the black palm tree.

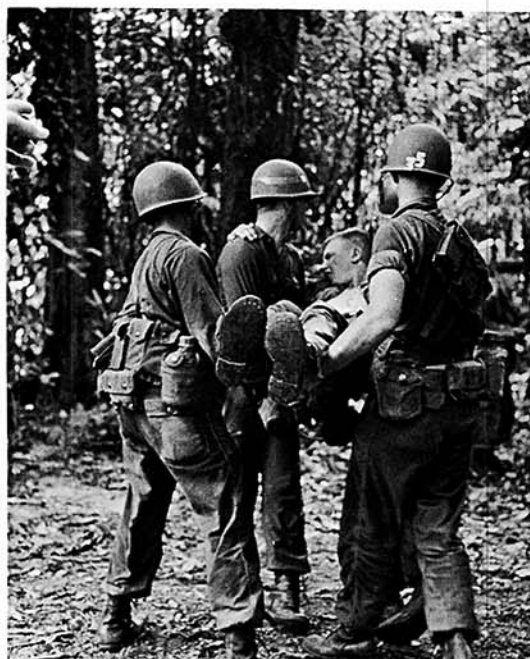
Marine lands in hornets' nest while seeking cover during simulated enemy fire. He was back to duty the next day.

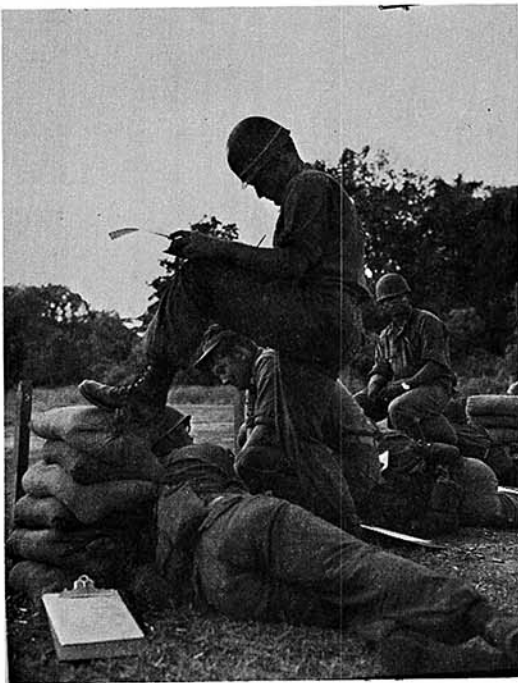
Armorer checks malfunction cause.

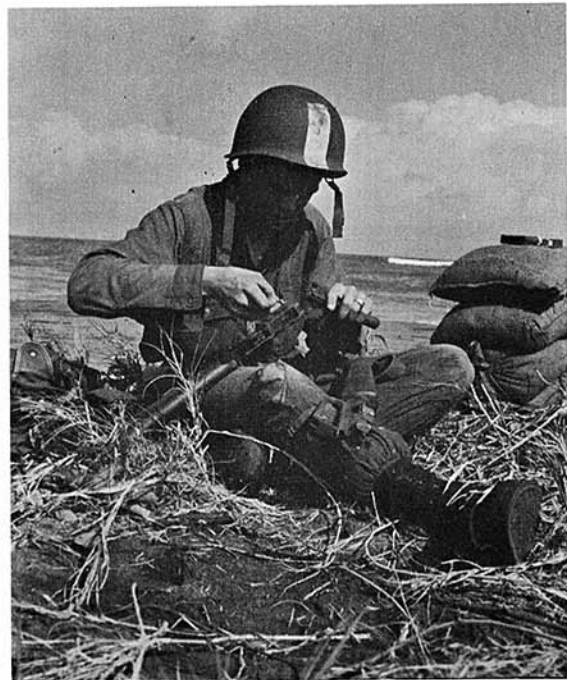
Rifleman cleans weapon on firing line.  
A Category II malfunction.

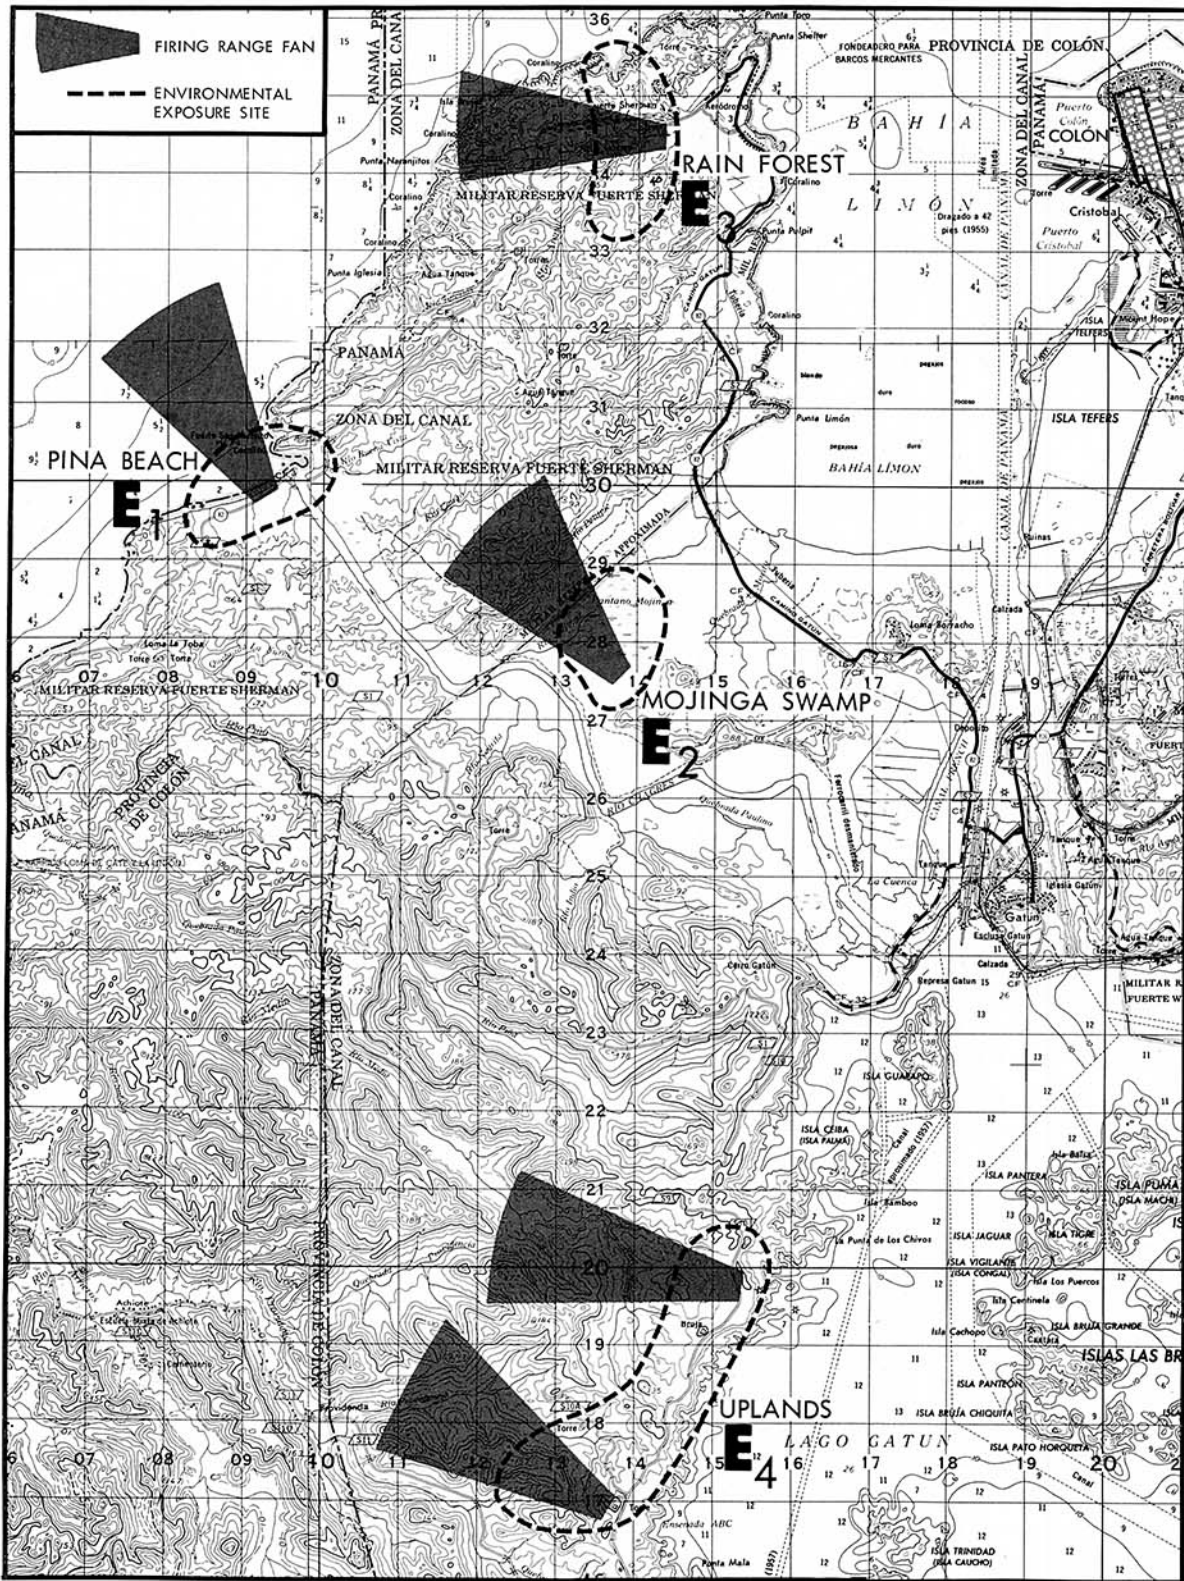
The sites were examined by the Tropic Test Center personnel on 13, 14, and 15 January 1968. The descriptions which cover topography, vegetation, and ground and water, represent conditions existing at that time. Information concerning atmospheric salt content is derived from prior studies made by the

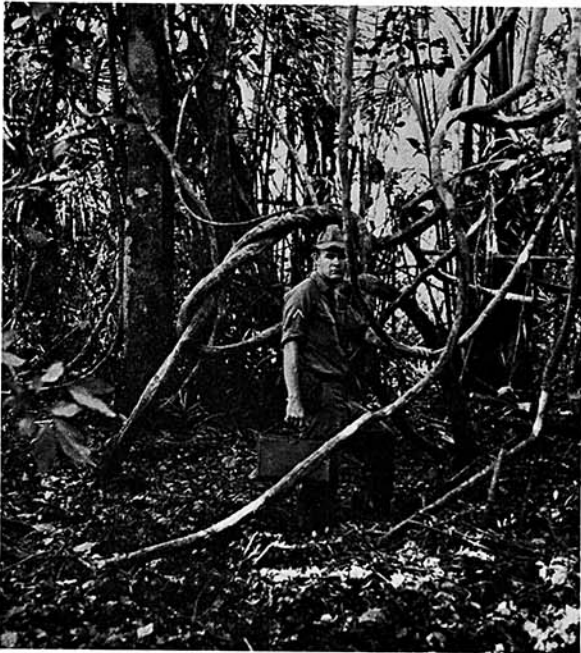
FIGURE H4. Transitional Zone Between Damp and Inundated Area. Note Depth of Muck and Increasing Density of Undergrowth and Lianas

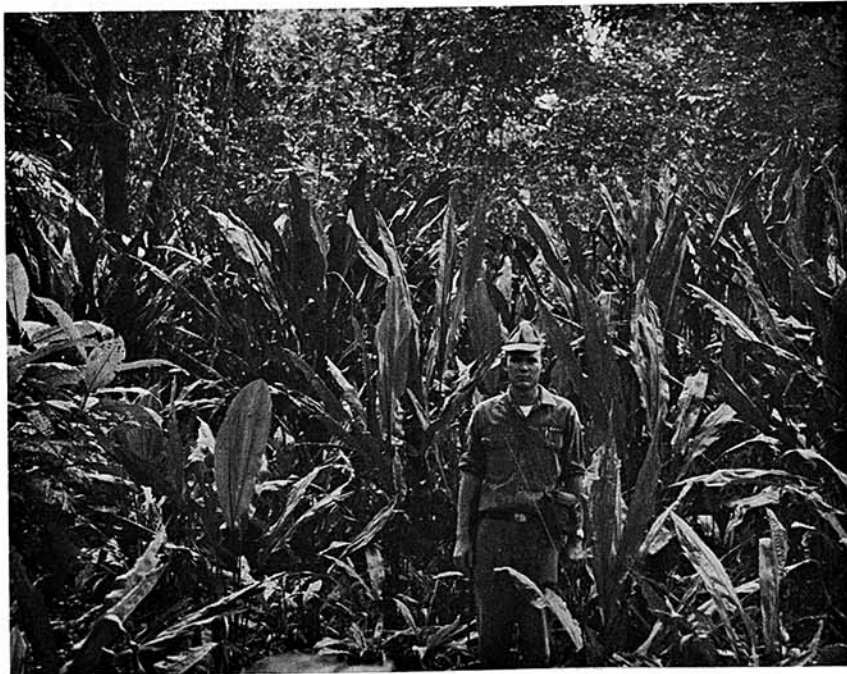
FIGURE H9. Vegetation in a Clearing 400 Meters from Devils Beach Road

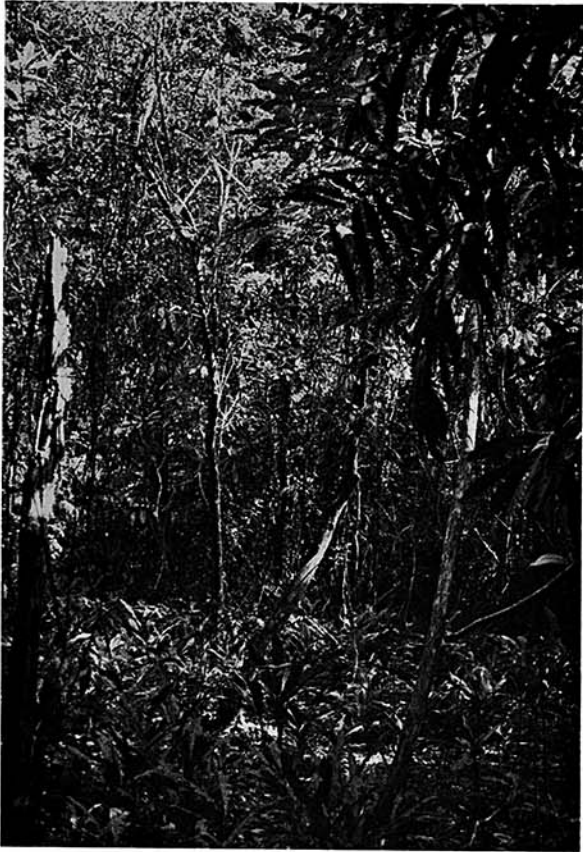
FIGURE H10. Vegetation Density in Southern Exposure Site

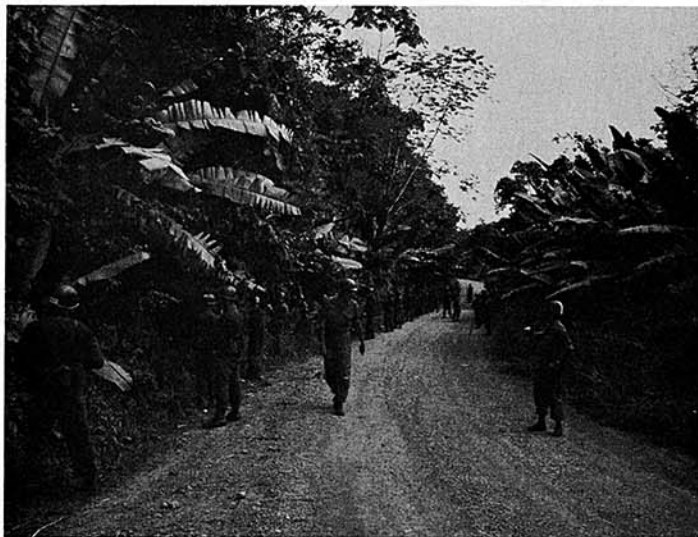
FIGURE H14. View Southward Along Road S-10  
Adjacent to Southern Exposure Site (Steep Hill  
on Left)

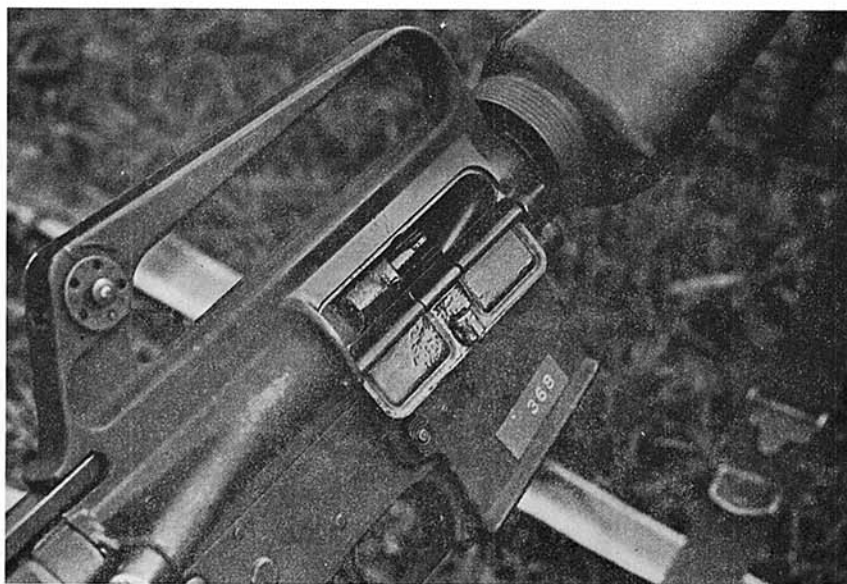
FIGURE I1. Failure to Chamber (Note Lubricant on Dust Cover)

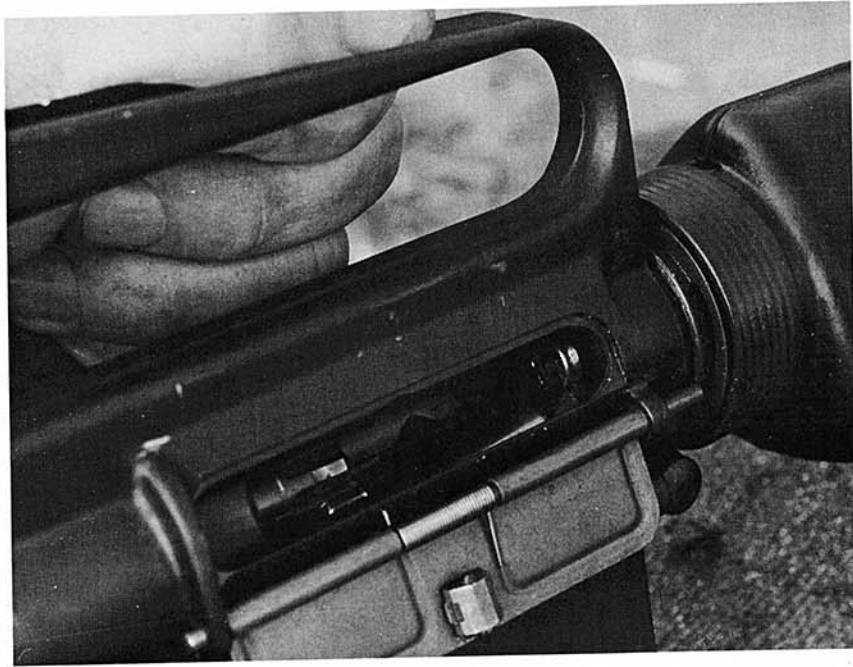
FIGURE I4. Failure to Extract (Note Head of Cartridge Showing in Chamber)

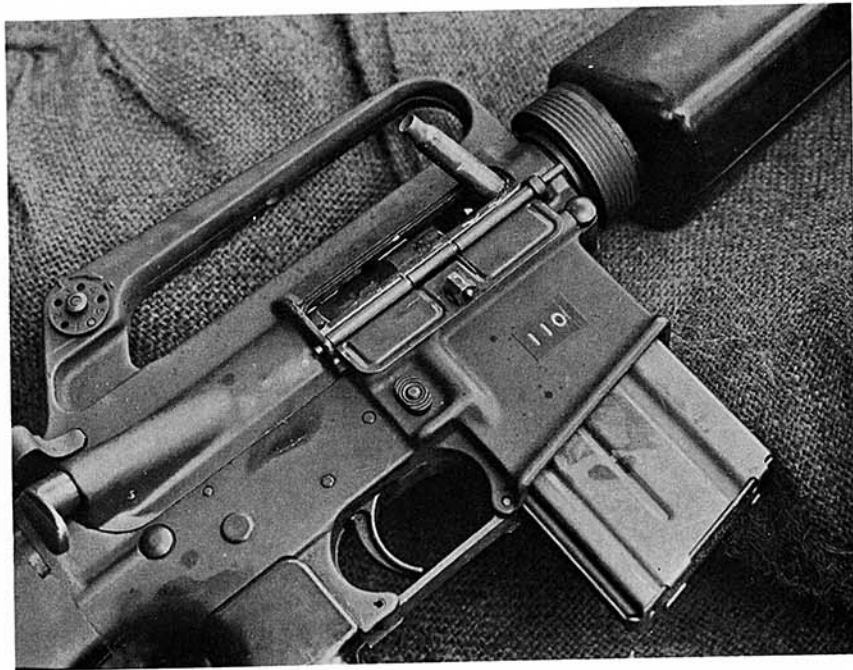
FIGURE I5. Failure to Eject (Cartridge was not Thrown Free)

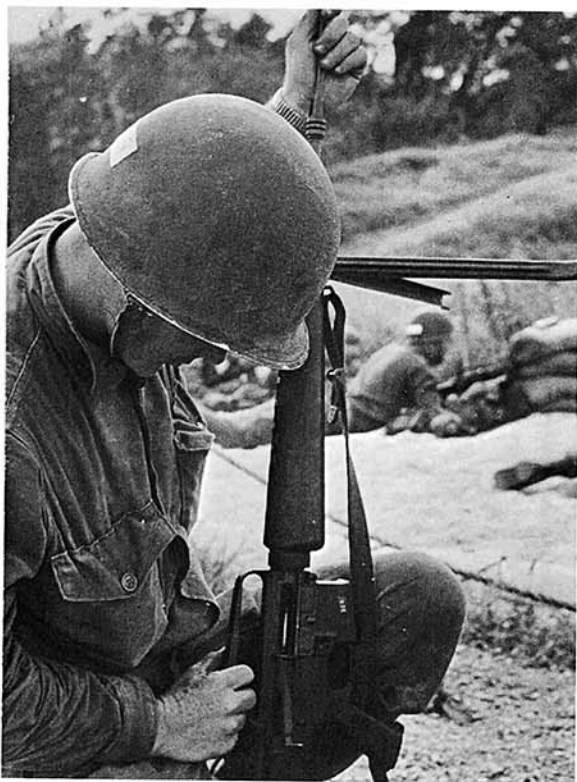
FIGURE I 6. Rifleman Using Cleaning Rod to Dislodge Expended Cartridge Which the Rifle has Failed to Extract

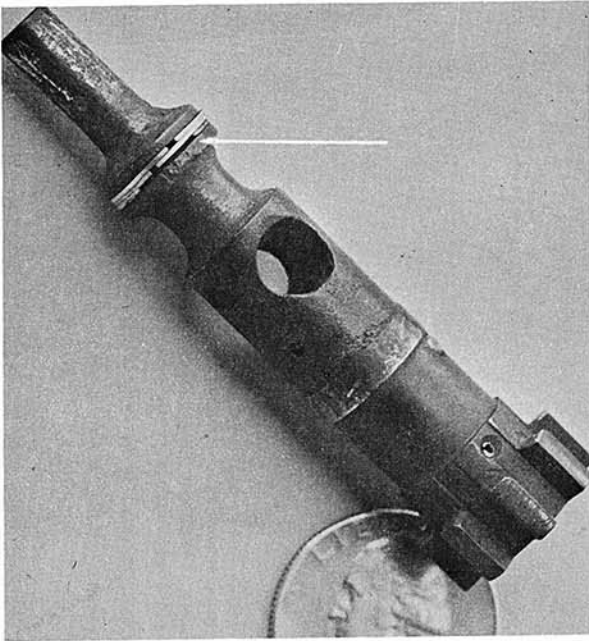
FIGURE I7. Broken Bolt Ring

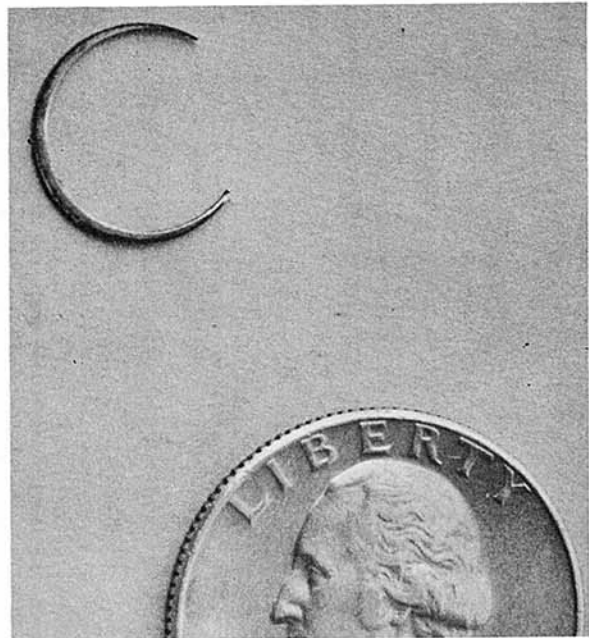
FIGURE I8. Worn Bolt Ring

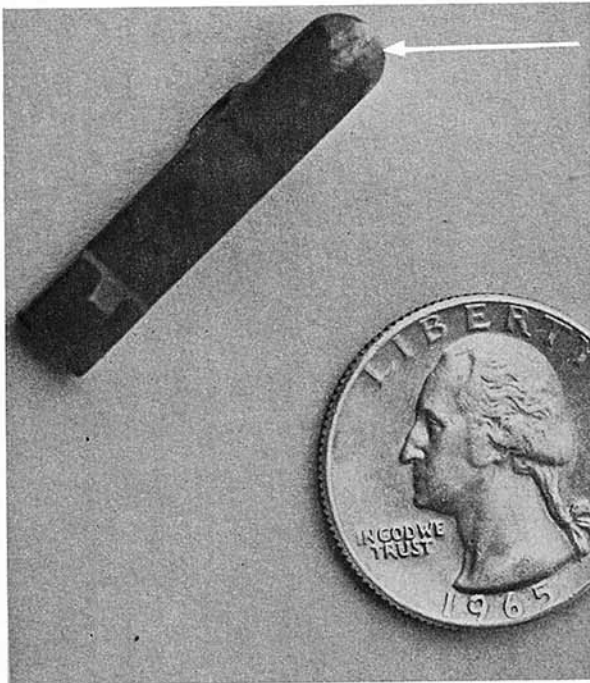
FIGURE I9. M-16 Rifle Extraction (Note Chafed Area Due to Binding)

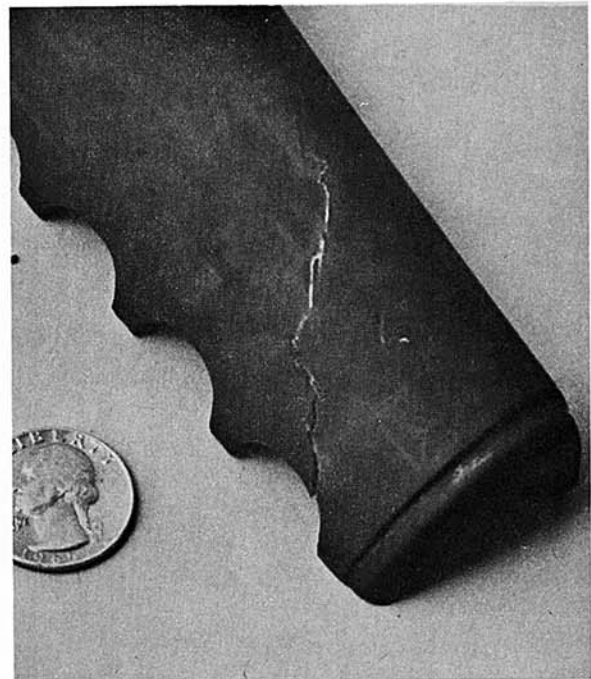
FIGURE I10. Broken Handguard from M-16 Rifle

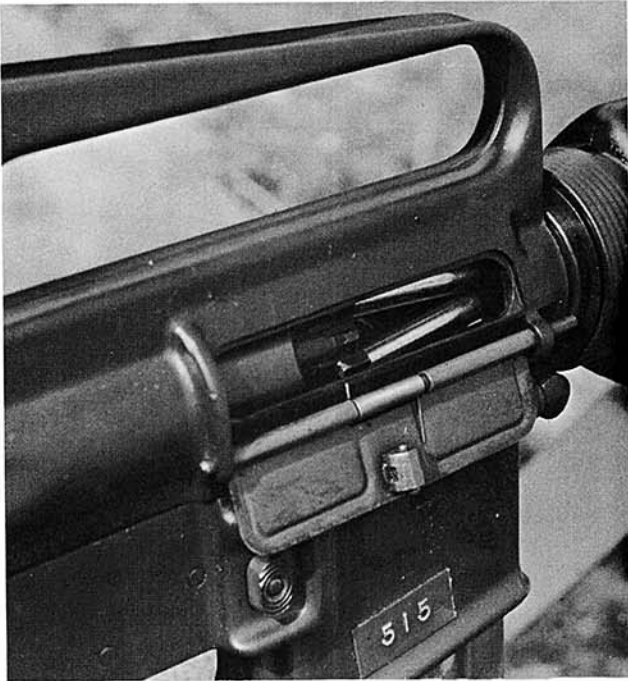
FIGURE I 11. Double Feed

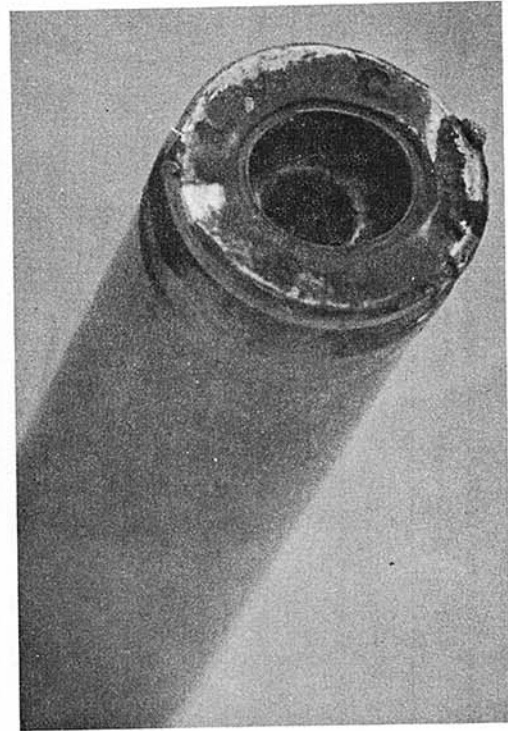
FIGURE I16. M-16 Cartridge with Defective Primer

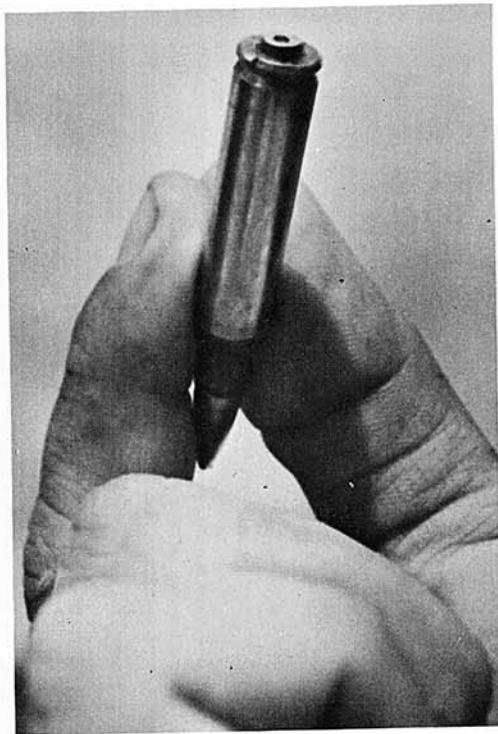
FIGURE I17. M-16 Cartridge with Defective Primer. Propellant did not ignite

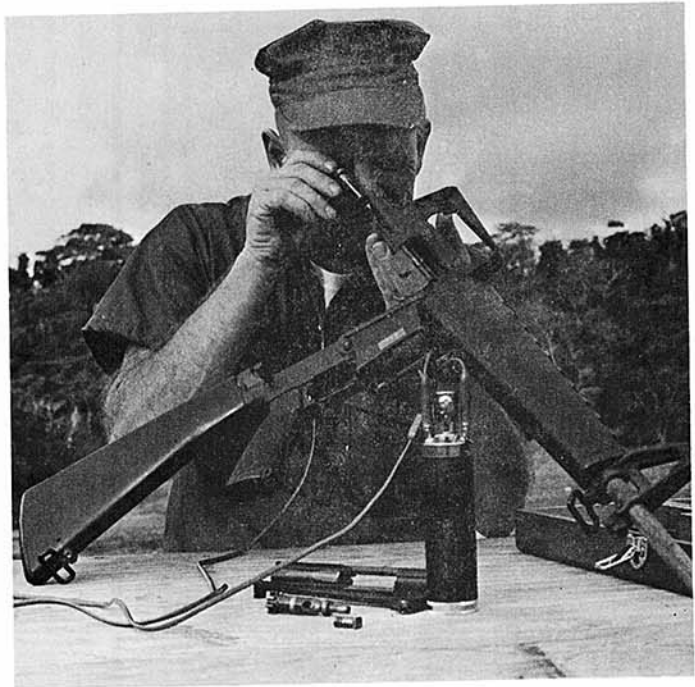
FIGURE I18. M-16 Rifle Bore and Chamber Being Examined with Borescope

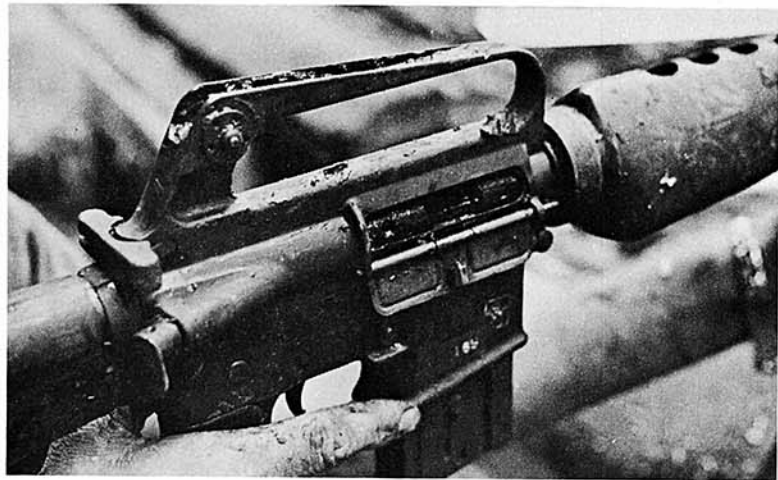
FIGURE I 21. M-16 Rifle  
on the Firing Line After  
Swamp Exposure
