AD NO. _____
TECOM PROJECT NO. 9-CO-150-000-216
REPORT NO. USACSTA-6125

FINAL REPORT
SPECIAL STUDY
OF
M16A1-TYPE RIFLE

FRANKLIN H. MILLER
ARMAMENT SYSTEMS DIRECTORATE

US ARMY COMBAT SYSTEMS TEST ACTIVITY
ABERDEEN PROVING GROUND, MD 21005-5059

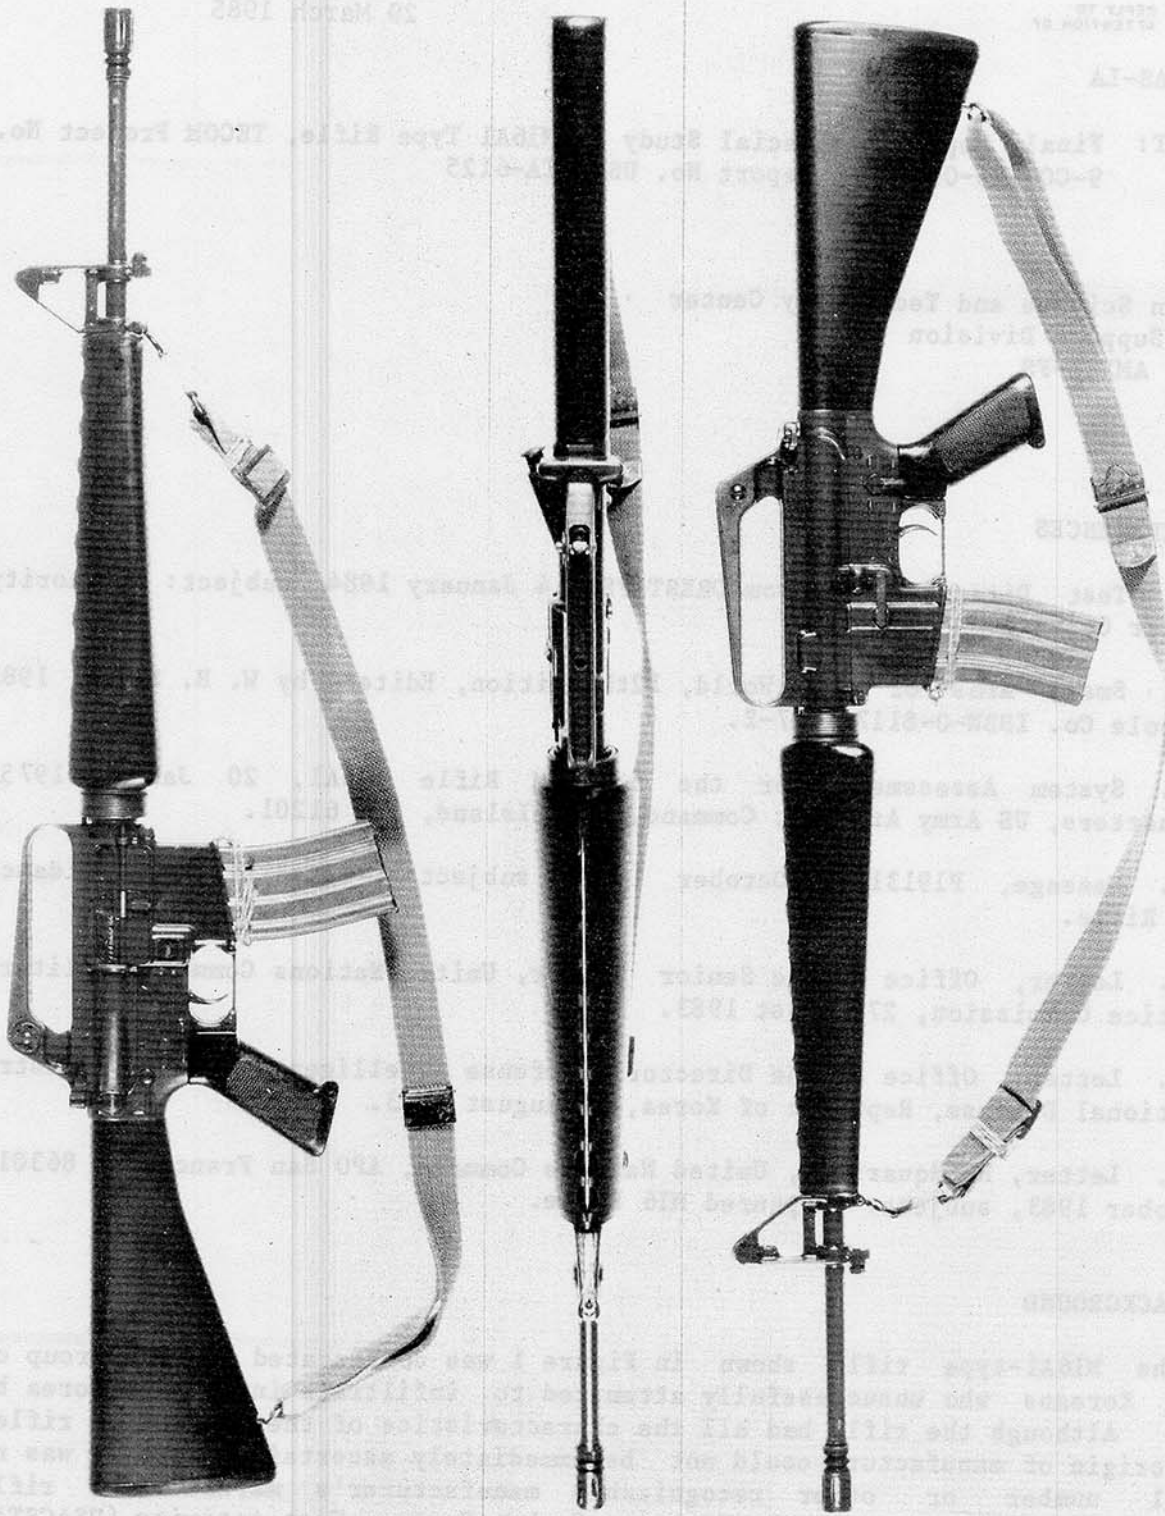
Figure 1. General views of the unmarked M16A1 rifle.

The M16A1-type rifle shown in Figure 1 was confiscated from a group of North Koreans who unsuccessfully attempted to infiltrate into South Korea by boat. Although the rifle had all the characteristics of the US service rifle, its origin of manufacture could not be immediately ascertained. There was no serial number or other recognizable manufacturer's marks. The rifle subsequently delivered to the US Army Combat Systems Test Activity (USACSTA) for analysis was one of five rifles captured.

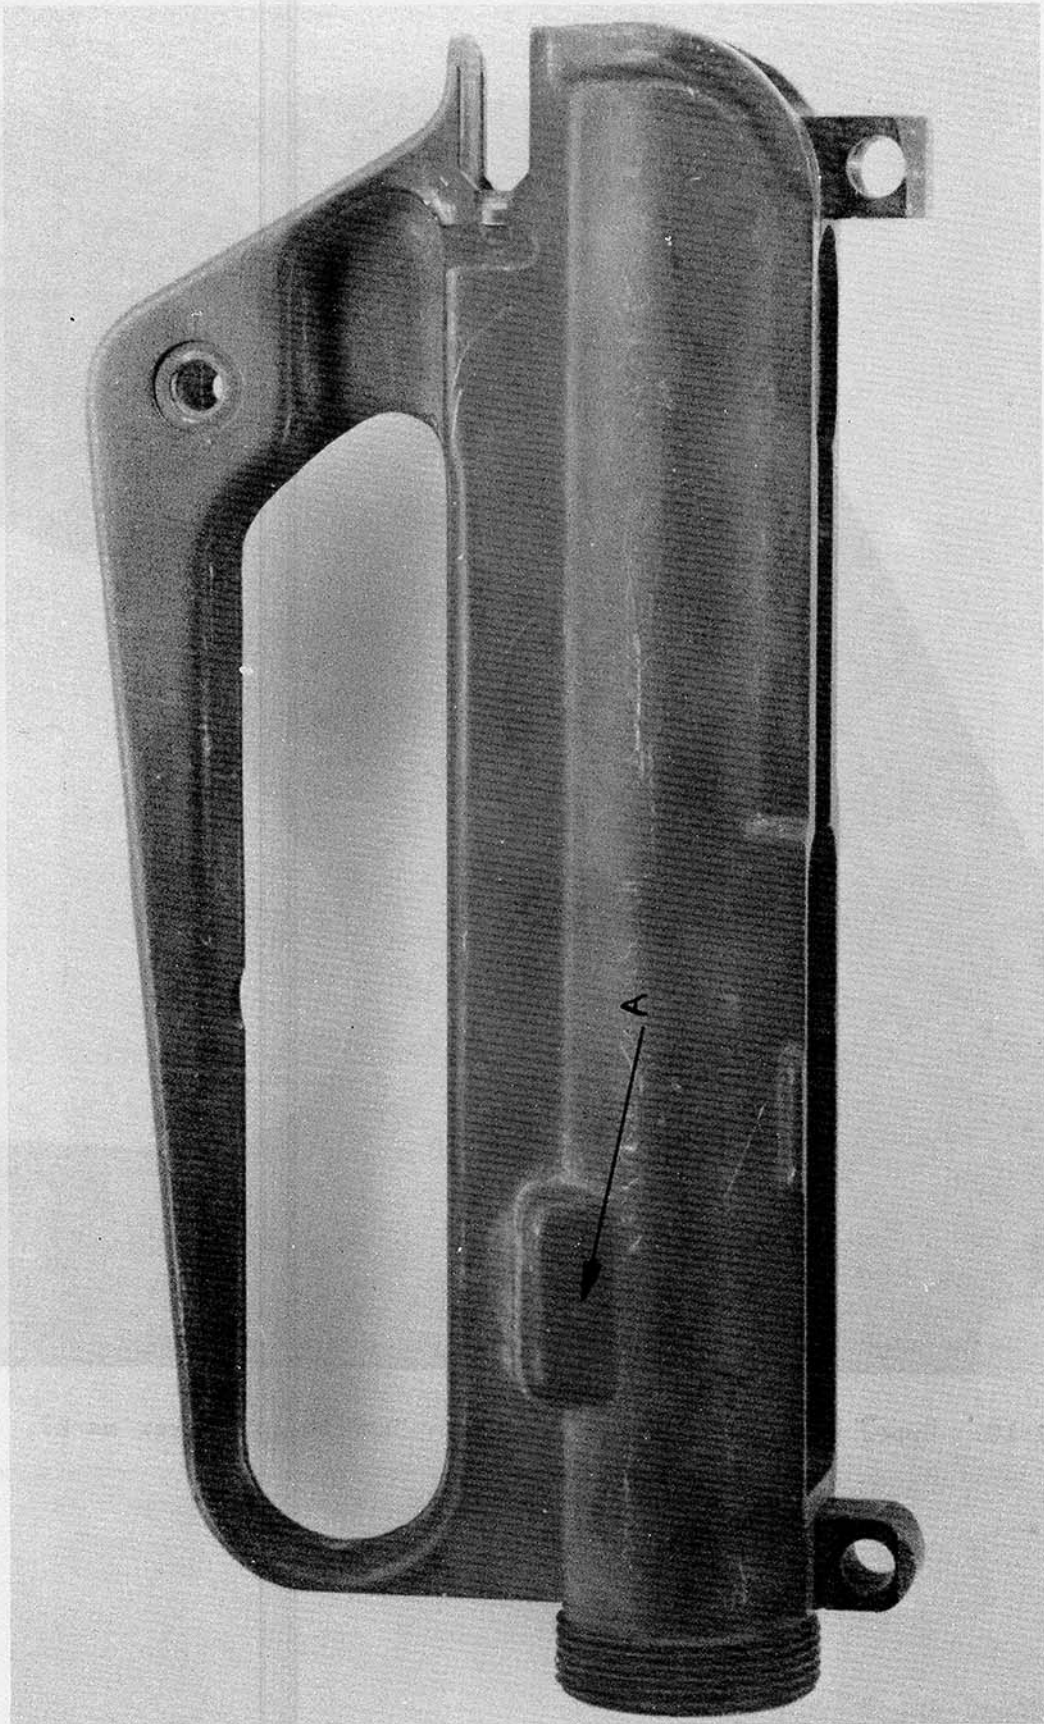
Figure 2-11. Test rifle upper receiver.

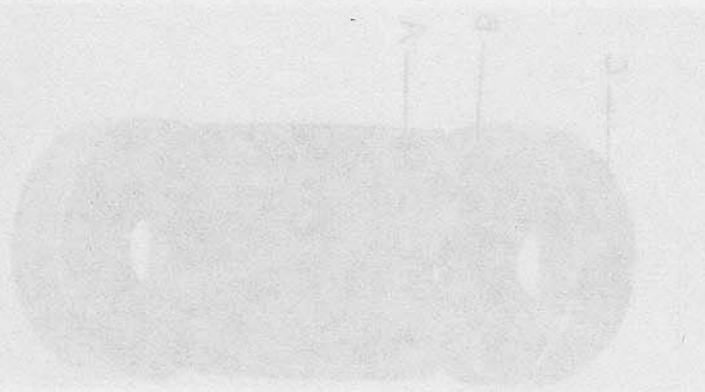
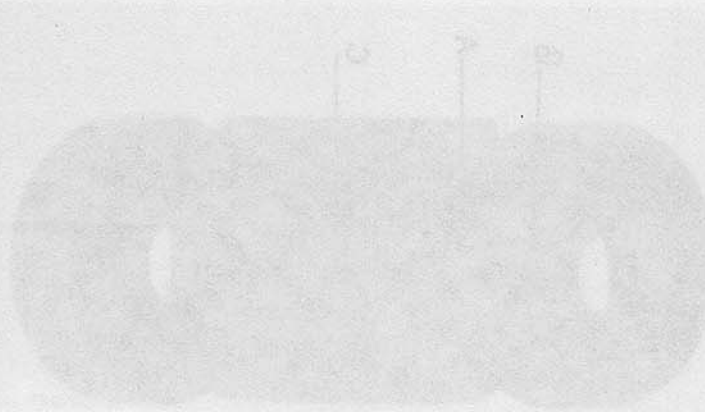
The test rifle part is machined from bar stock. The Colt rifle part is made from powdered metal (A). There is a chamfer at the inner edge of the center hole on the test rifle part, but none on the Colt rifle part (B). Numerical marking of the drum is different on the two parts (C). Turning marks and edge chambers are present on the test rifle part, but not on the part from the Colt rifle (D and E).

Note: The letters in () refer to the arrow indicators in the figures.

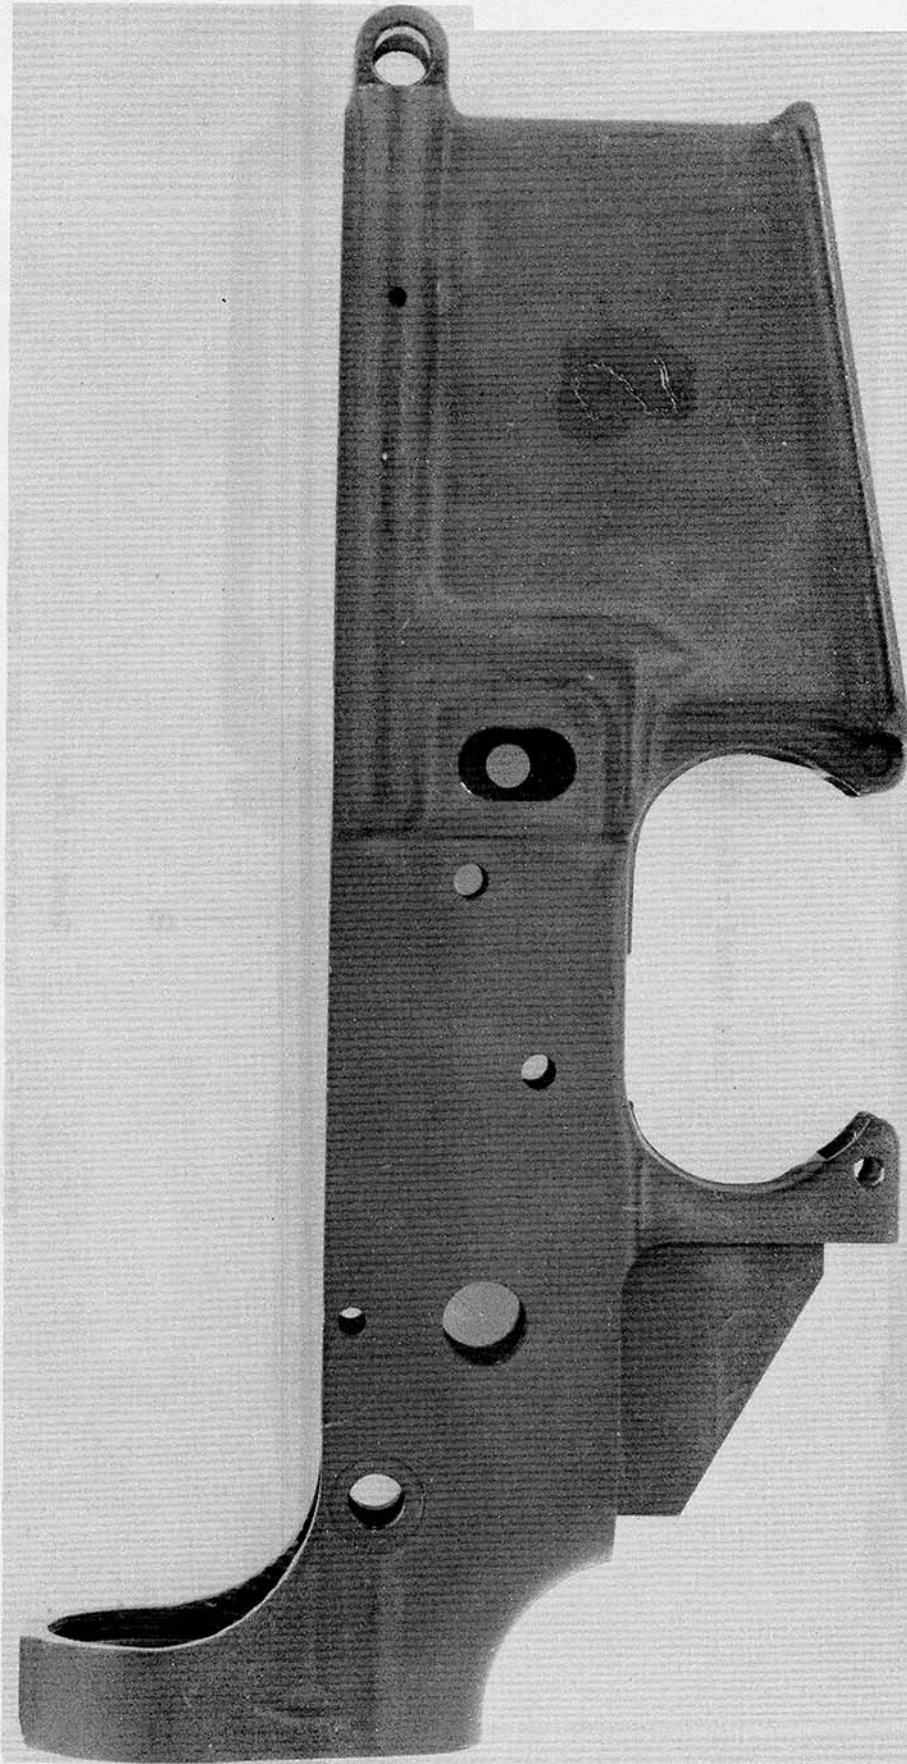
Figure 2-71. Colt M16A1 rifle SN 6418244 lower receiver (right side view). Note: The No. 2 marked on magazine well is an Aberdeen Proving Ground marking only. It was added after receipt of the rifle.

Figure No.	Description
2-3, 2-4	Left and right side views of markings of the known, US Government approved M16/M16A1 rifle lower receivers.
2-68 2-69	Left side view markings (A) on the test rifle consists of SAFE, SEMI, and AUTO. All are in English. There is no indication of defacement of the receiver at that location or other locations where manufacturers identification and serial number markings are normally found. These other locations are shown in the Colt produced rifle (B) and (C), and Figures 2-2, 2-3, and 2-4.
2-70 2-71	There are no machine made markings on the right side of either the test or Colt rifle lower receiver. The No. 2 shown on the Colt rifle was a test agency applied number.
2-72	There is a difference in the means of removing the rough flashing from the bottom of the lower receiver (A and B). The test rifle partially grinds and polishes (A) and machines (B) while the Colt rifle uses grinding to remove only excess metal at these two locations. The front edge of the magazine well is slightly different (C) due to the manner in which the front face of the lower receiver is machined.
