REPORT R-1936

M16 RIFLE GAS TUBE FOULING - COMPOSITION,
PROPERTIES, AND MEANS OF ELIMINATION

LUDWIG STIEFEL
and
BRUCE W. BRODMAN

August 1969

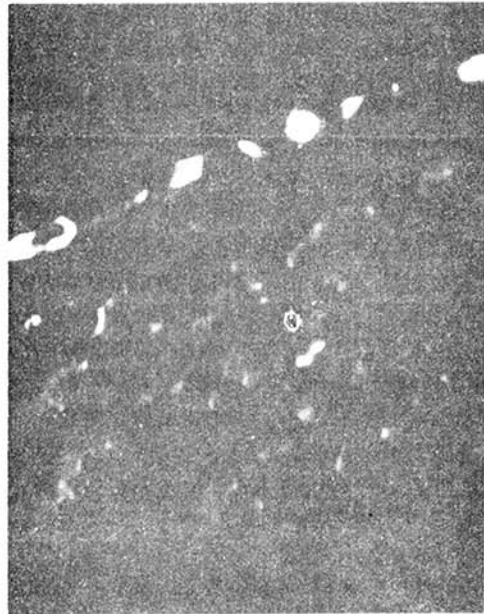
Figure 10. Electron Microprobe Scanning Displays for Iron and Chromium, showing the Tube Wall Fouling Residue Interface

Optical

Specimen Current
(Reference oscilloscope pattern
obtained when current is applied
to sample)

Iron k_{α}

Chromium k_{α}

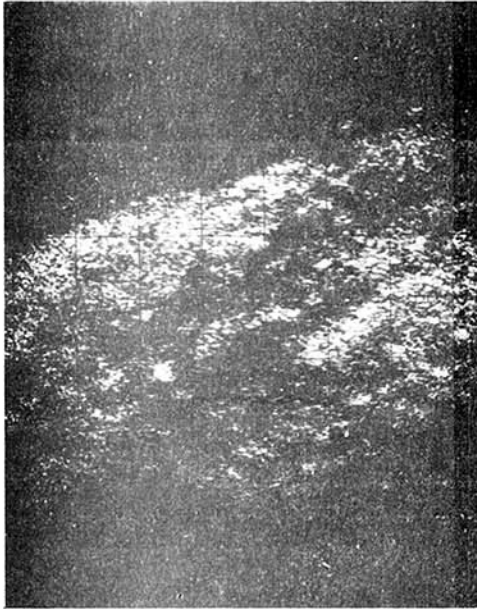
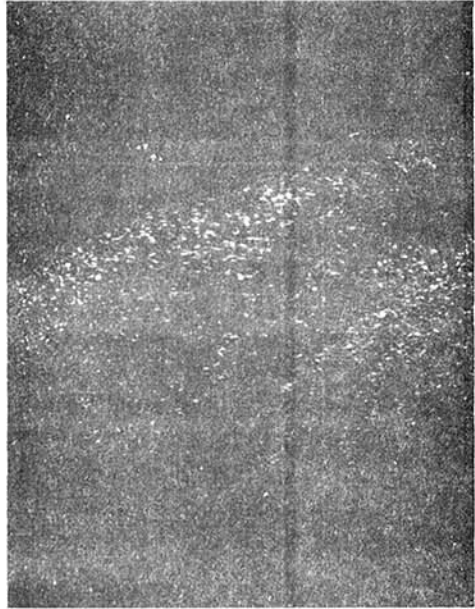
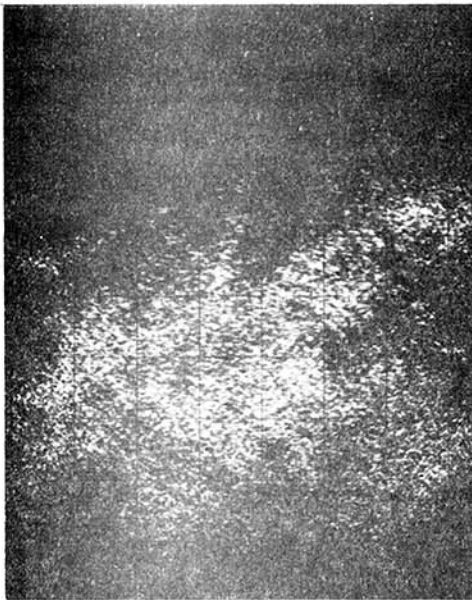
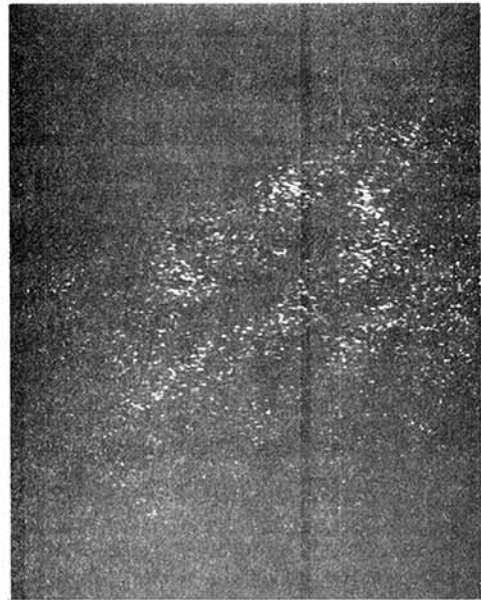
Figure 11. Electron Microprobe Scanning Display for Copper, Zinc, Calcium, and Lead, showing the Tube Wall Fouling Residue Interface

Copper k_{α}

Zinc k_{α}

Calcium k_{α}

Lead k_{α}

data, it could be seen that CaCO_3 was the continuous phase, with pieces of gilding metal (brass containing 95 percent Cu and 5 percent Zn) imbedded in the CaCO_3 matrix. In order to obtain a visual conception of the elemental distribution in various areas of the tube, scanning displays were used. In the method employed for this purpose, the electron beam is scanned across an area of the specimen by means of orthogonal deflection coils. The monitored signal (which in this case was a specific x-ray line) was used to modulate the brightness of a cathode ray tube having a sweep synchronous with the electron beam. In this manner a visual representation of the elemental distribution was obtained.
