REPORT R-2052

THE MECHANISM OF BARREL FOULING AND EROSION IN THE M16A1 RIFLE

BRUCE W. BRODMAN
MICHAEL P. DEVINE

September 1972

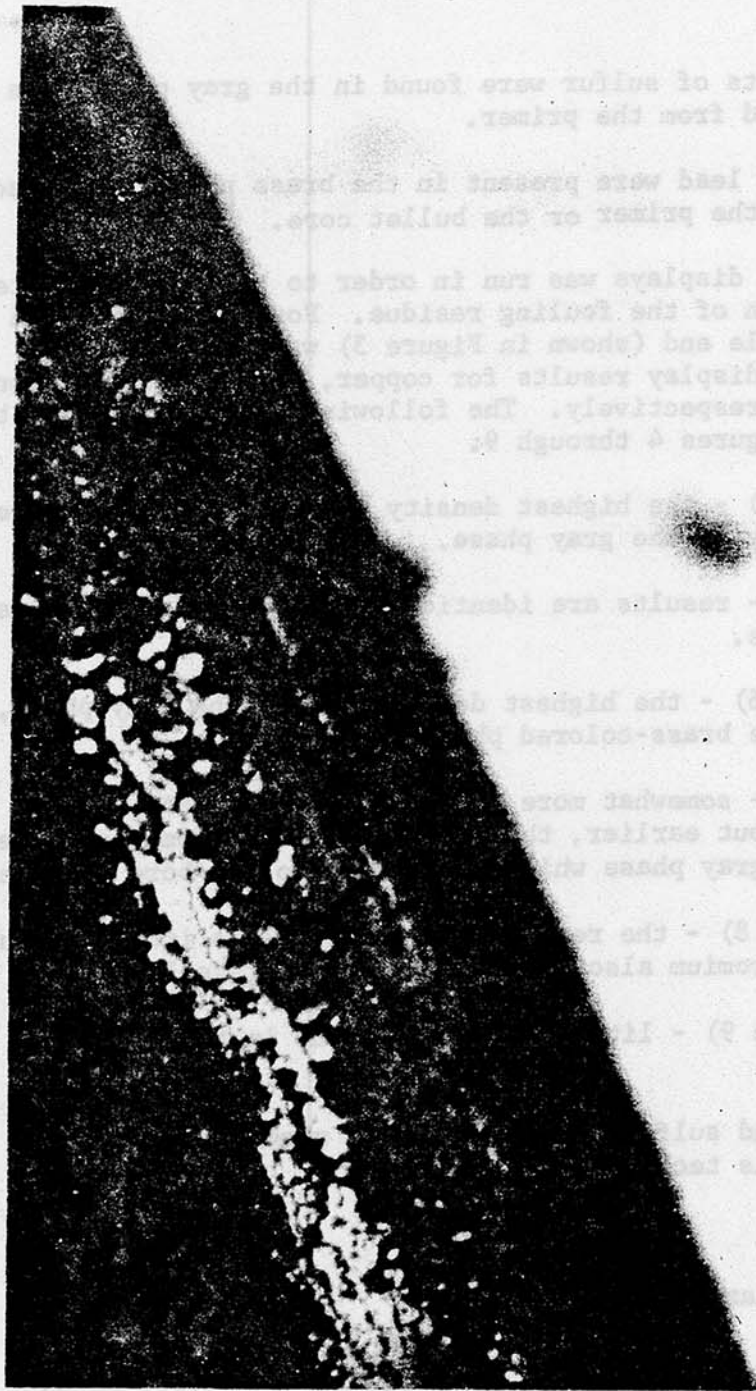
Figure 3. Photomicrograph of Section B (Near Muzzle End) of Barrel No. 167512

Bakelite
Mount

Brass

Gray

Void

Steel

A series of scanning displays was run in order to better illustrate the elemental distribution of the fouling residue. For this purpose, a section (B) near the muzzle end (shown in Figure 3) was used. Figures 4 through 9 are scanning display results for copper, zinc, calcium, iron, chromium, and manganese, respectively. The following observations can be made by examination of Figures 4 through 9:

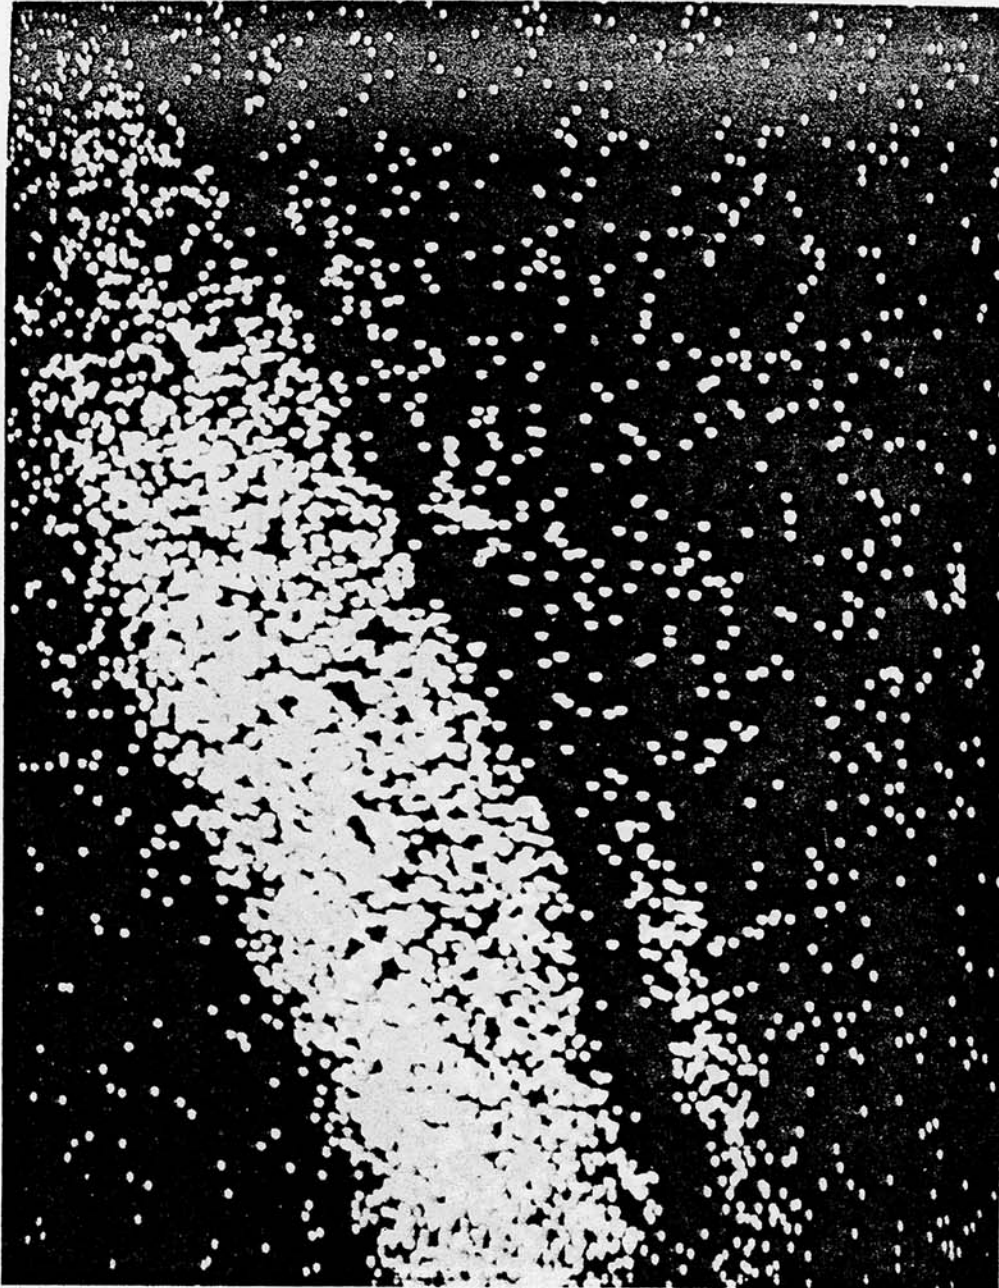
Figure 4. Copper Distribution in Section B of Barrel No. 167512

1. Copper (Figure 4) - the highest density was in the brass-colored phase, with a high density in the gray phase.

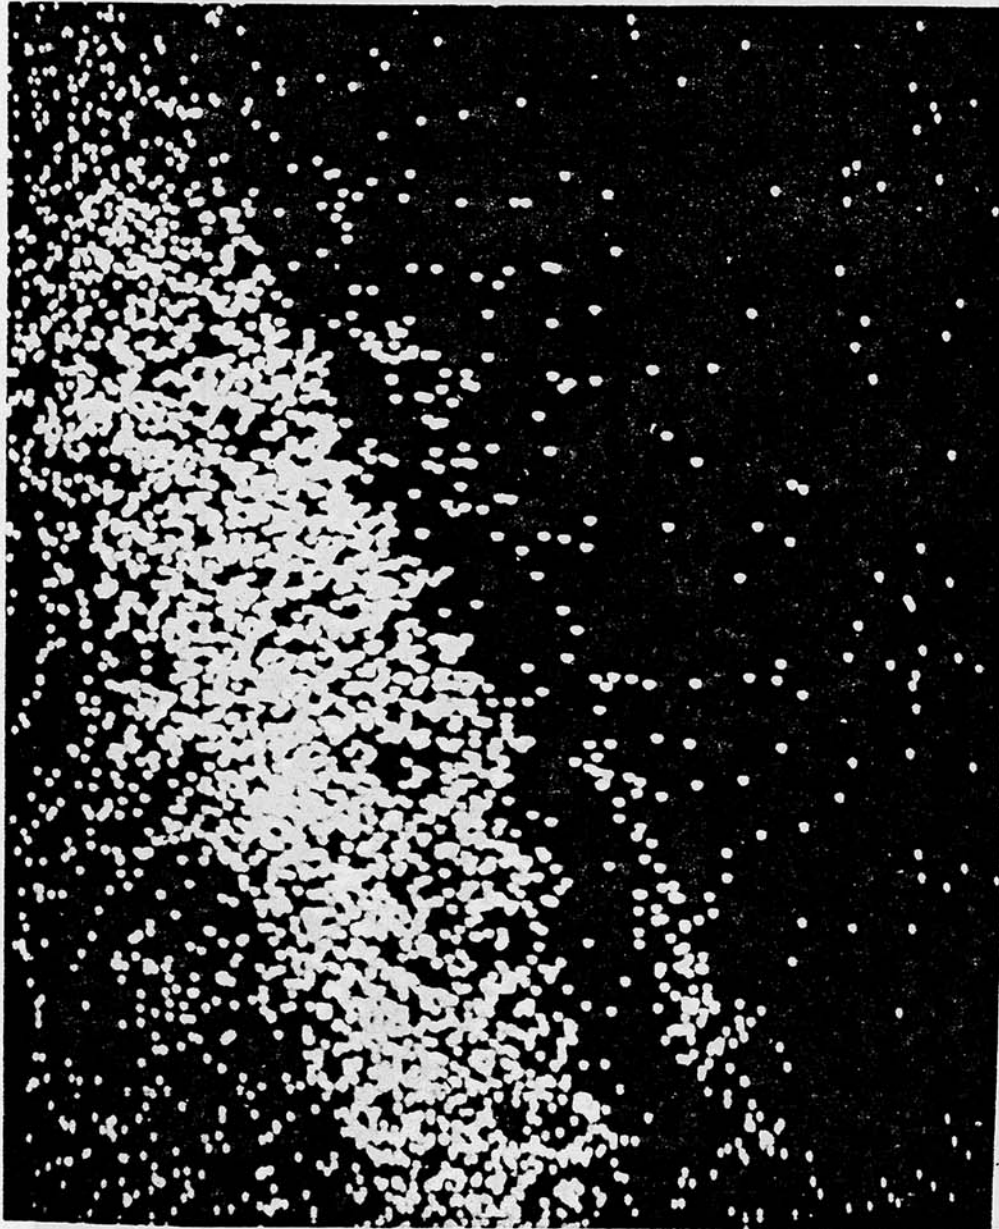
Figure 5. Zinc Distribution in Section B of Barrel No. 167512

2. Zinc (Figure 5) - results are identical to copper, again indicating the presence of brass.

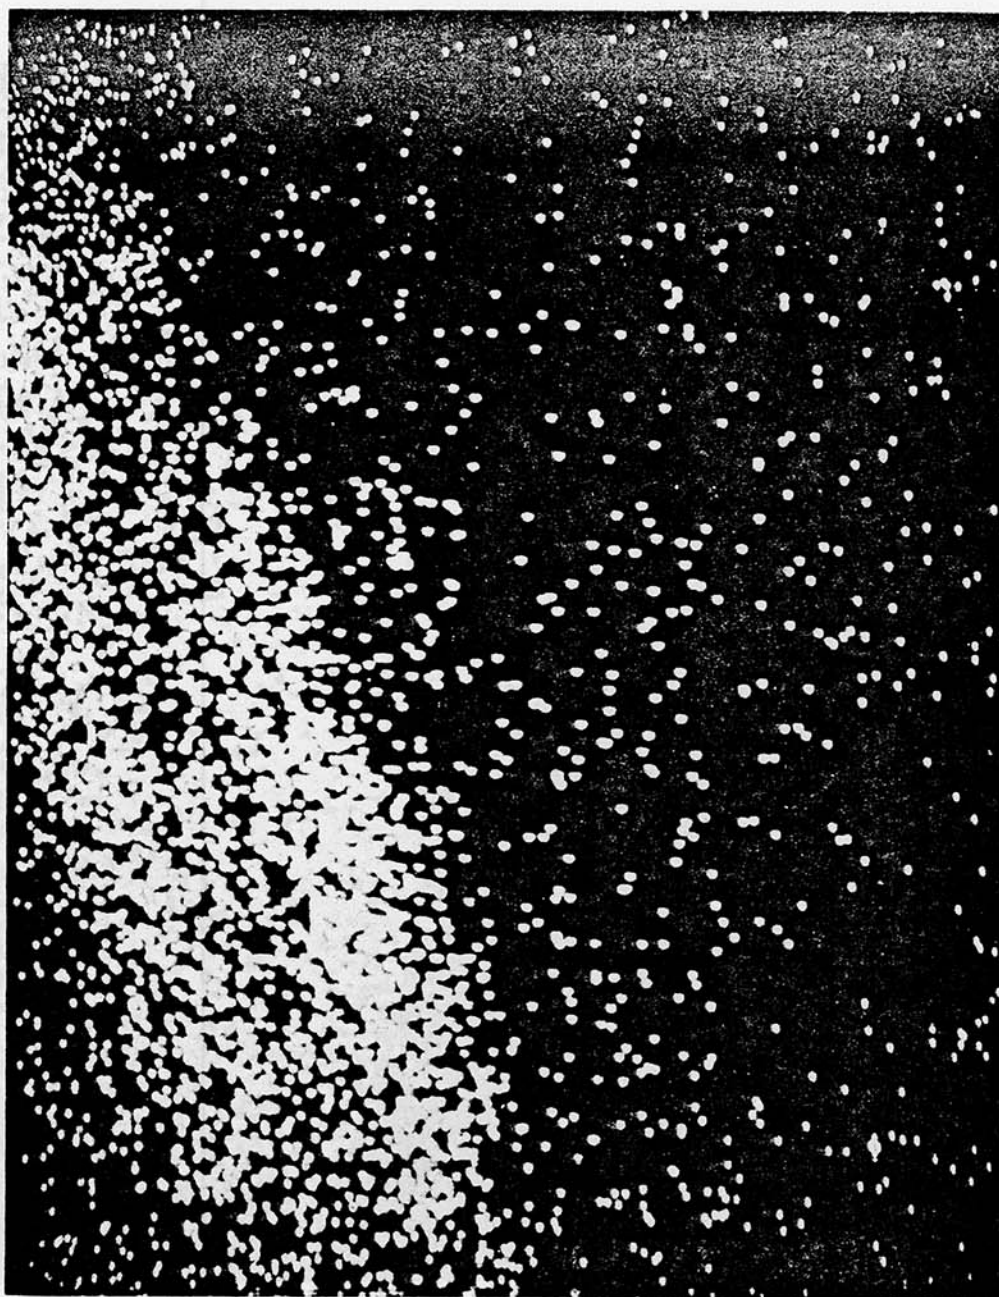
Figure 6. Calcium Distribution in Section B of Barrel No. 167512

3. Calcium (Figure 6) - the highest density was in the gray phase, with a high density in the brass-colored phase.

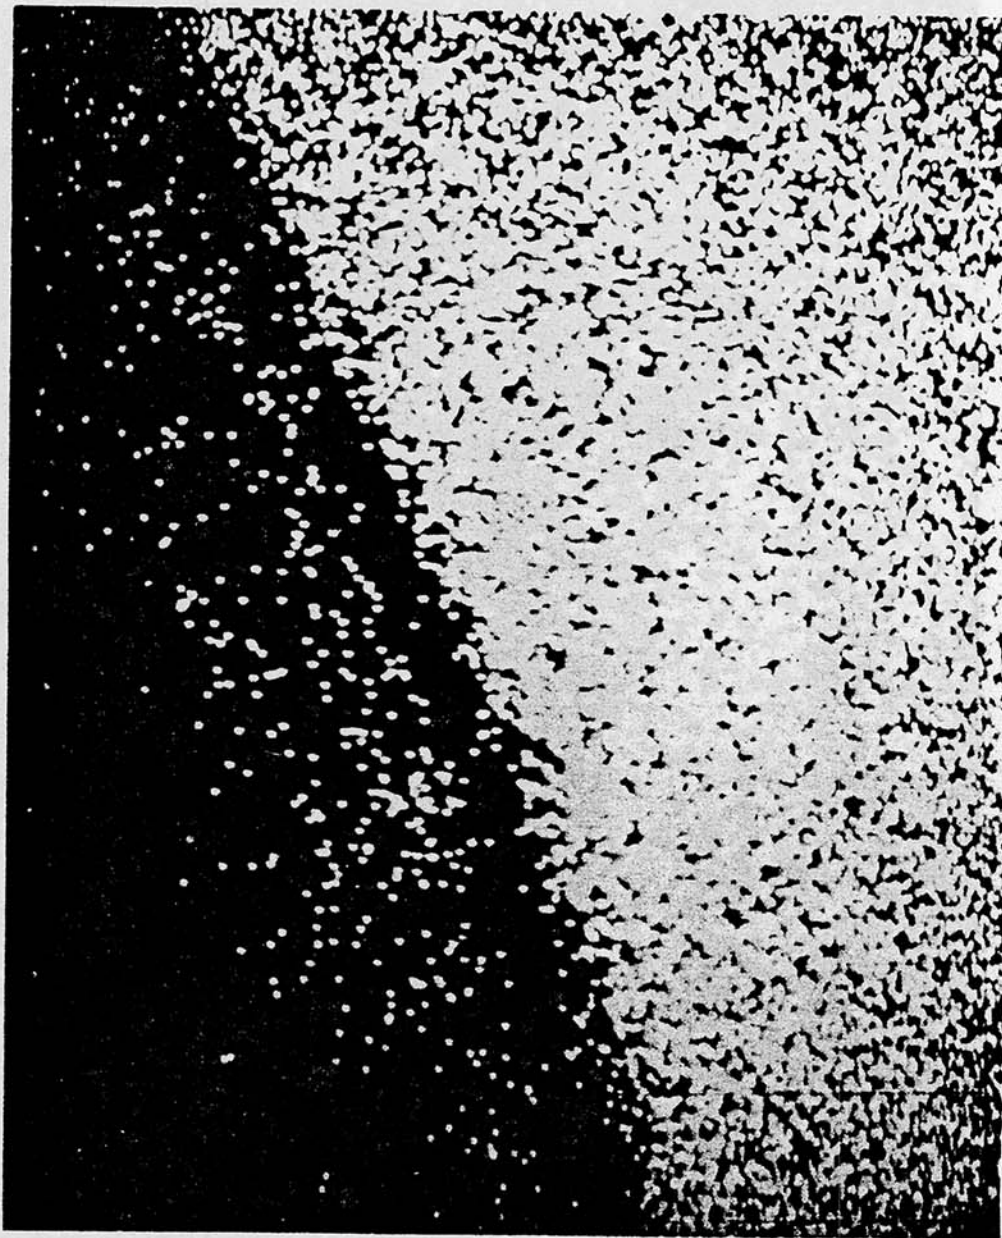
Figure 7. Iron Distribution in Section B of Barrel No. 167512

4. Iron (Figure 7) - somewhat more in the gray phase than in the brass phase. As pointed out earlier, the iron originates from the barrel and has collected in the gray phase which is closest to the bore surface.

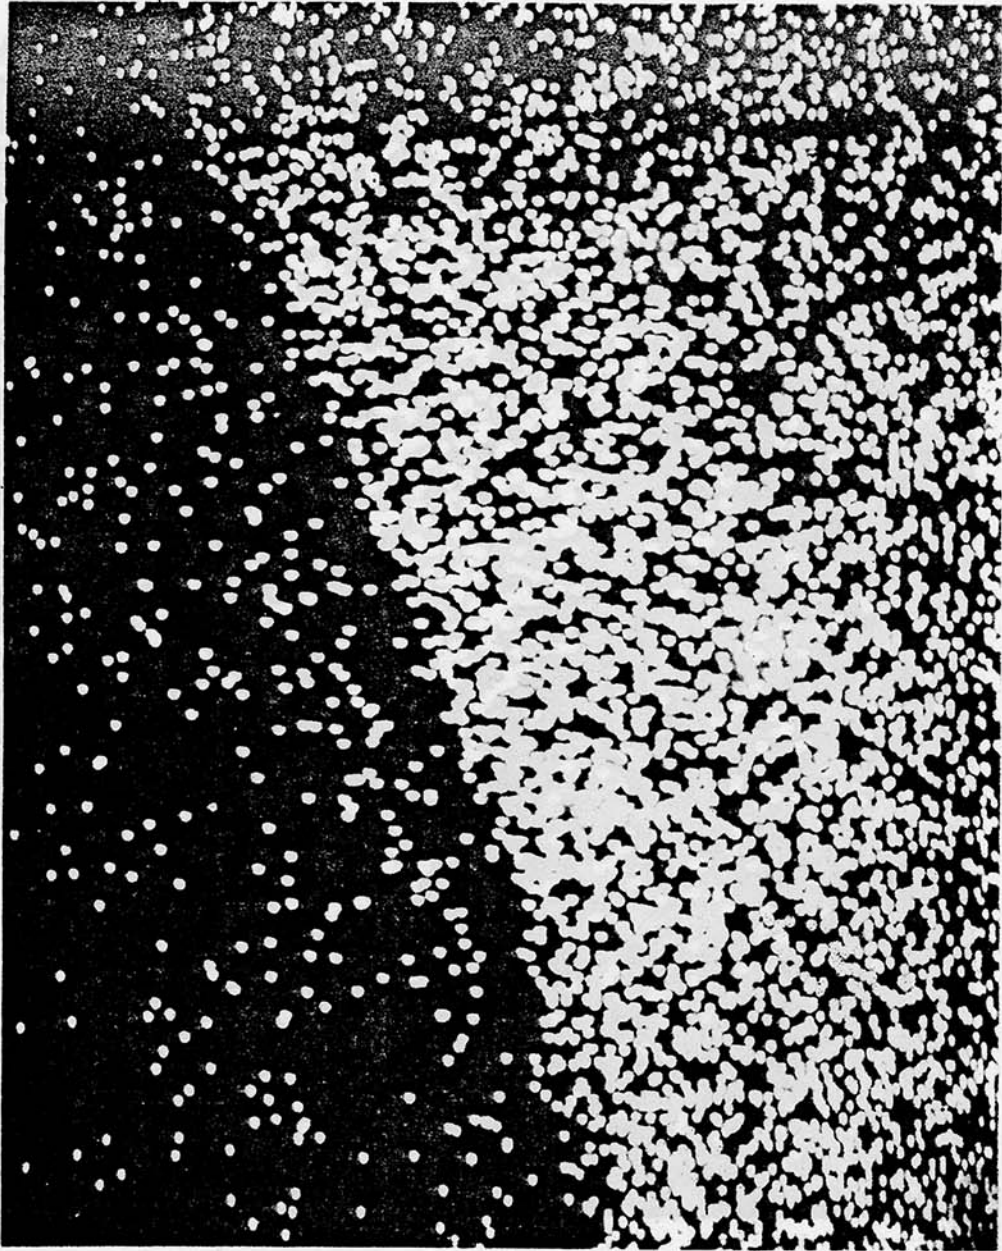
Figure 8. Chromium Distribution in Section B of Barrel No. 167512

5. Chromium (Figure 8) - the results are identical to iron, as would be expected, since the chromium also originates from the steel bore.

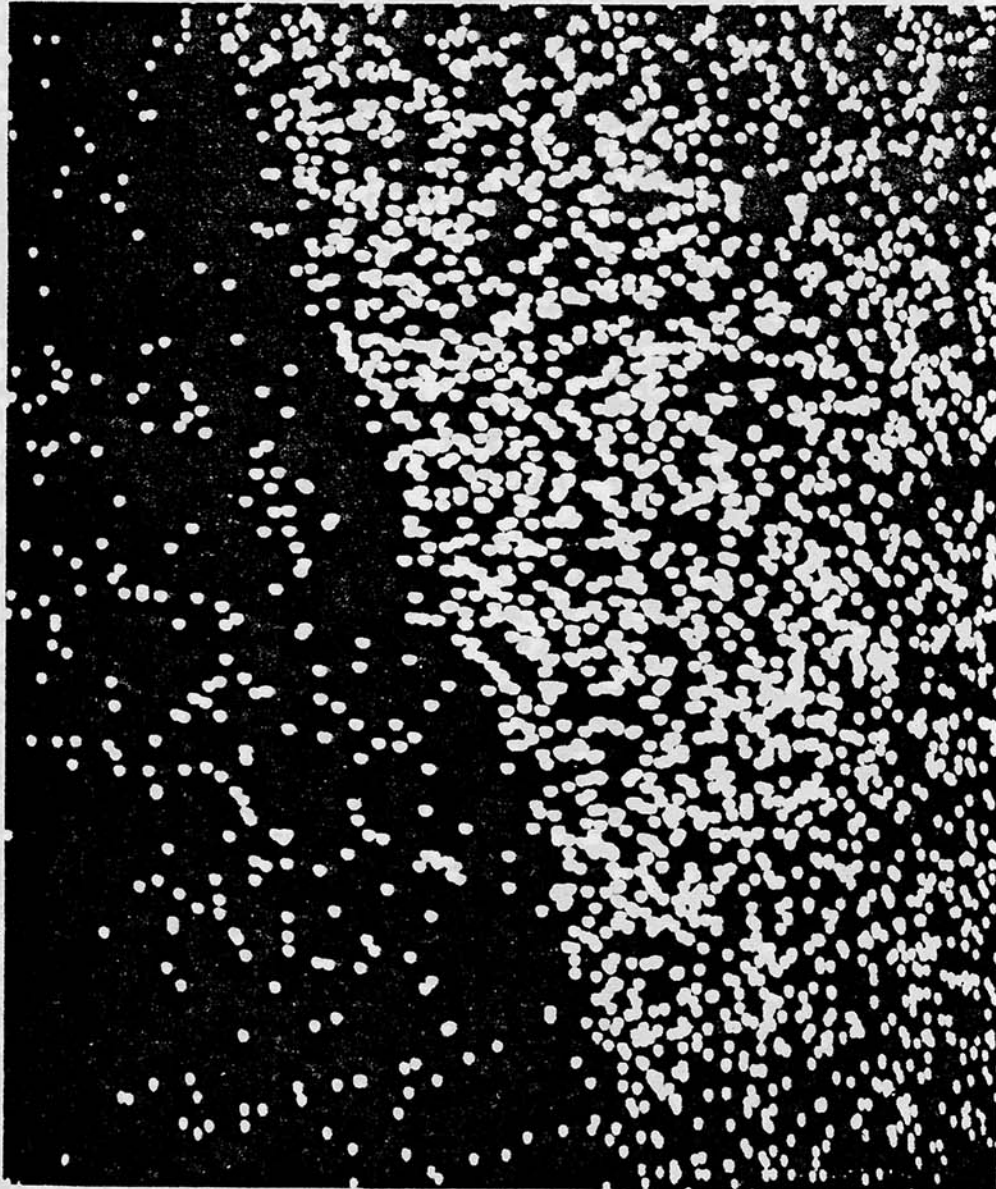
Figure 9. Manganese Distribution in Section B of Barrel No. 167512

6. Manganese (Figure 9) - little or none present in the fouling residue.

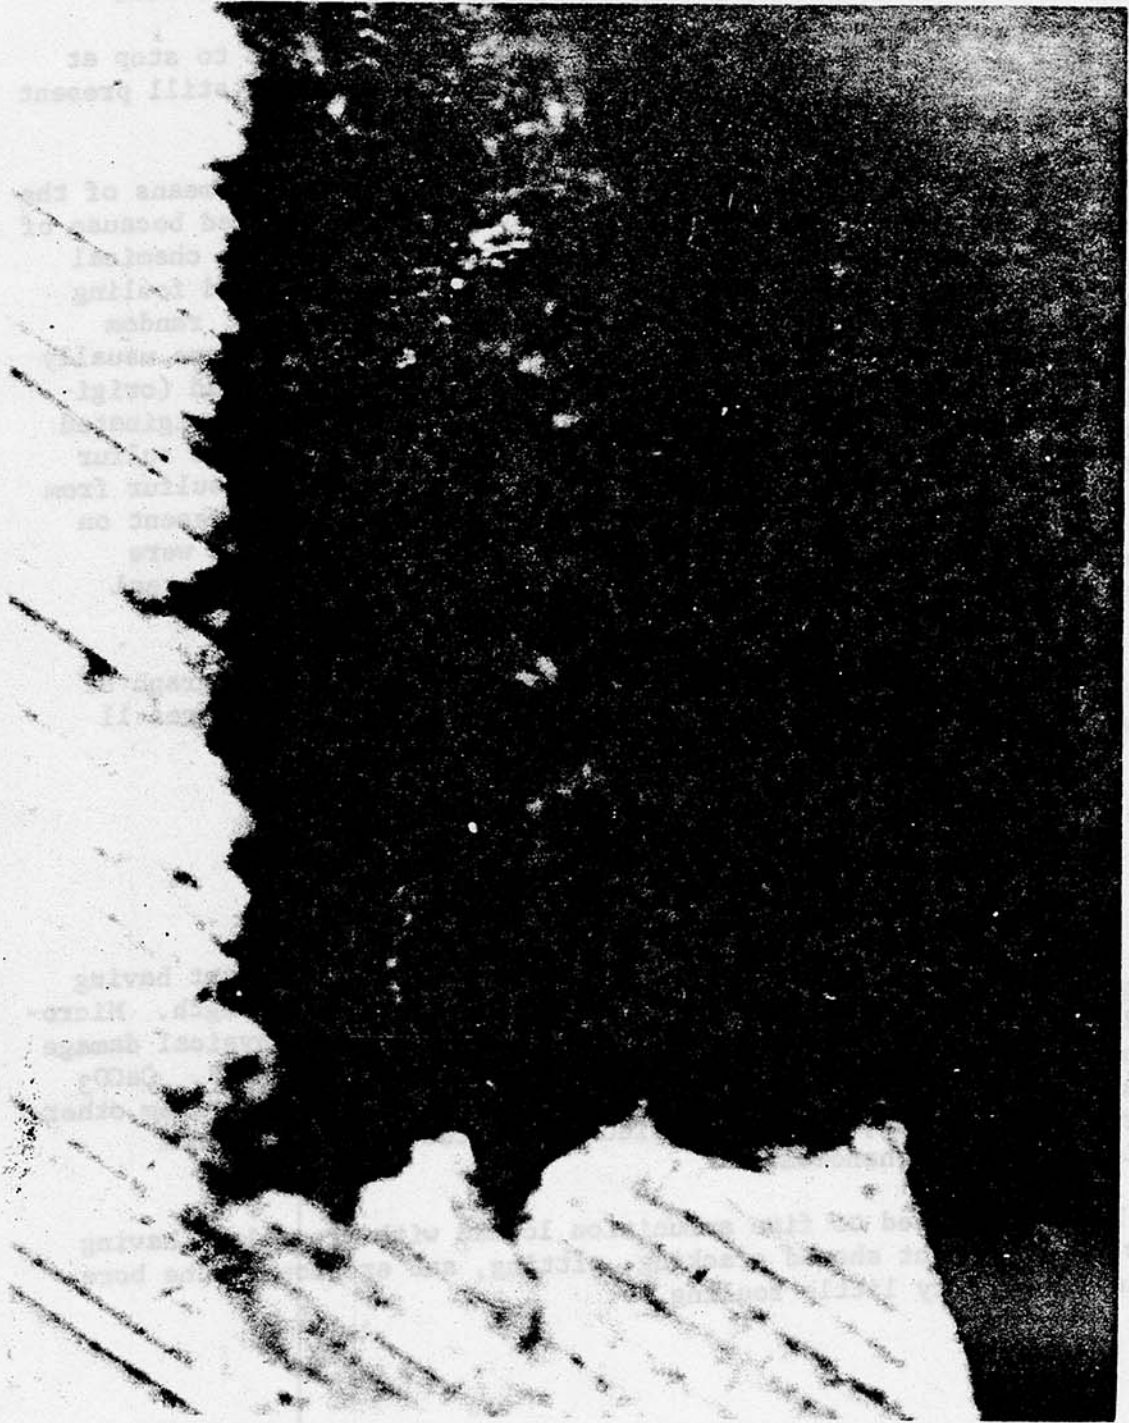
Figure 10, Photomicrograph of Section C of Barrel No. 859740

1. In general, very little fouling was present in this barrel. When present, the fouling appeared in small, isolated areas, and consisted of a brass-colored phase and a dark phase.
2. In general, the three sections near the chamber end of the barrel showed pitting, cracking, and erosion of the bore surface.
3. The cracking effect of the bore surface appeared to stop at about the middle of the barrel. Erosion and pitting were still present near the muzzle end.

These findings are visually represented in a photomicrograph of Section C (Figure 10) and a series of scanning displays (Figures 11 through 17).

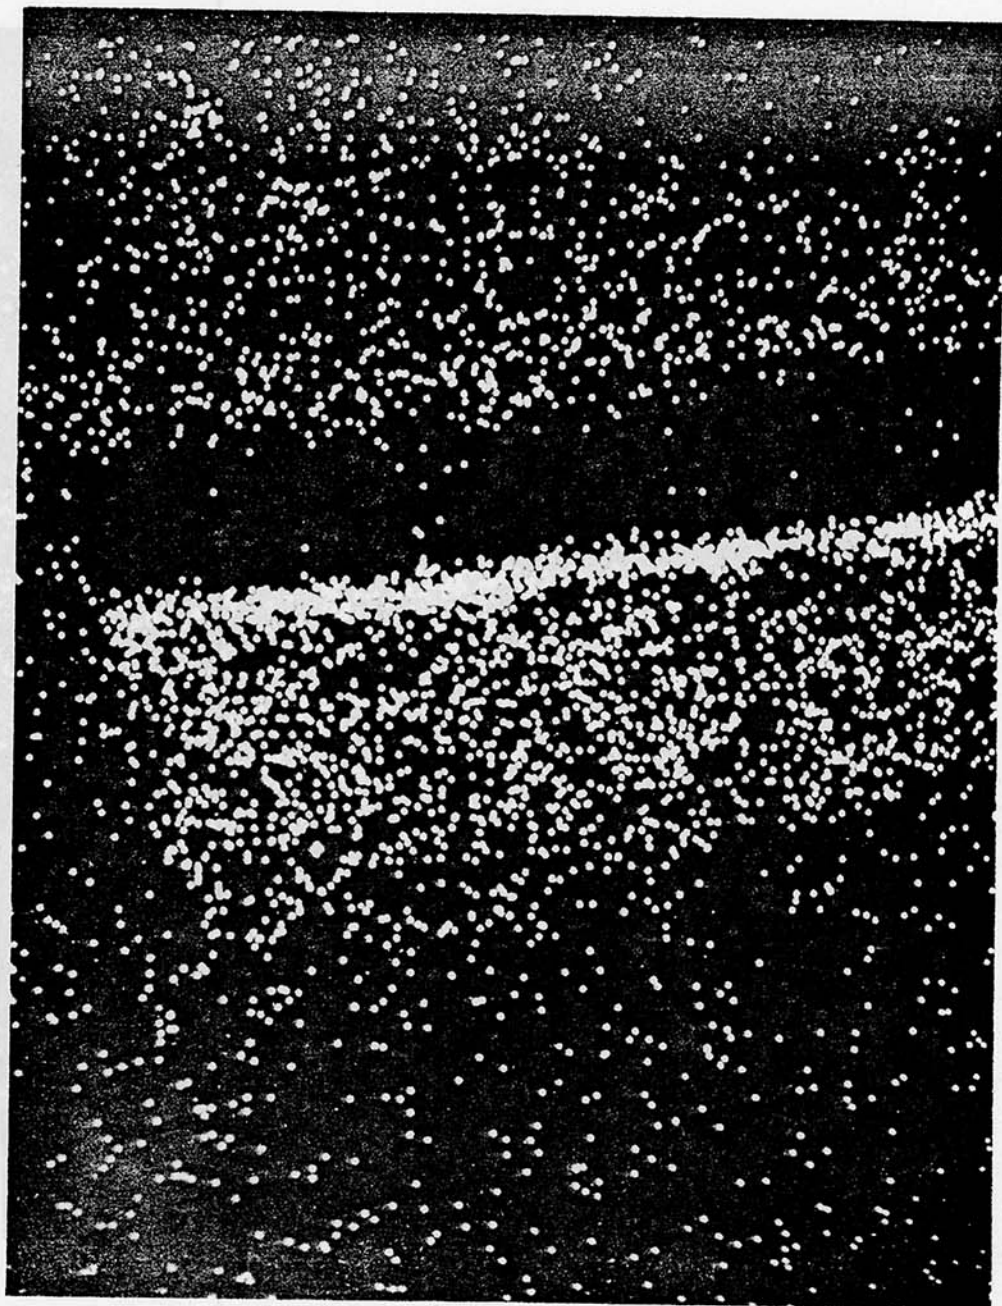
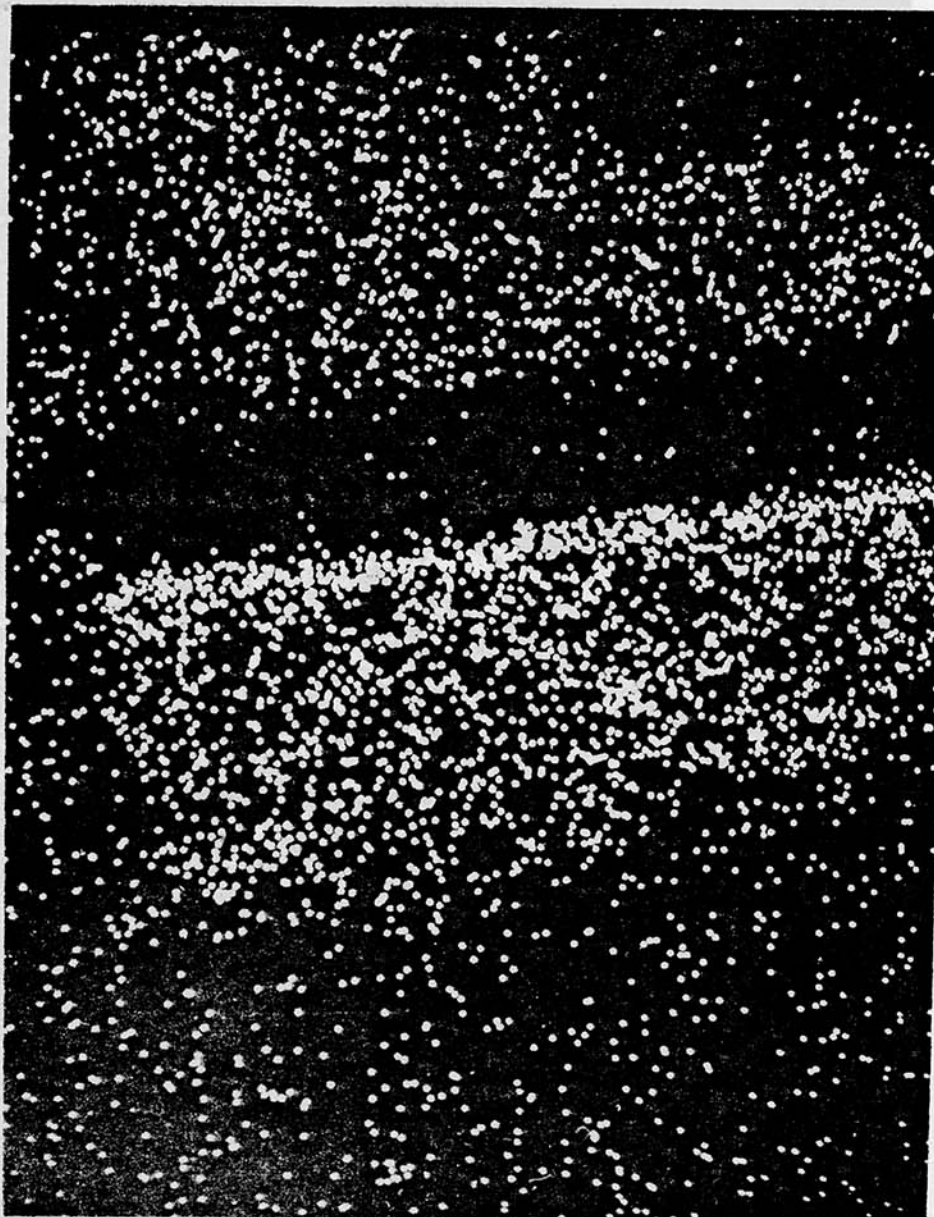
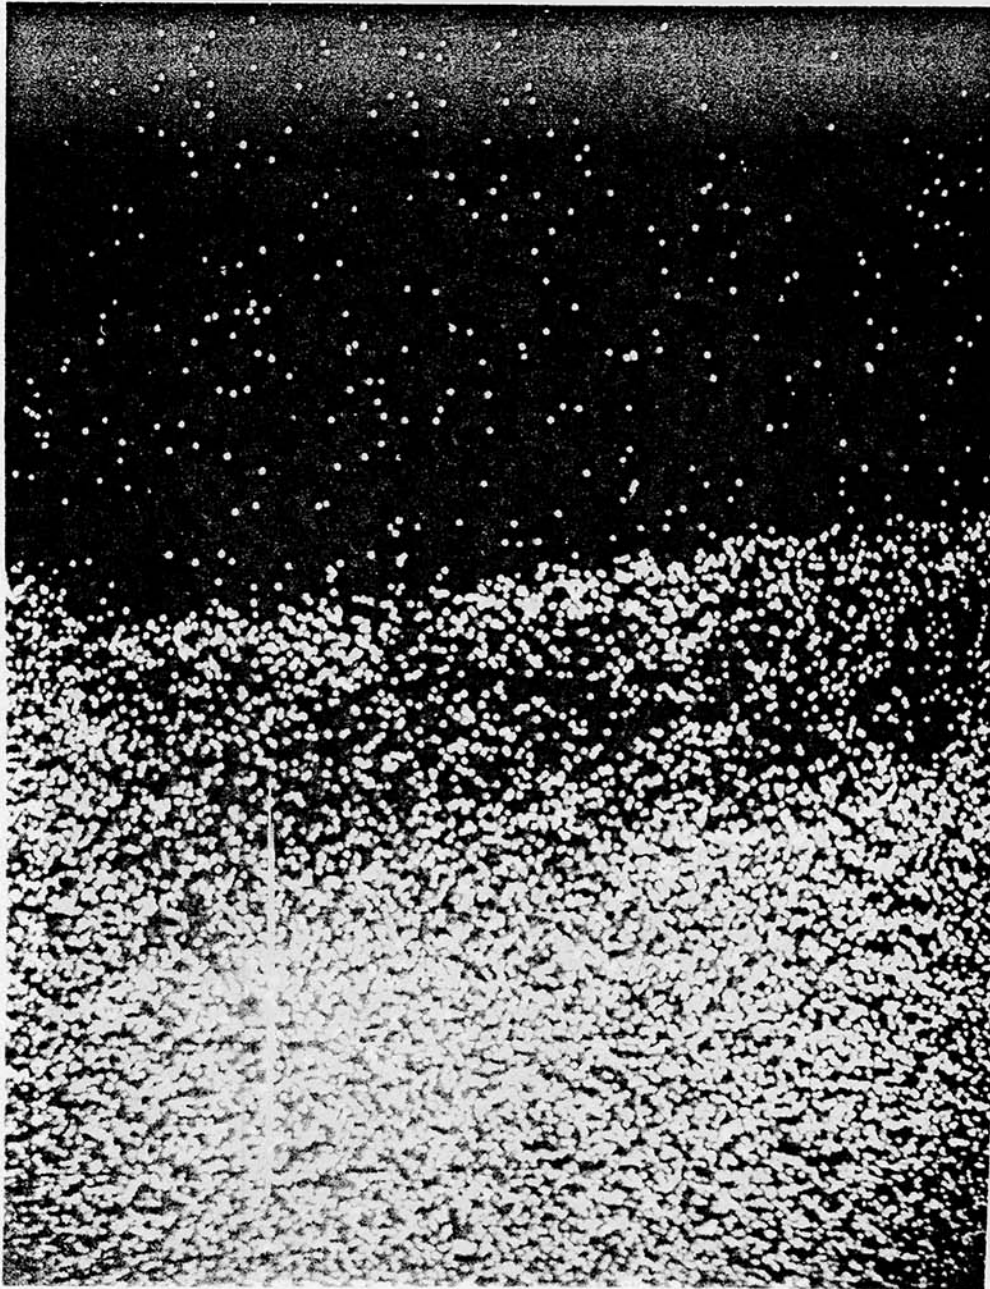
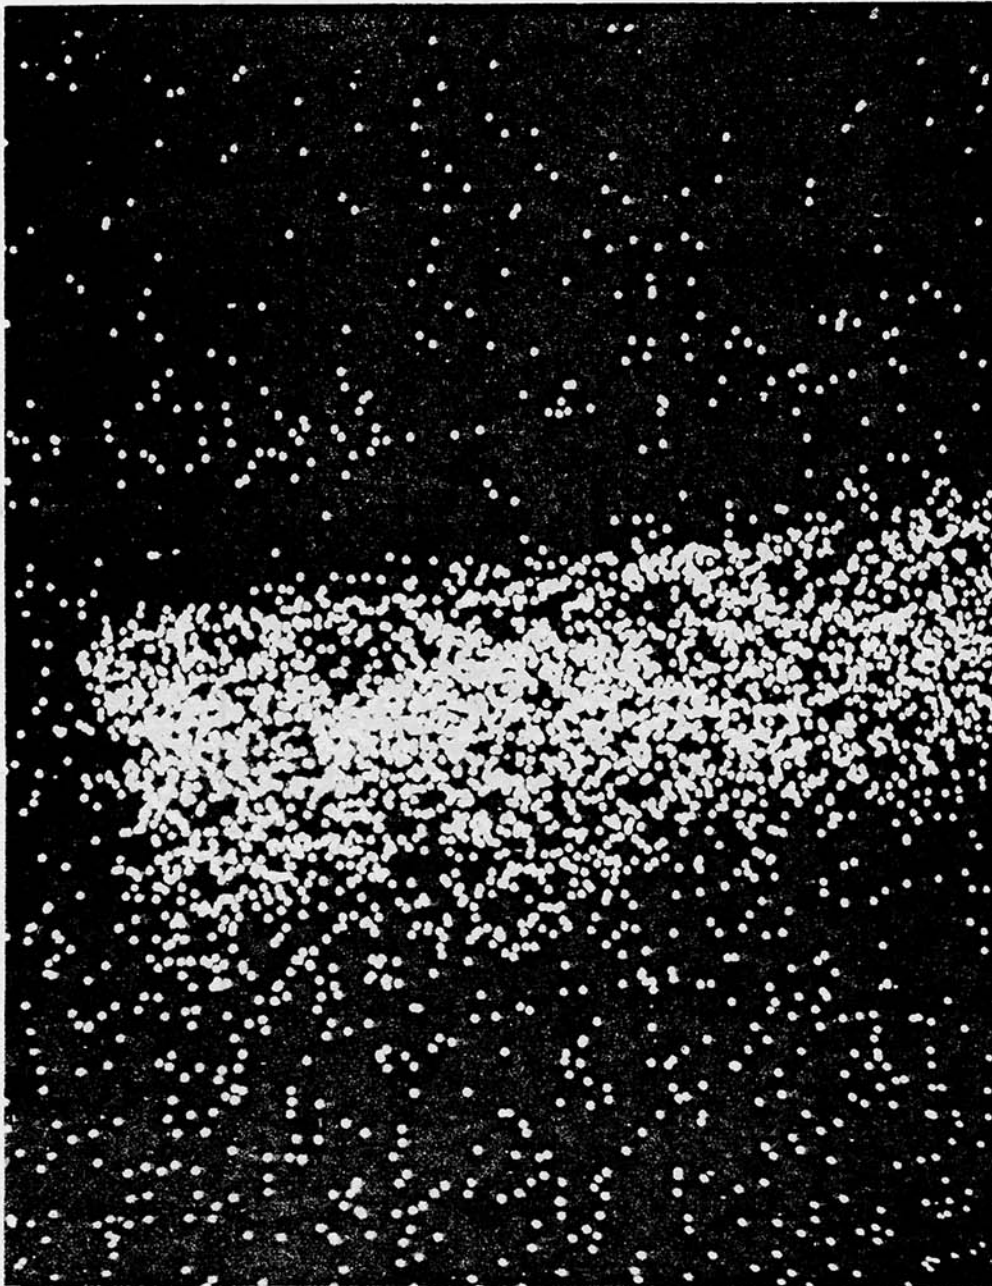
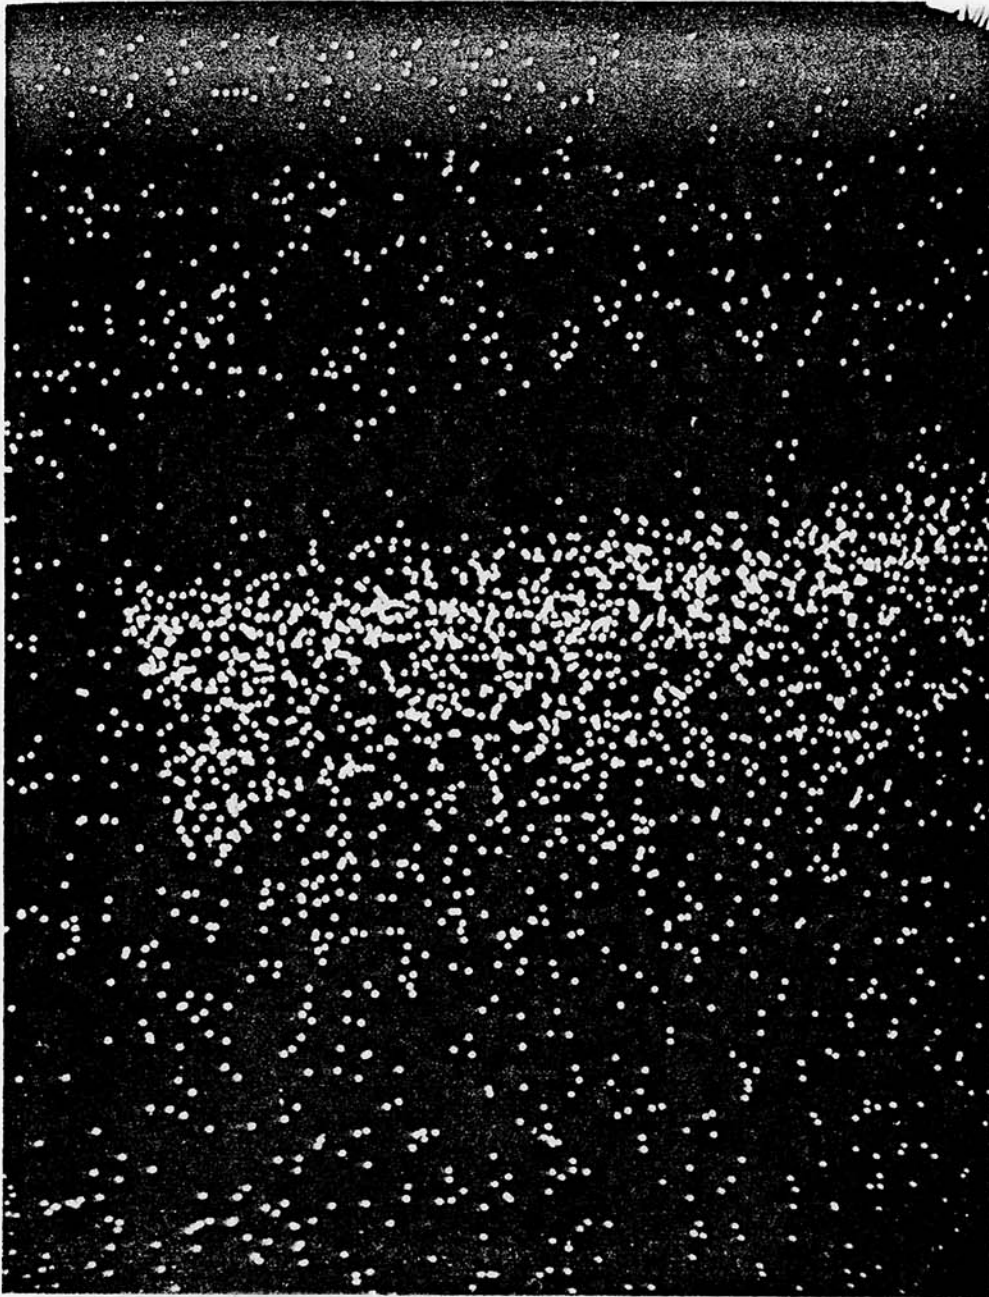
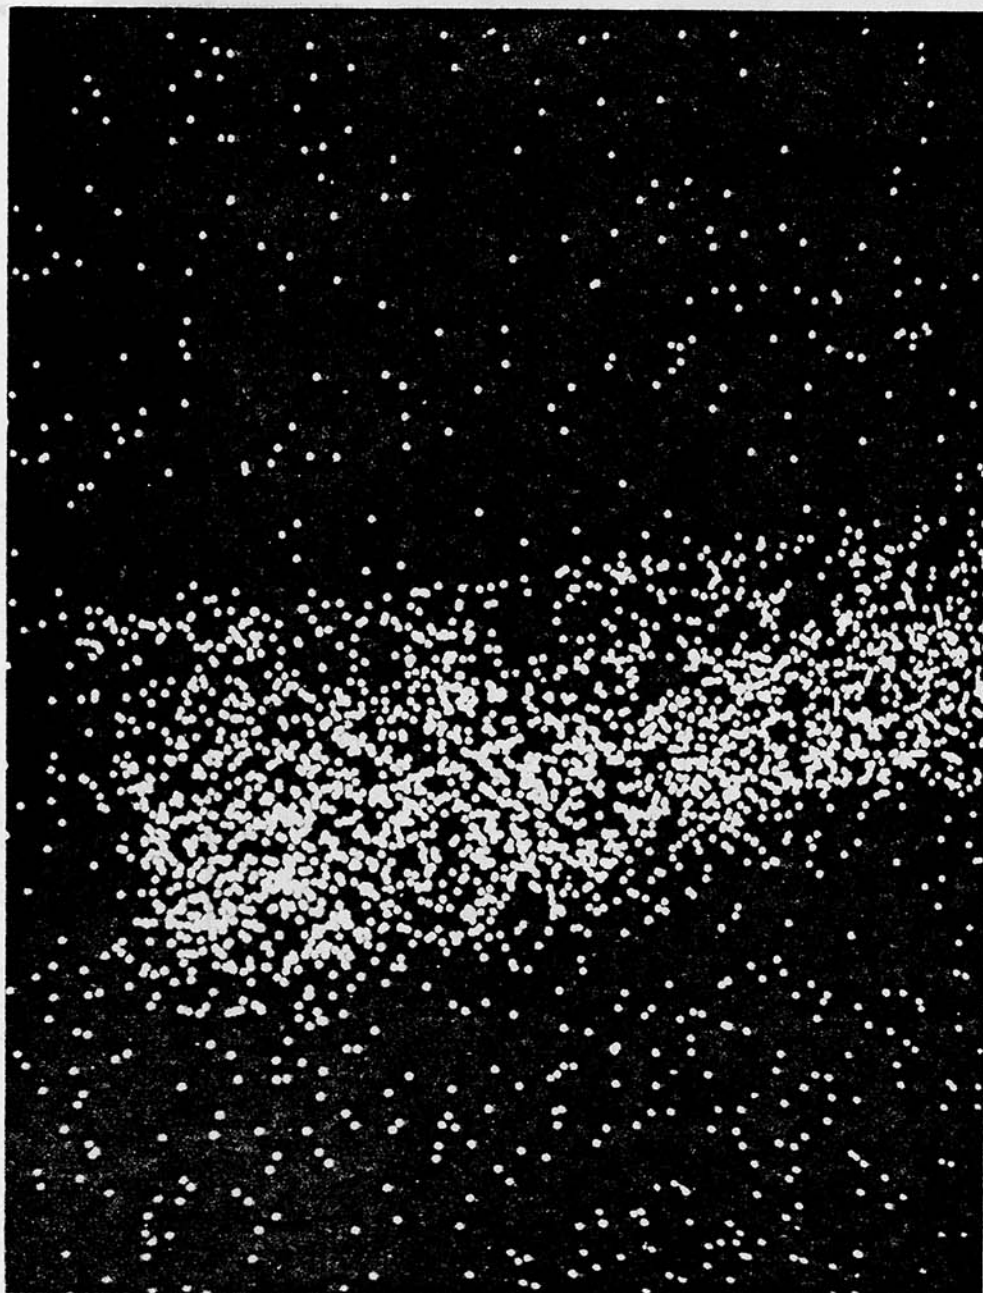
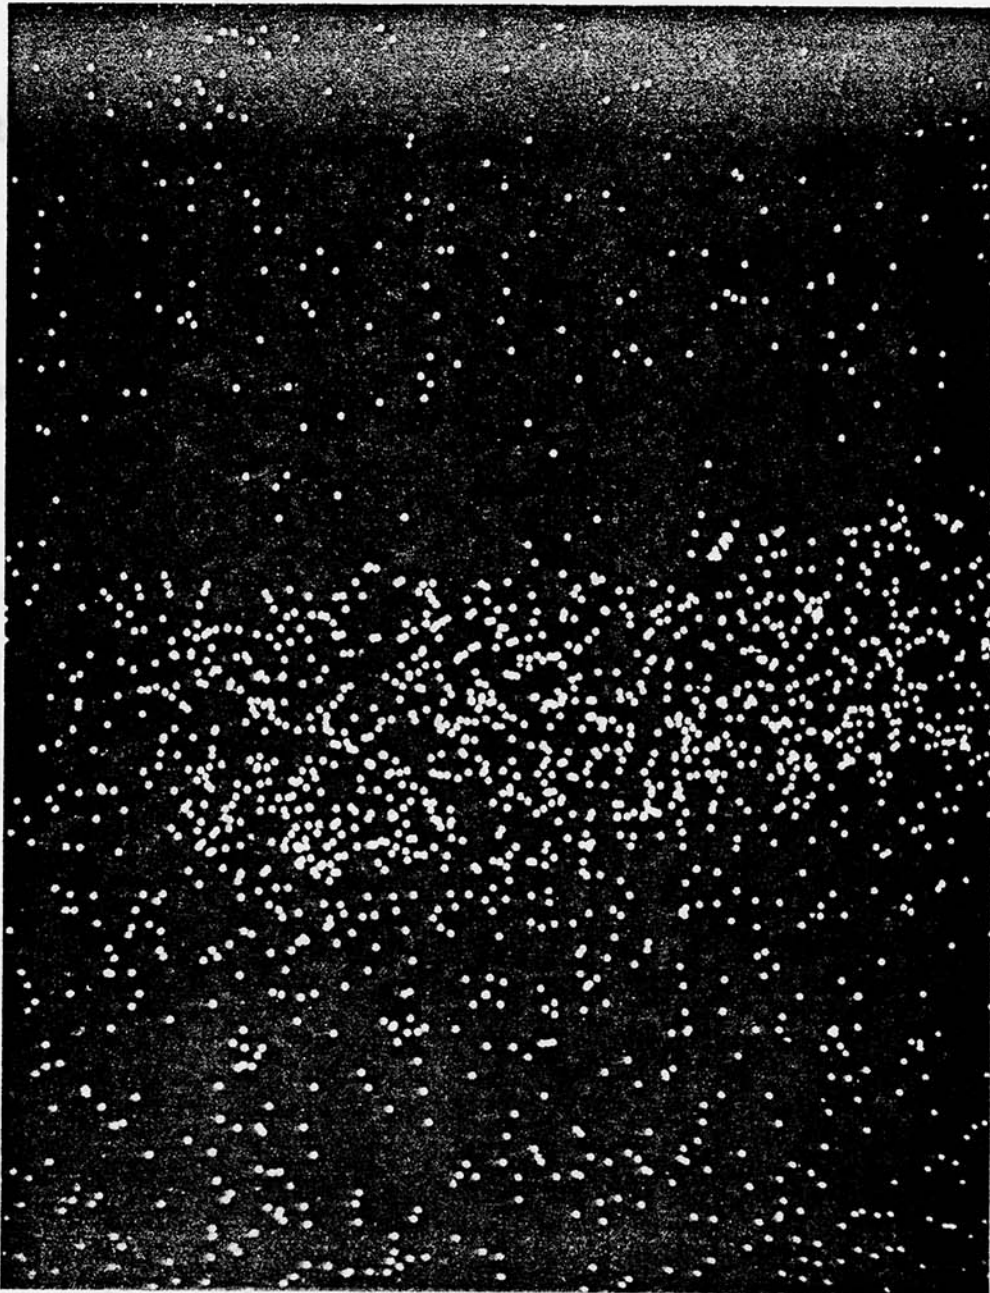
Chemical analysis of each section was accomplished by means of the electron microprobe. No x-ray diffraction data was obtained because of the small amount of fouling present. Only a summary of the chemical findings is presented for this barrel because of the limited fouling produced. In general, the barrel appears to contain small, random deposits throughout. These deposits were all similar and were usually composed of copper and zinc (brass) and small amounts of lead (originating from the bullet core or primer) and antimony (which originated from the primer). Varying amounts of calcium, potassium, and sulfur were present. The calcium originated from the propellant, sulfur from the primer, and potassium possibly from a surface coating present on the projectile. Traces of manganese, chromium, and vanadium were present, and small amounts of iron, all originating from the steel barrel surface.

Mag: 400X
Figure 11. Calcium Distribution in Section C of Barrel No. 859740

Figure 12. Sulfur Distribution in Section C of Barrel No. 859740

Figure 13. Iron Distribution in Section C of Barrel No. 859740

X004 :25M
Mag: 400X
Figure 14. Copper Distribution in Section C of Barrel No. 859740

Figure 15. Zinc Distribution in Section C of Barrel No. 859740

Figure 16. Lead Distribution in Section C of Barrel No. 859740

Figure 17. Antimony Distribution in Section C of Barrel No. 859740
