MEMORANDUM REPORT M70-10-1

METALLURGICAL EXAMINATION OF THE FOULED GAS TUBE AND  
FLASH SUPPRESSOR FROM AN M16A1 RIFLE

EDWARD H. HESS

February 1970

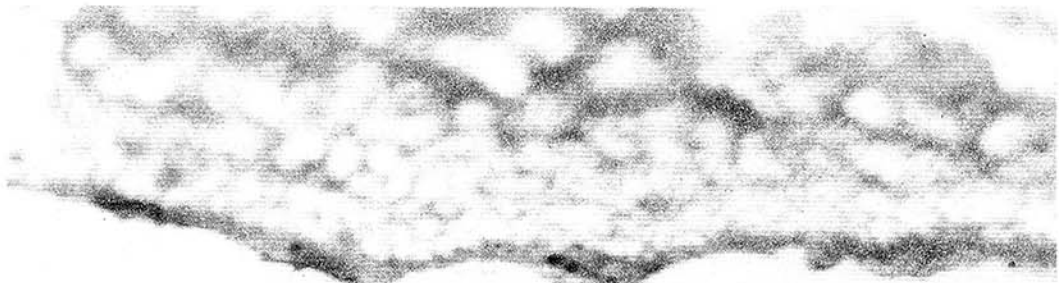
Figure 1. Boundary between Residue and Tube Wall

A representative sample of a sectioned gas tube is shown in Figure 1 at a magnification of 500X and 1000X. Incipient cracks can be seen in the sidewall of the tube. The crack in the lower photograph is approximately 0.0005 inch long. A crack of this size is not significant in materials as ductile as that used for the gas tube. These photographs also show very clearly that there has been no penetration of the stainless steel tube wall by the residue. The bond is mechanical.

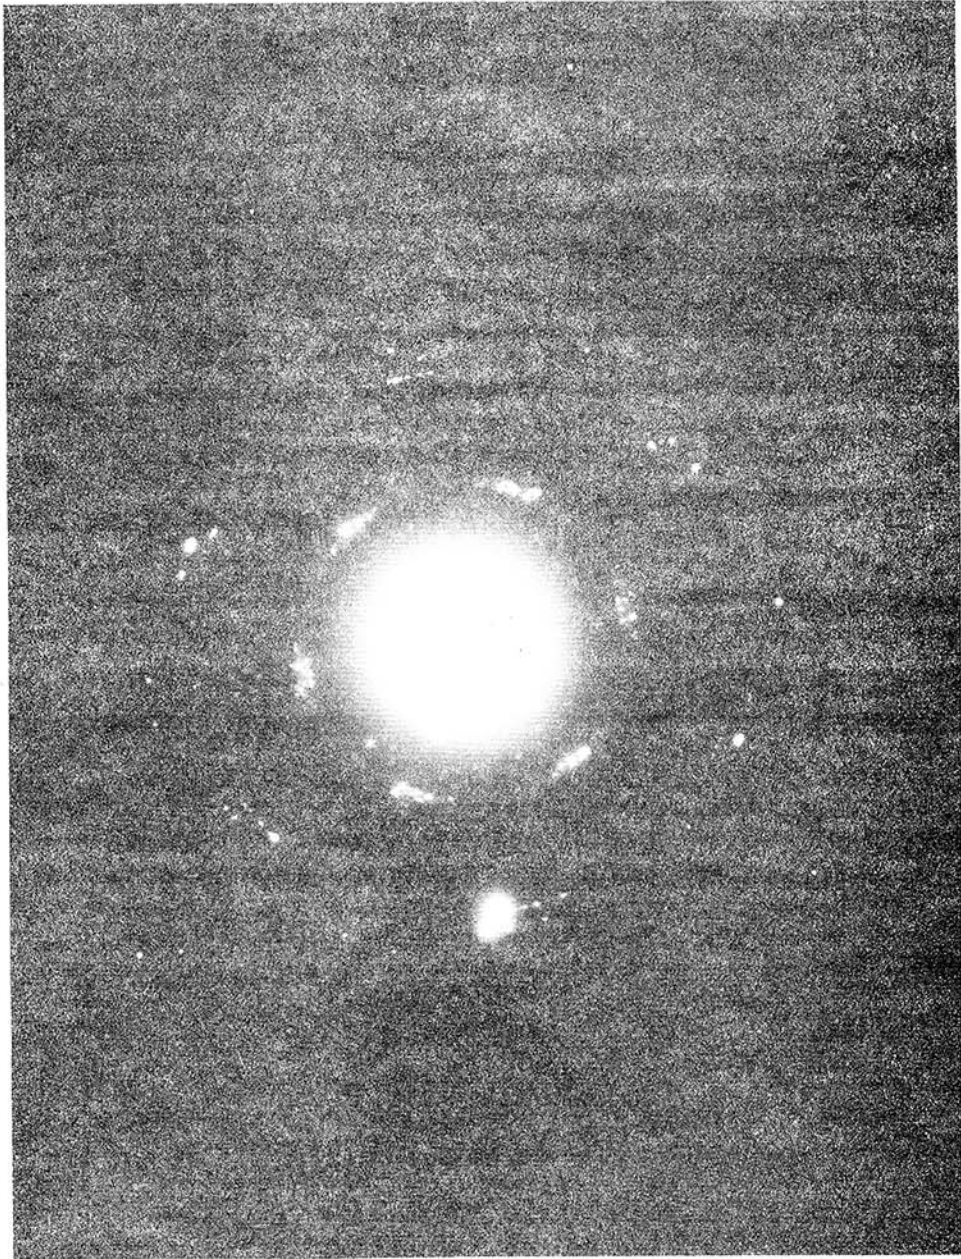
Figure 19. Diffraction Pattern of Residue in Gas Tube

the area of Figure 18) is shown in Figure 19. An analysis of Figure 19 is given in Table IV. Again, all but one line are matched by gilding metal or  $\text{CaCO}_3$ . The spotty nature of the Cu-Zn rings suggests that the discrete particles are metal; therefore, to identify the particles positively as metal, a dark field image was taken using one of the bright spots from the diffraction pattern. The micrograph shown in Figure 20 is of the same area of interest as is shown in Figure 19.
