Technical Report ARWSB-TR-09012

Variant M4 Barrel Characterization

July 2009

ARMAMENT RESEARCH, DEVELOPMENT AND ENGINEERING CENTER
Weapons & Software Engineering Center
Benét Laboratories

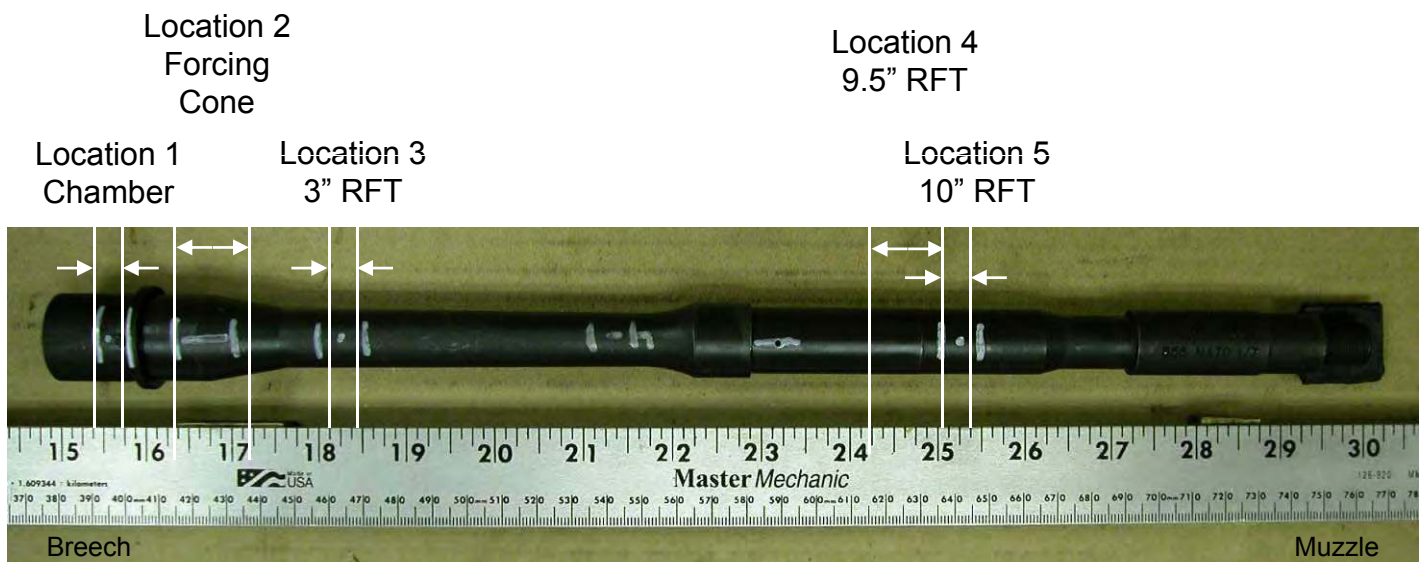
Figure 1: M4 Barrel Cut Plan

The barrels were sectioned to facilitate analysis. Five sections were identified (see Figure 1) mirroring the locations used previously¹⁻³. These locations for analysis are:

- Location 1 – chamber – ¼” ring section
- Location 2 – forcing cone – ½” longitudinal section
- Location 3 – 3” forward of the rear face of the tube (RFT) – ¼” ring section
- Location 4 – 9.5” RFT – ½” longitudinal section
- Location 5 – 10” RFT – ¼” ring section

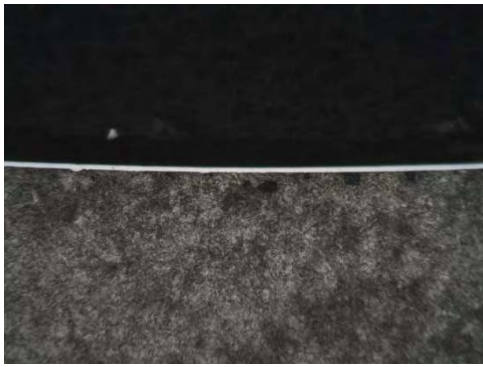
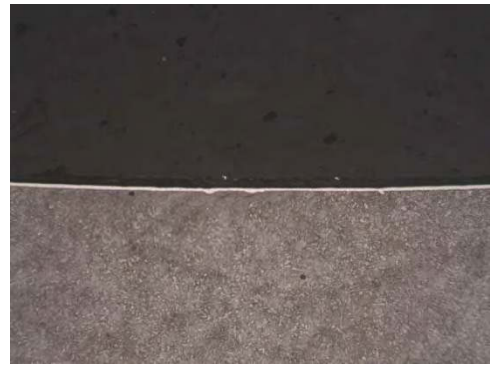
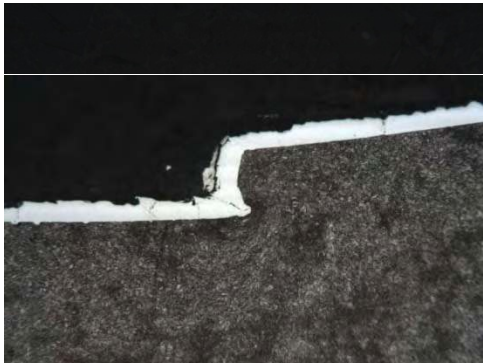
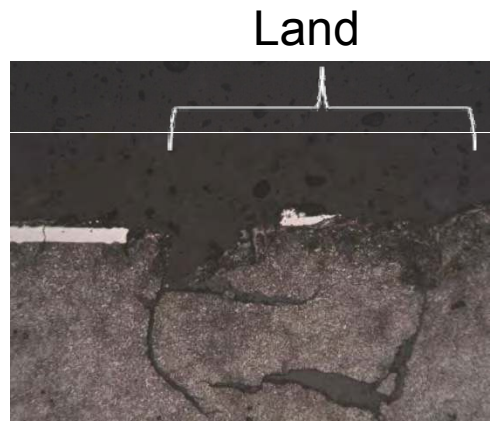
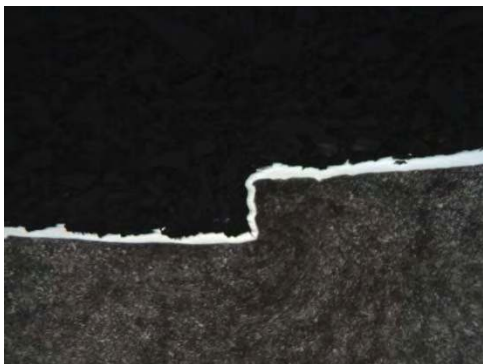
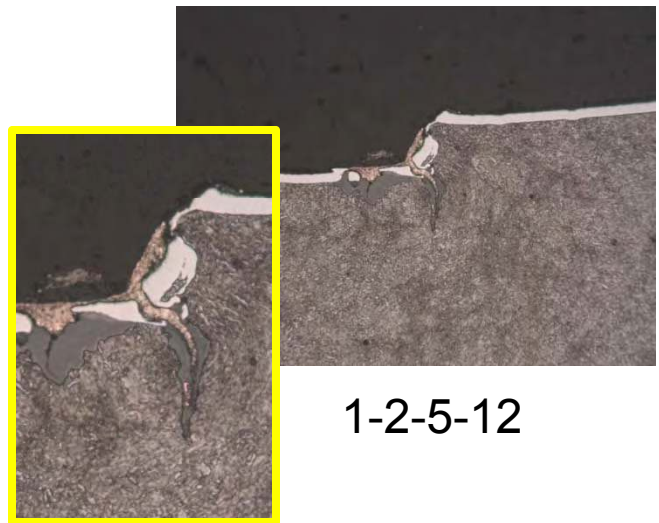
Figure 2: As-received and Fired Configuration 1 Cross-sections

Image height equals 0.020"

The three ¼” ring sections from each as-received and fired barrel (Location 1, 3, and 5) were metallographically mounted in cross-section and polished to a mirror finish. The samples were then etched with Nital to reveal the steel microstructure. Representative images comparing the as-received and fired barrels are posed as Figures 2 through 5.

The microstructure of the two steels was indistinguishable. All fired barrels showed a tempering in the microstructure, when compared to the as-received steel. This is confirmed in section 4.3 *Microhardness*. Heat affected zones seen in the fired barrels are relatively thin and localized to wide cracks and surfaces where the chromium has been completely removed.

All fired barrels show extensive copper deposits and damage to the rifling lands, and the type of damage appears to be dictated by the rifling profile. The Configuration 1 and 4 button broach barrels had large deposits of copper at the root of the lands; in addition to collecting copper and firing debris at surface cracks and disparities. The Configuration 2 and 3 hammer forged barrels have a rougher as-received surface. During firing, the rough surface tended to collect copper and debris in the surface troughs. For all fired barrels, the damage was heavier at Location 3 compared to Location 5.

The Configuration 1 and 4 button broach barrels exhibited a limited amount of cracking in the steel in the as-received barrels. These cracks were relatively shallow and extended into the wall at a 45° angle from the bore surface at the root of the land. During firing, these 45° cracks initiated and extended at each land root, on both the driving and leeward side of the land. The location and orientation of the cracks suggest shear forces on the side of the land are the motivating force for cracking. In some instances, the driving and leeward side cracks of a land eventually linked up, and the land is completely removed.

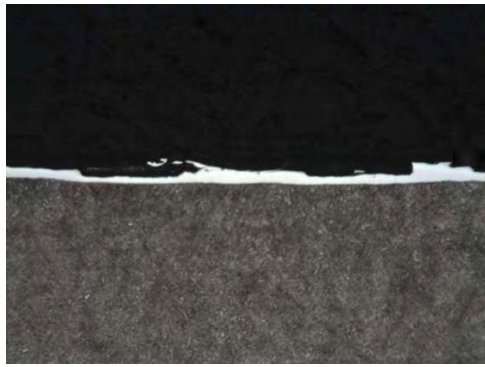
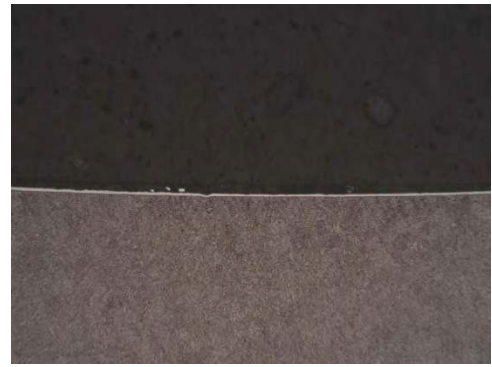
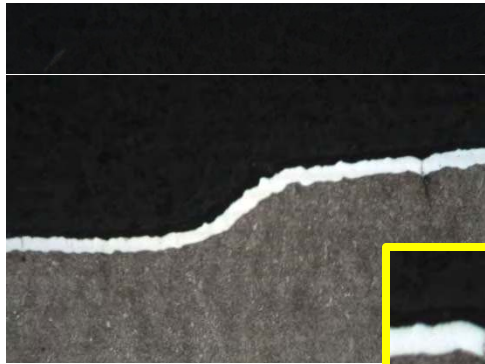
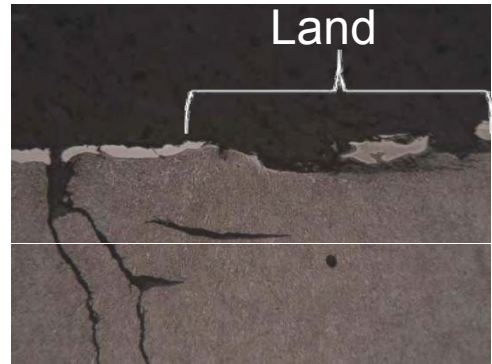
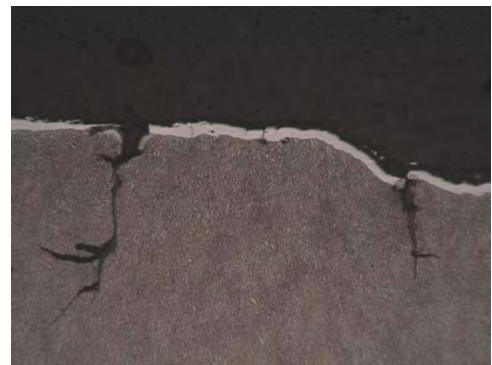
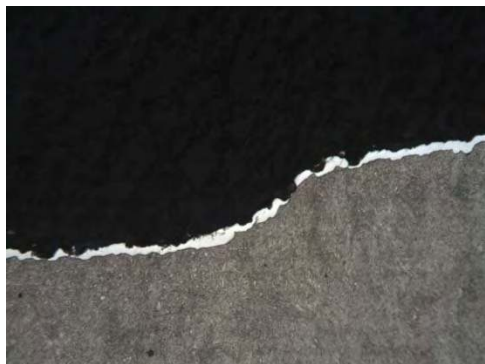
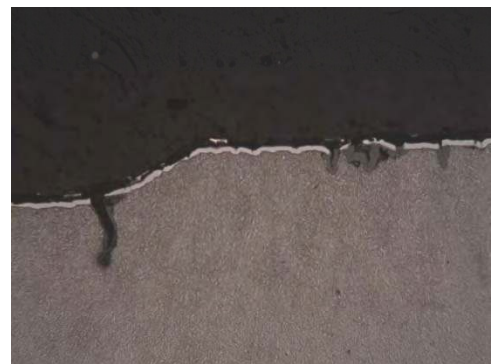
Figure 3: As-received and Fired Configuration 2 Cross-sections

Image height equals 0.020"

The Configuration 2 and 3 hammer forged barrels showed deeper and more extensive cracking in the as-received barrels. However, the cracks were oriented perpendicular to the bore surface, and were not associated with a land corner. These cracks tended to occur in the middle of the land or groove surface. During firing, these cracks widened and extended further through the wall. Damage to the land was predominately wear to the driving side land wall. The driving side wall was worn down to a very shallow slope; while the leeward land side was relatively undamaged.

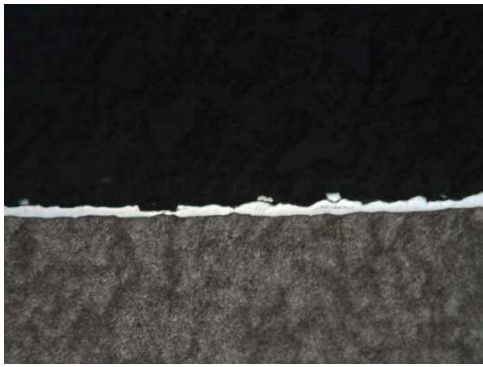
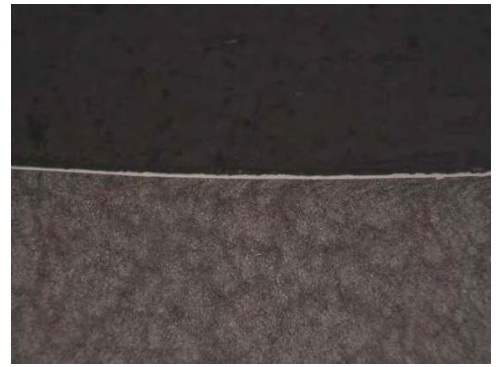
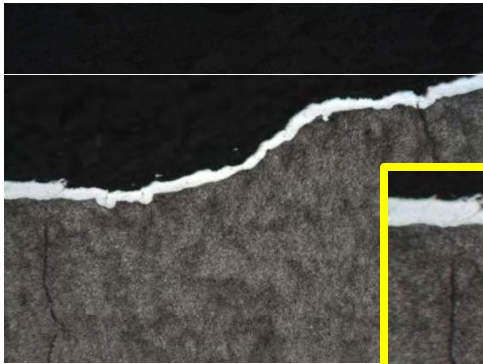
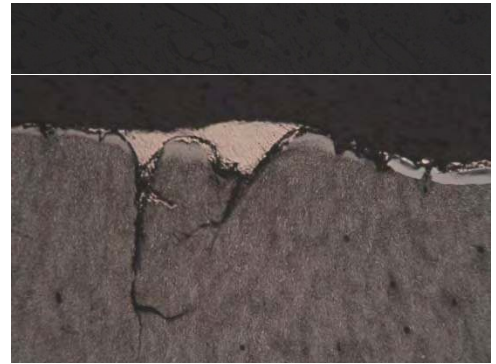
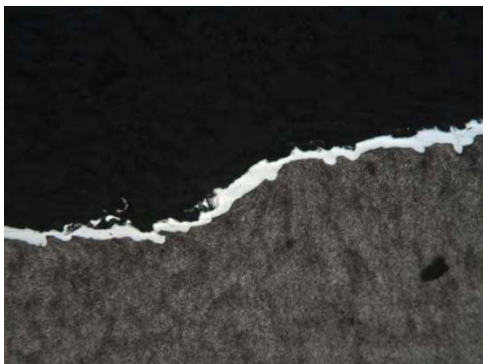
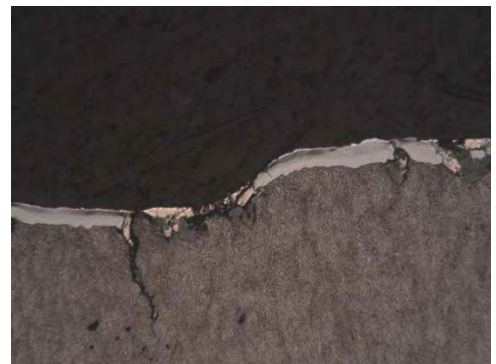
Figure 4: As-received and Fired Configuration 3 Cross-sections

Image height equals 0.020"

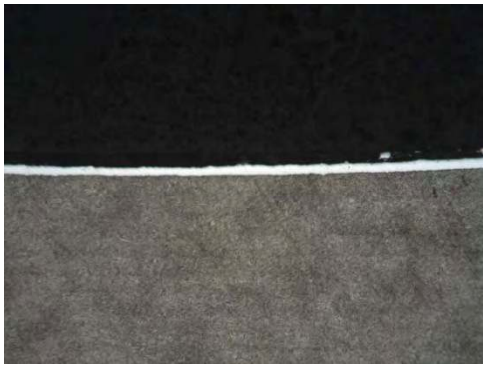
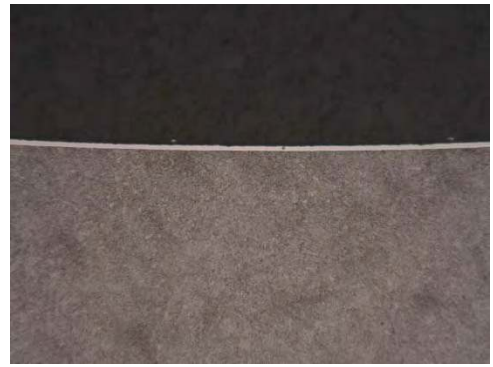
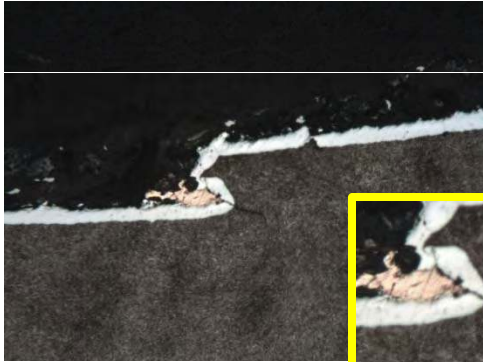
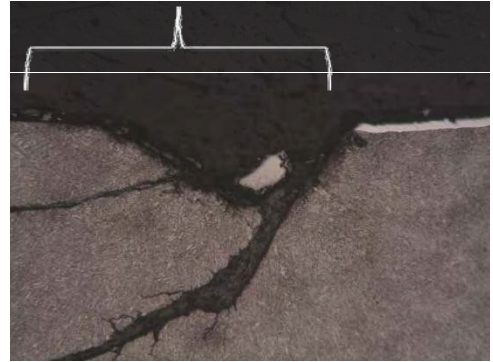
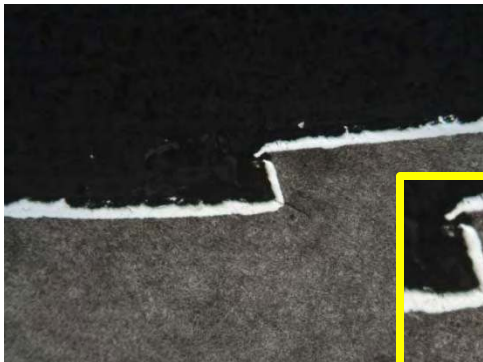
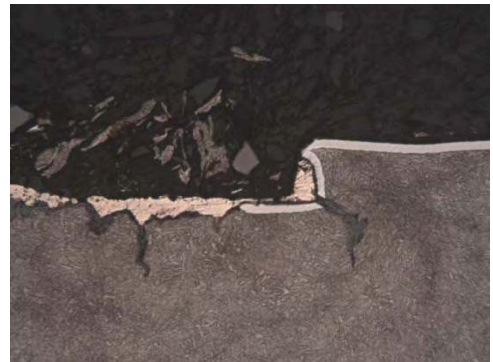
Figure 5: As-received and Fired Configuration 4 Cross-sections

Image height equals 0.020"

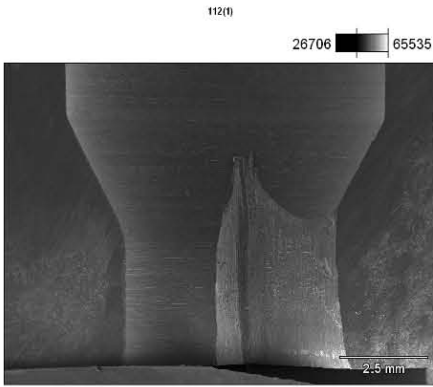
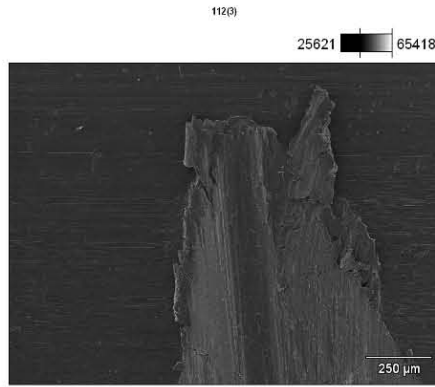
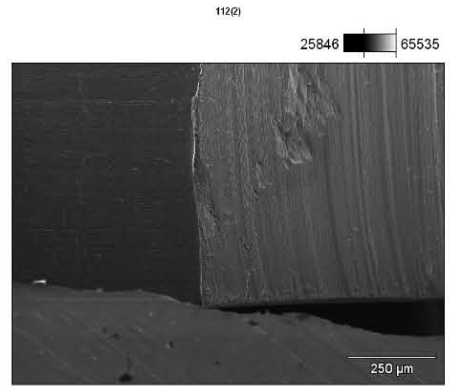
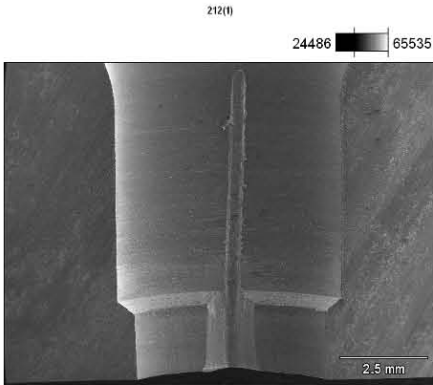
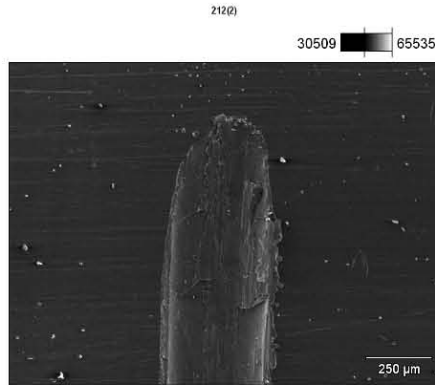
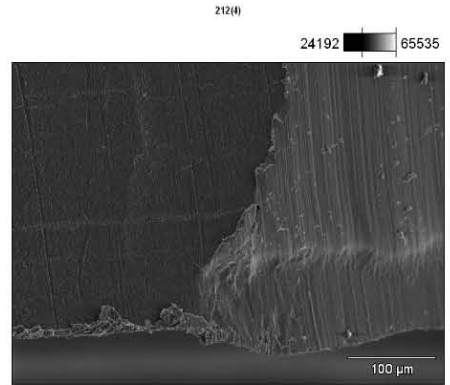
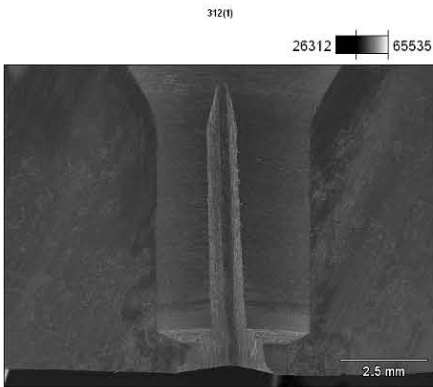
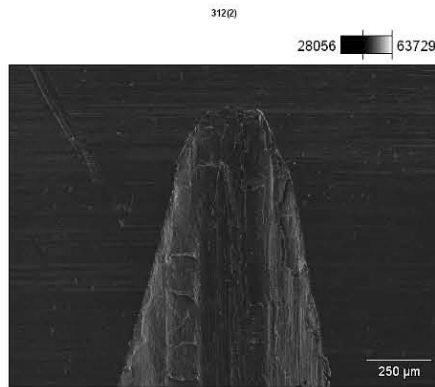
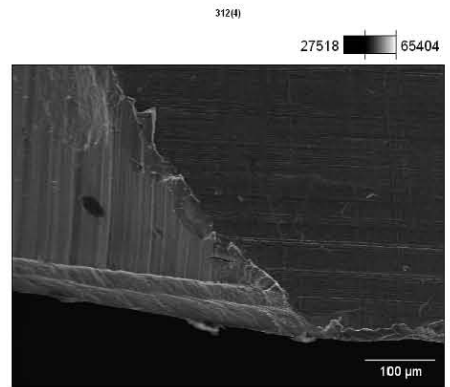
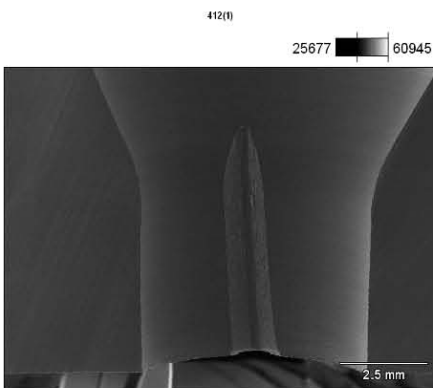
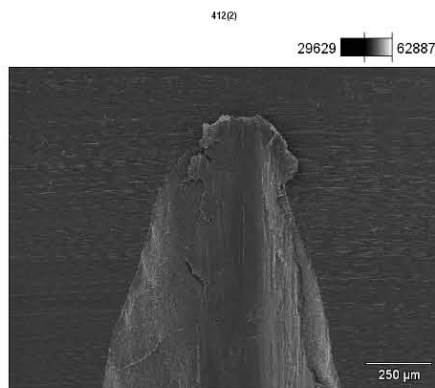
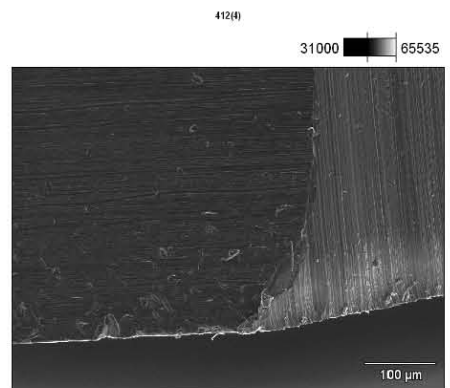
Figure 6: As-Received Forcing Cone Surface and Groove Images

Surface imaging of the as-received Location 2 samples (Figure 6) shows a smooth and complete chromium coating. These samples are also used for coating adhesion testing; see section 4.5 *Adhesion testing* for more information.

The as-received Location 2 samples (Figure 6) were subjected to groove adhesion testing. A tungsten-carbide tool bit was scribed through the coating along the axis of the barrel. This groove was then analyzed for adhesive failure adjacent to the groove. No adhesive coating failure was identified.

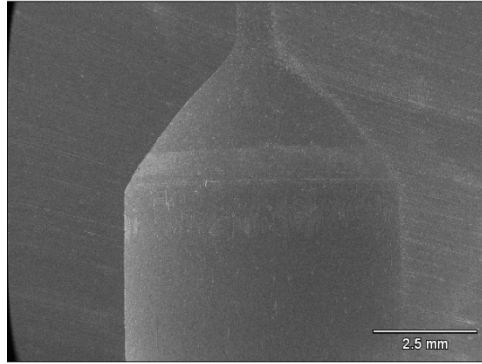
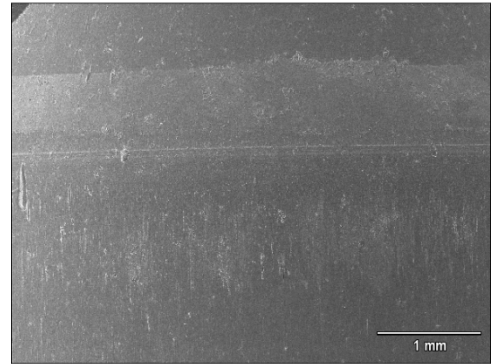
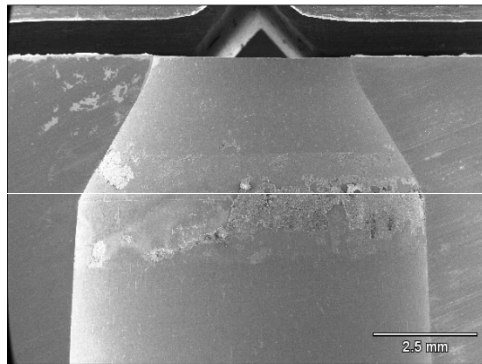
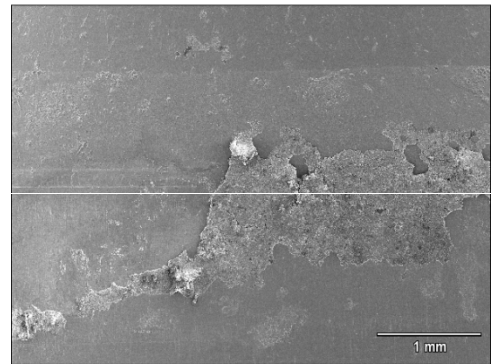
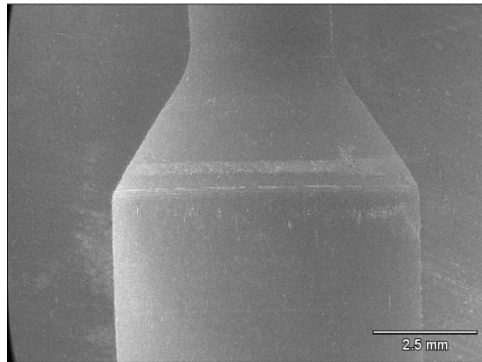
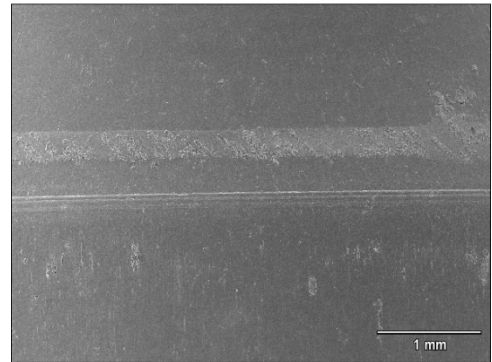
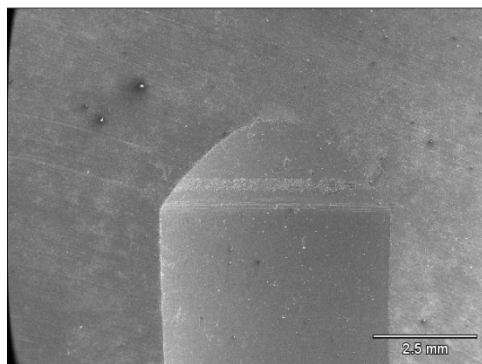
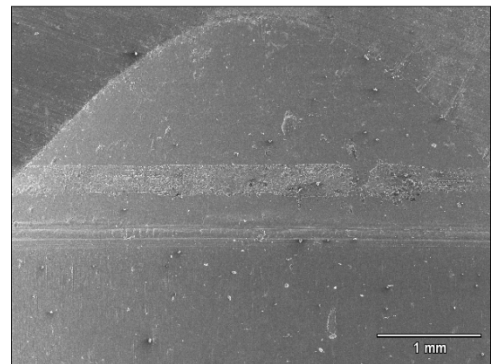
Figure 7: Fired Forcing Cone Surface Images

Surface imaging of the fired Location 2 samples (Figure 7) shows two distinct wear bands in each of the barrel configurations. The first wear band occurs approximately 0.5mm rearward of the chamber/forcing cone junction. This approximate 1mm wide band exhibits extensive mechanical damage to the chromium through numerous axial scratches, dings, and dent. A small percentage of these scratches penetrate the chromium into the steel. The second wear band occurs approximately 0.25mm forward of the chamber/forcing cone junction. This approximate 1mm zone is a contiguous band where the chromium coating has been removed, revealing a belt of steel and corrosion/combustion products. Samples 1-2-2 and 2-2-2 have wider forward wear bands than 3-2-2 and 4-2-2. Sample 2-2-2 was also image with a large amount of combustion products adhered to the chamber/forcing cone junction area. These wear zone issues appear independent of the material and rifling configuration of the barrel.

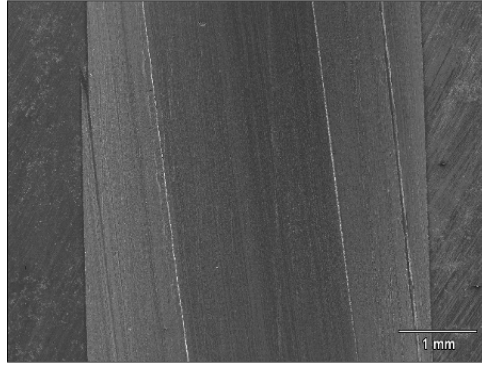
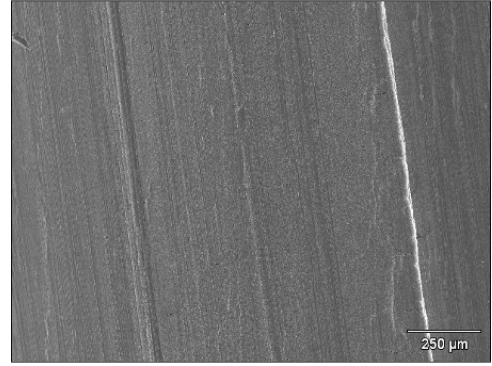
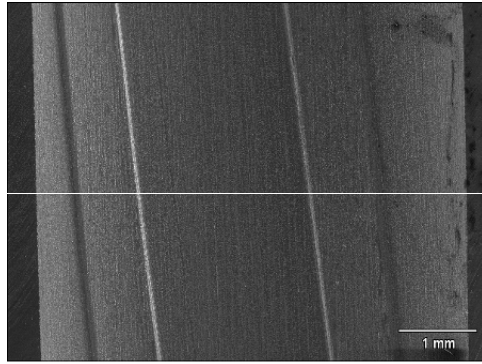
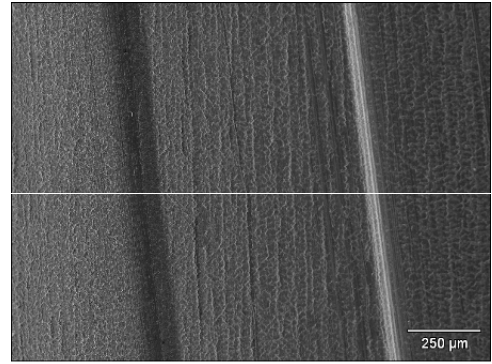
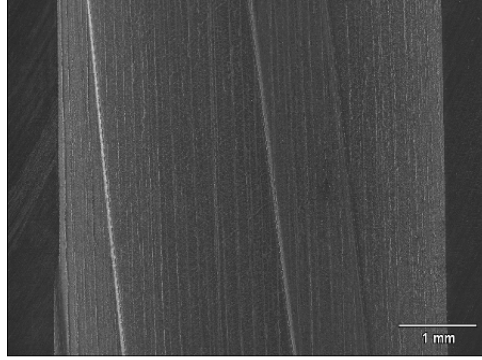
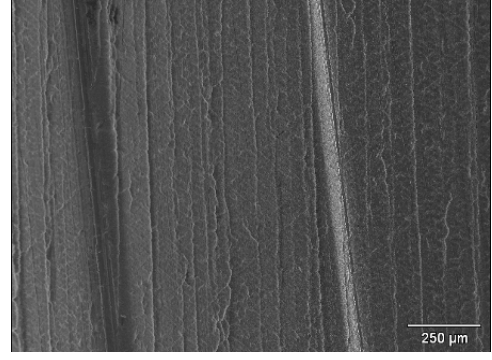
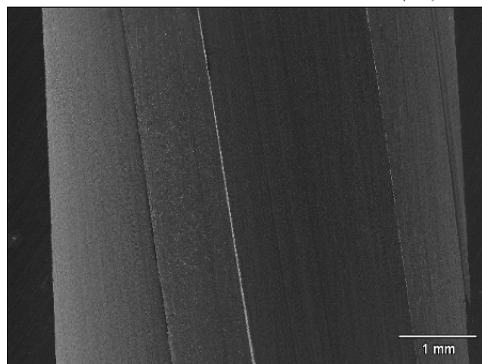
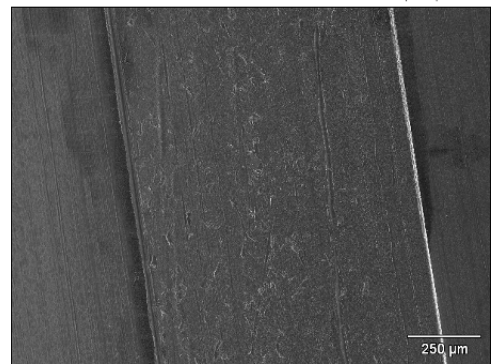
Figure 8: As-Received 9.5" RFT Surface Images

Surface imaging of the as-received Location 4 samples (Figure 8) shows a textured bore surface. Samples 1-1-4 and 4-1-4, the button broached samples, exhibit shallow machining marks on the surface. These marks tend to follow the rifling profile of the bore. Samples 2-1-4 and 3-1-4, the hammer forged samples, exhibit a furrowed surface. Compared with the broached tube surface, these ruts are slightly deeper than the machining marks and align with the tube axis instead the rifling profile.

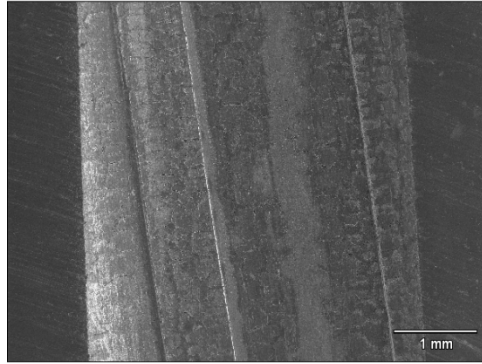
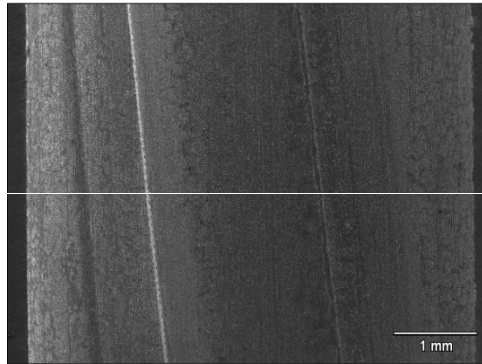
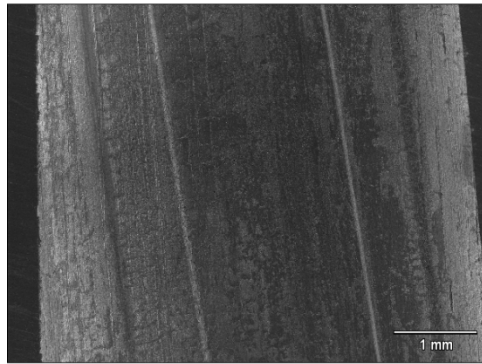
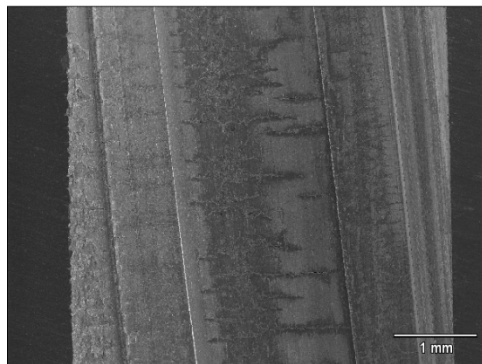
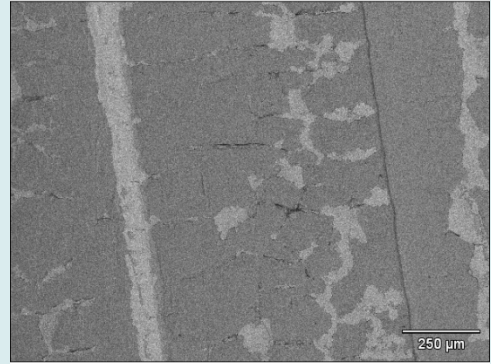
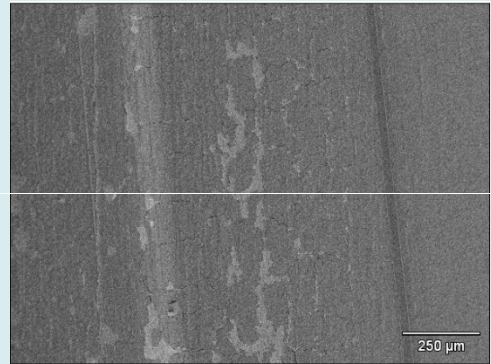
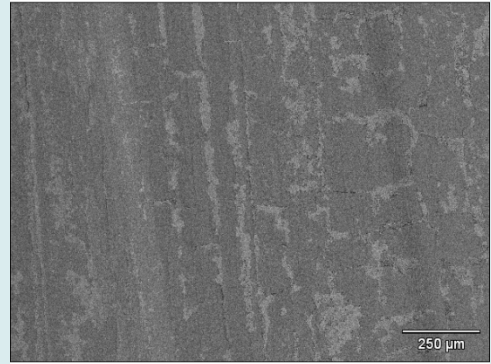
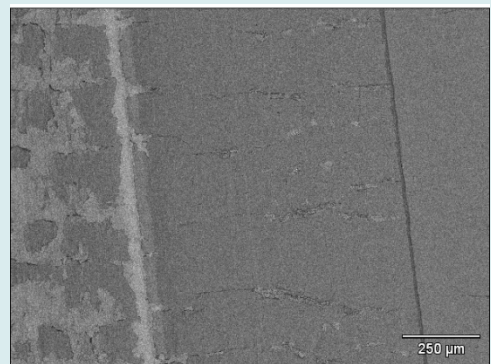
Figure 9: Fired 9.5" RFT Surface Images

Surface imaging of the fired Location 4 samples (Figure 9) shows a cracked and contaminated surface. All the samples exhibit heat check cracking, and these cracks have been subsequently packed with copper and combustion products. The axial surface furrows on the hammer forged samples 2-2-4 and 3-2-4 are also filled with copper. The button broached samples 1-2-4 and 4-2-4 showed a large amount of copper adhered to the root of the driving side land; this driving-side copper build-up is not present in the hammer forged samples.

Backscatter Images.
Cu represented by light gray.
