Test Report

# PROTOTYPE QUALIFICATION TEST - GOVERNMENT OF CONUS-PRODUCED SAW AMMUNITION (M855/M856)

Franklin H. Miller
Light Weapons Systems Division
Armament, Systems Directorate

August 1988

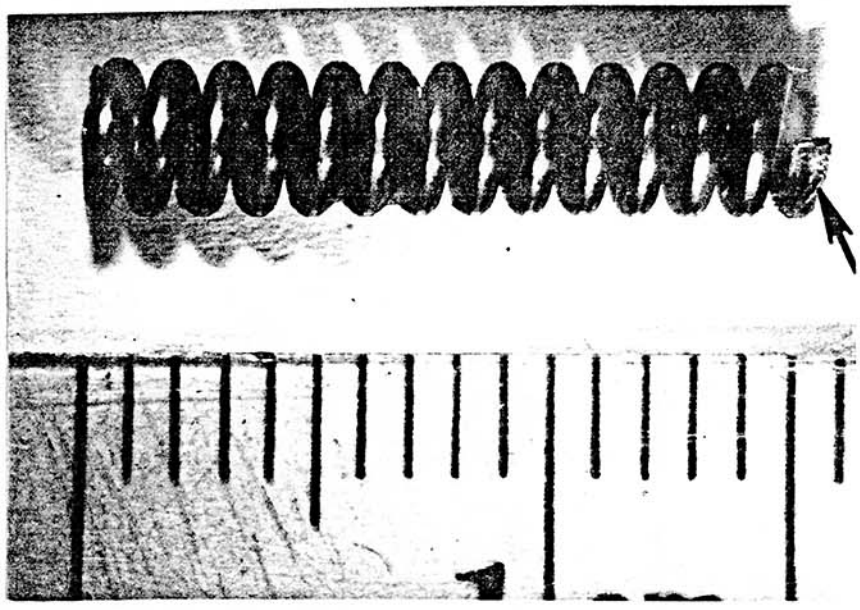
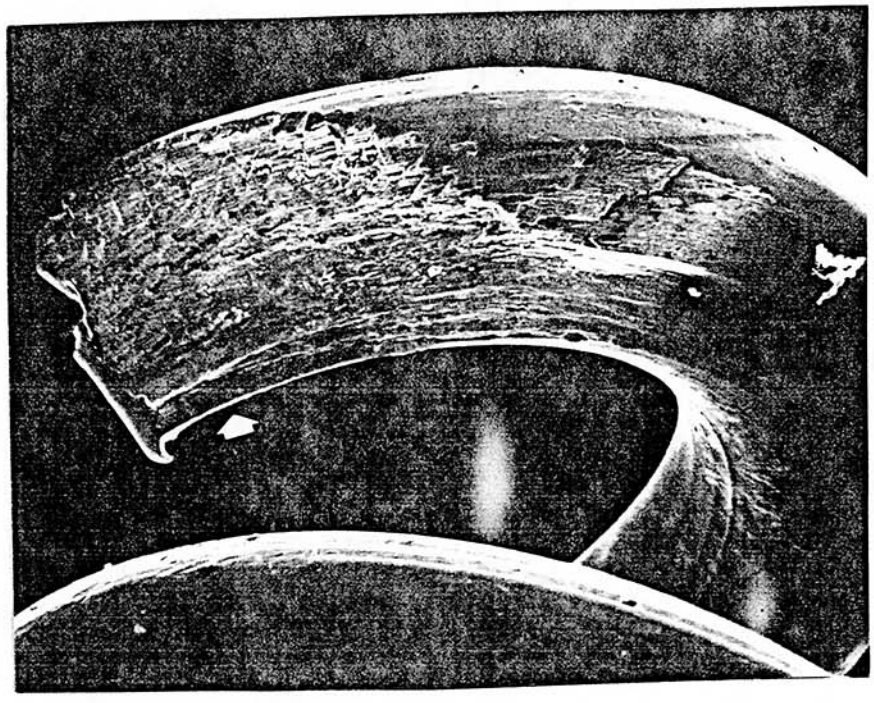
Examination of the failed extractor spring, Figures 5.3-1 and 5.3-2, revealed that it was a fatigue failure. The fracture initiation site was located along the horizontal axis of the inside of the first coil from one end. Scanning Electron Microscope (SEM) examination revealed no evidence of material imperfections or manufacturing defects that would contribute to a fatigue initiation.

Figure 5.3-1. Photograph (enlarged) of failed extractor spring which shows the location of the fracture (arrow).

Figure 5.3-2. Closeup of the extractor spring fracture surface. Fracture initiated along the inner edge of the spring coil in the area identified by the arrow. Magnification, 80X.

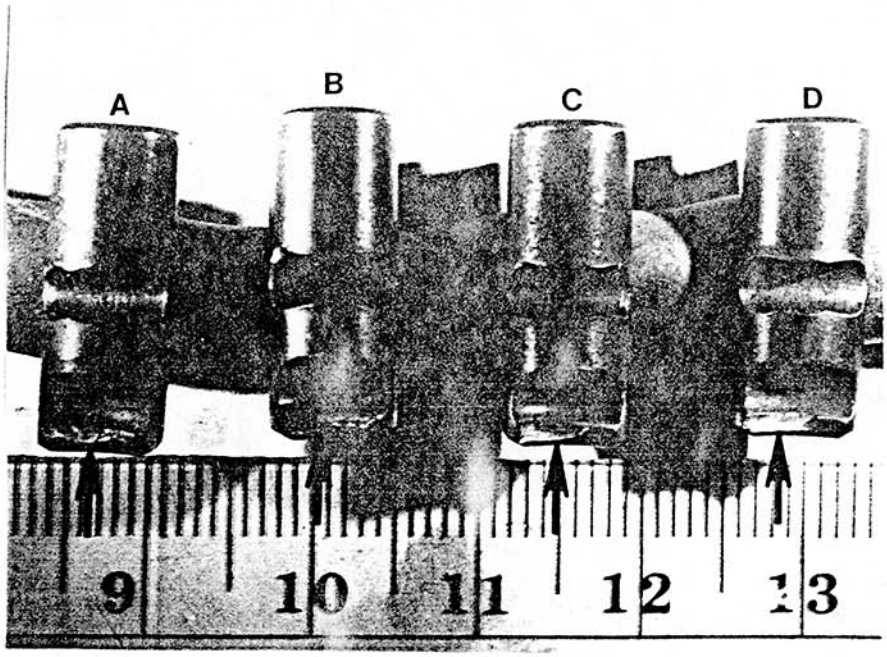
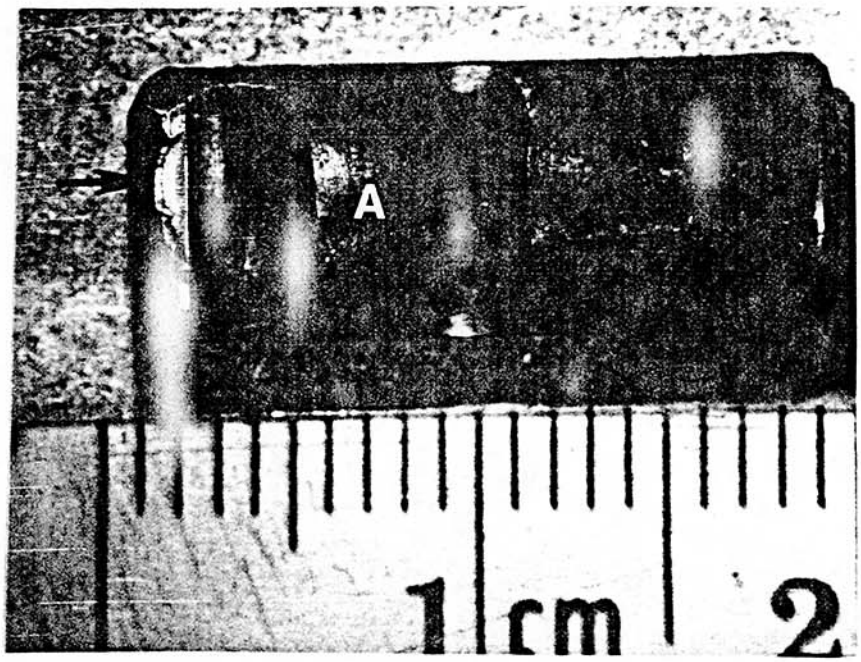
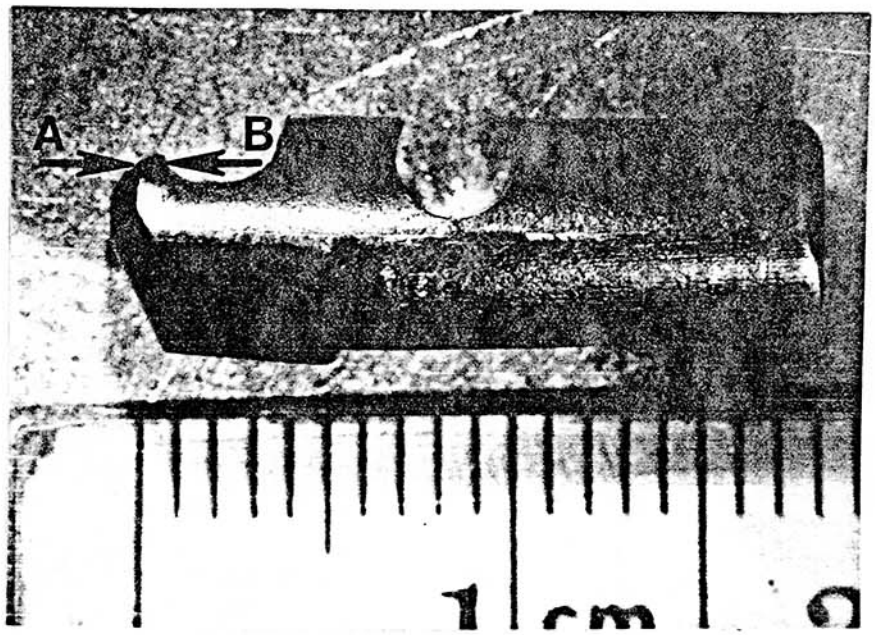
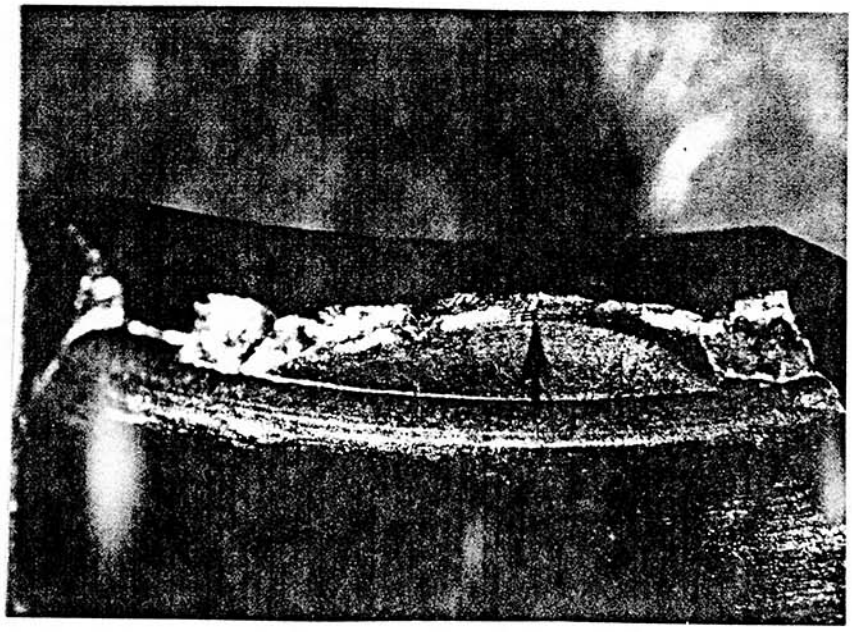
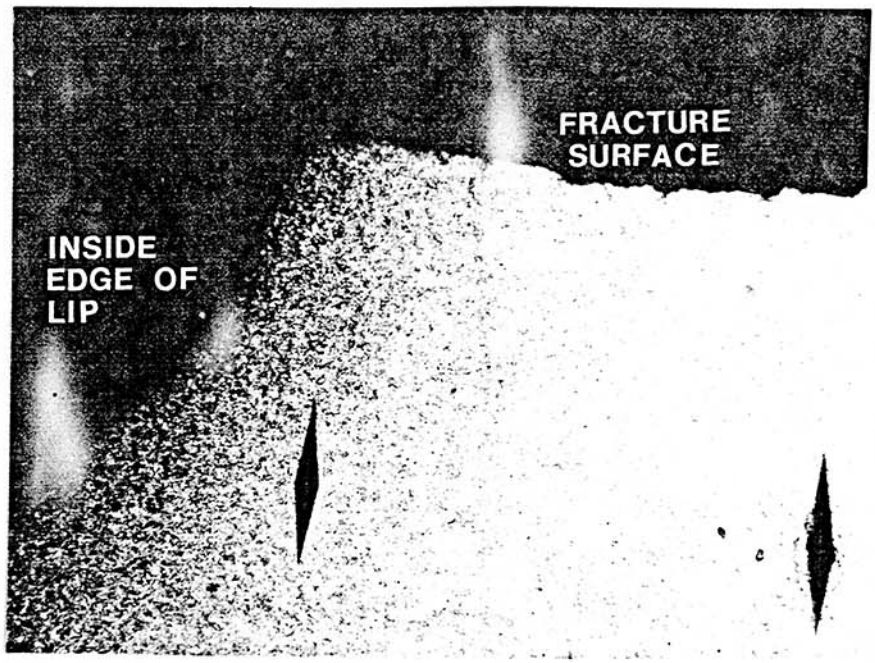
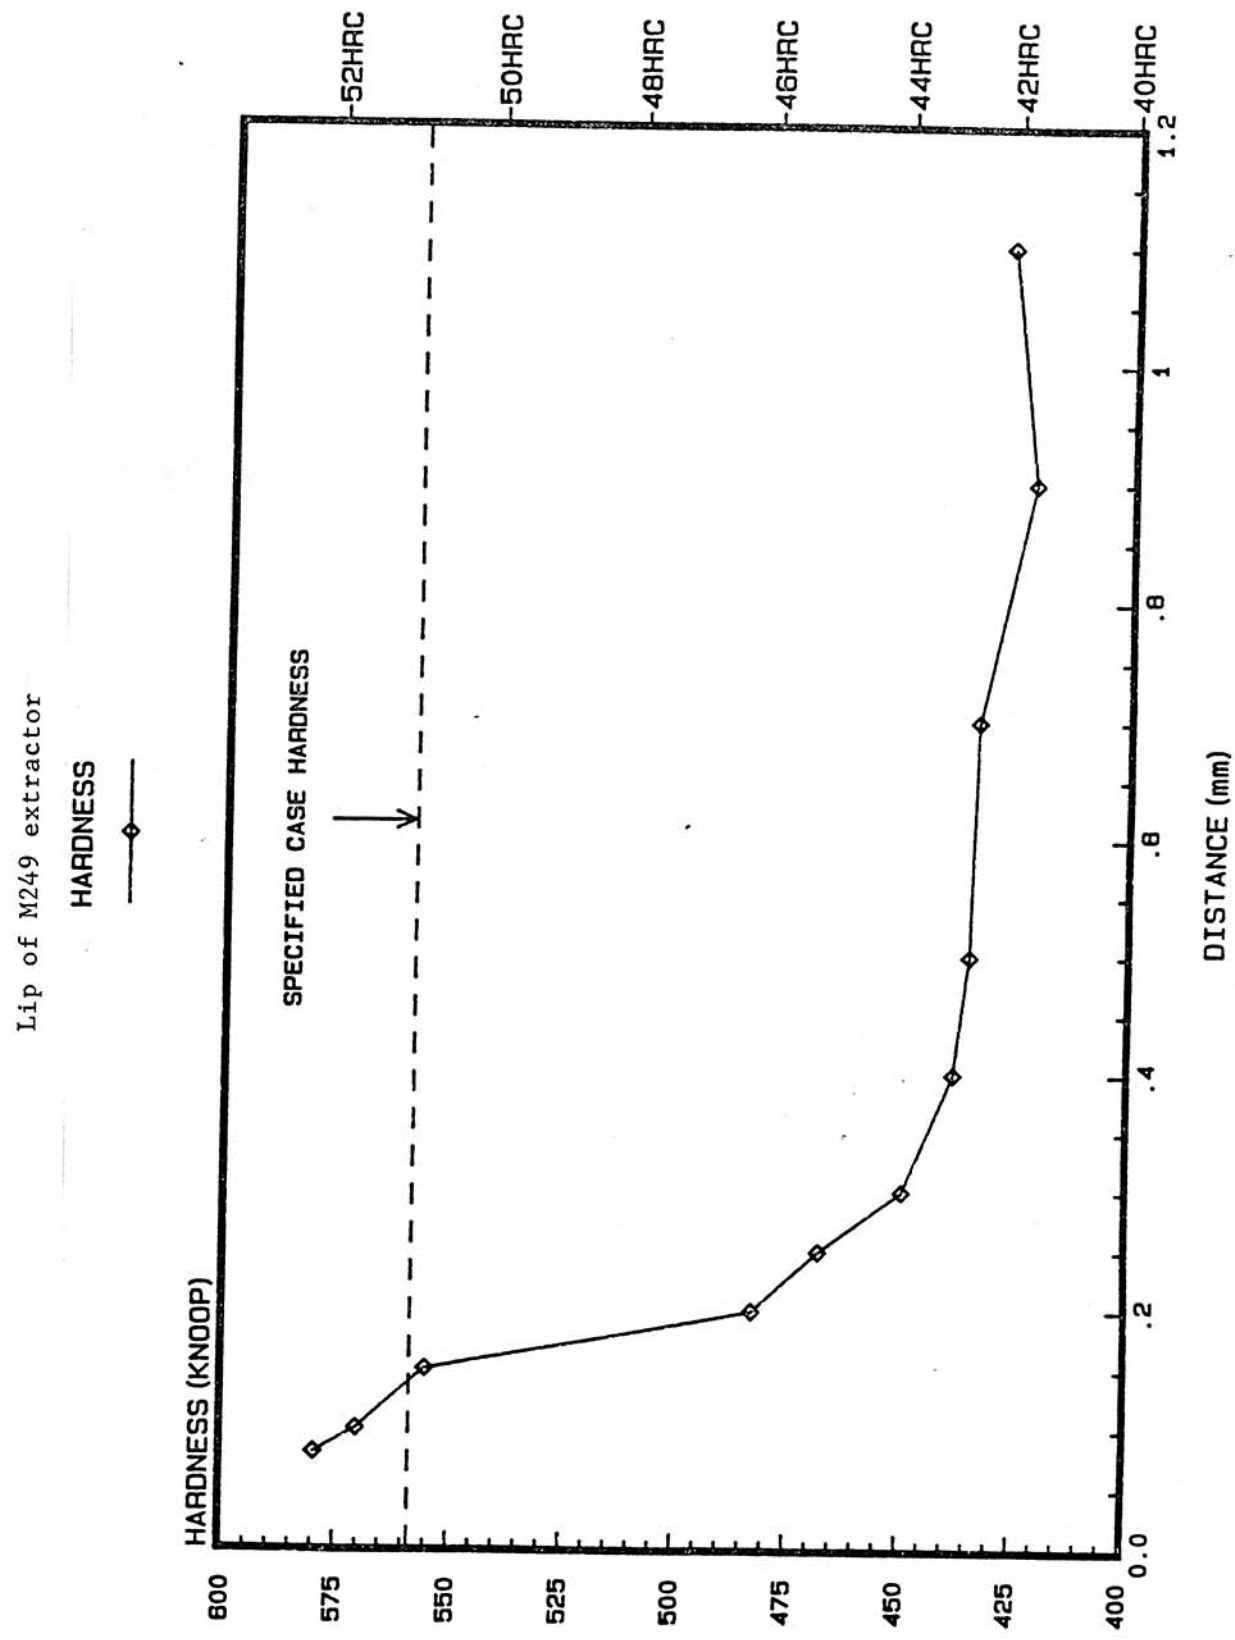
Examination of the failed extractors, Figures 5.3-3 to 5.3-8, shows that they were exposed to a compressive load during chambering of the cartridge and a tensile load during extraction and ejection of the fired case. Macroscopic examination of the fracture surfaces revealed a fracture zone with beach marks on the edge of the fracture zone. Metallurgically, the extractors have a case hardened zone with martensitric microstructure. Beneath this zone, the extractors have a microstructure of mixed transformation products. The extractor hardness was HRC 41, with a case hardened zone depth of 0.14 mm. The material used in the extractor was identified as 34xx-series nickel-chromium steel. No carbon determination was made because of insufficient sample quantities available. The hardness specified for the extractor (Drawing No. 390 04 41-003) was above the 86 HR15N minimum required. The case-hardened zone of 0.10 to 0.15 mm was also within specification. The microstructure of the extractors was sound, indicating that material imperfections were not a contributing factor in the failures. The extractors failed in fatigue initiated by tensile loading applied during extraction and ejection of fired cases.

Figure 5.3-3. Photograph of the four broken extractors submitted for analysis. Note the location of fracture (arrows).

Figure 5.3-4. Top view of extractor A showing fractured lip (arrow).

Figure 5.3-5. Profile view of extractor with the direction of both applied loads identified. A - compressive impact load, B - tensile load.

Figure 5.3-6. Closeup of fracture surface showing fatigue fracture surface with beach marks on the leading edge (arrow). Magnification: 20.X.

Figure 5.3-7. Micrograph of extractor where the fracture surface intersects the inside edge of the lip. This is a case hardened zone with a martensitic microstructure with the remainder having a microstructure of mixed transformation products. Magnification: 200 X.

Figure 5.3-8. Microhardness traverse.

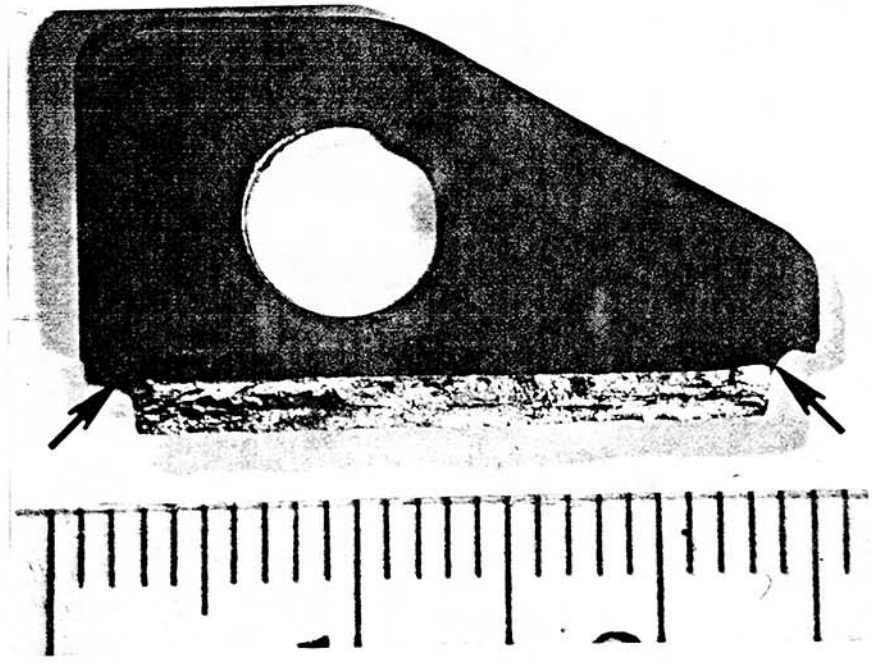
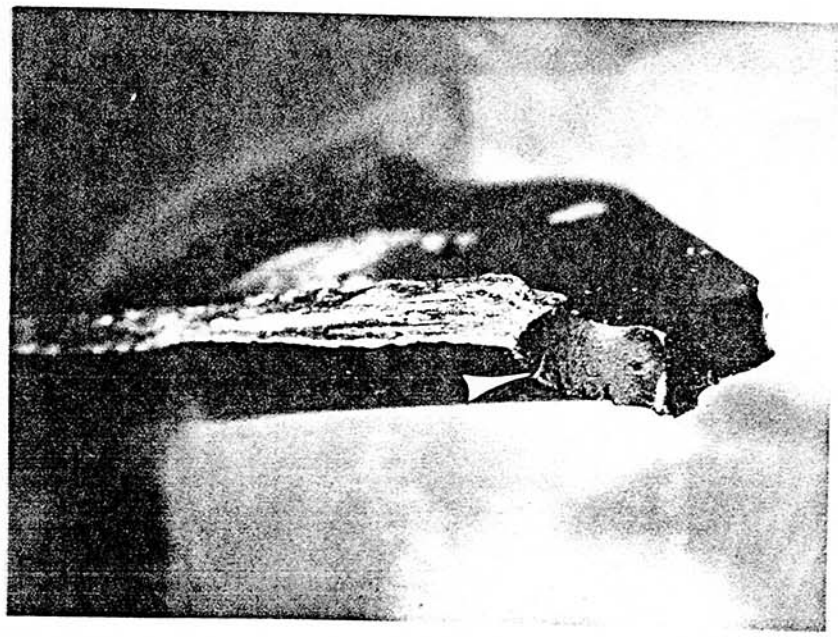
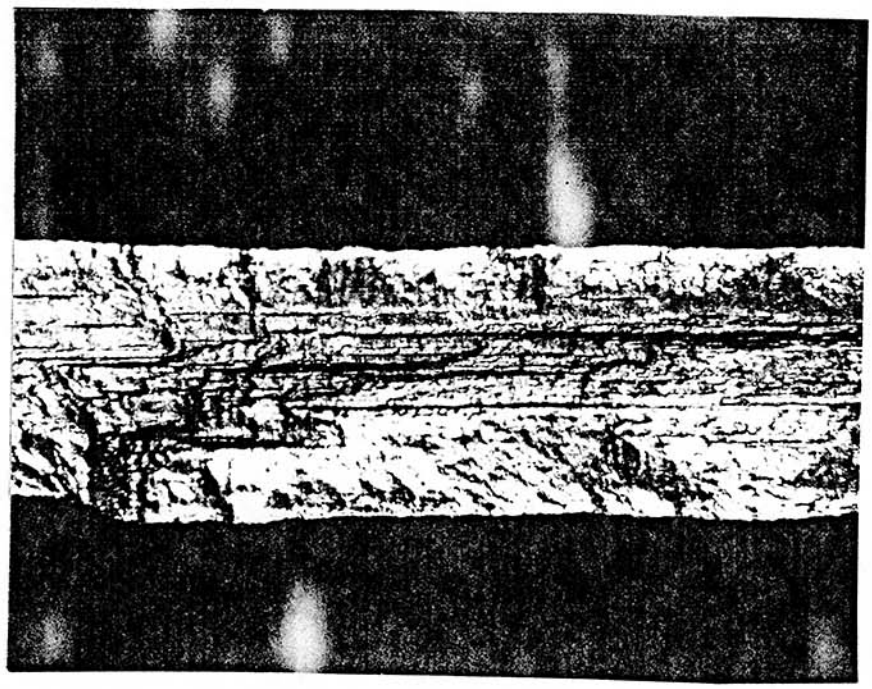
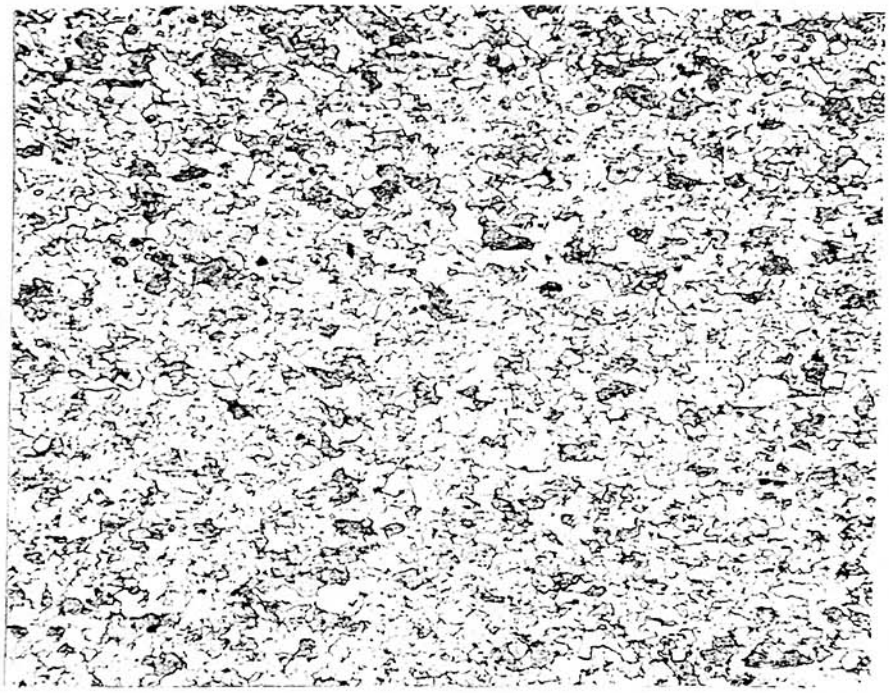
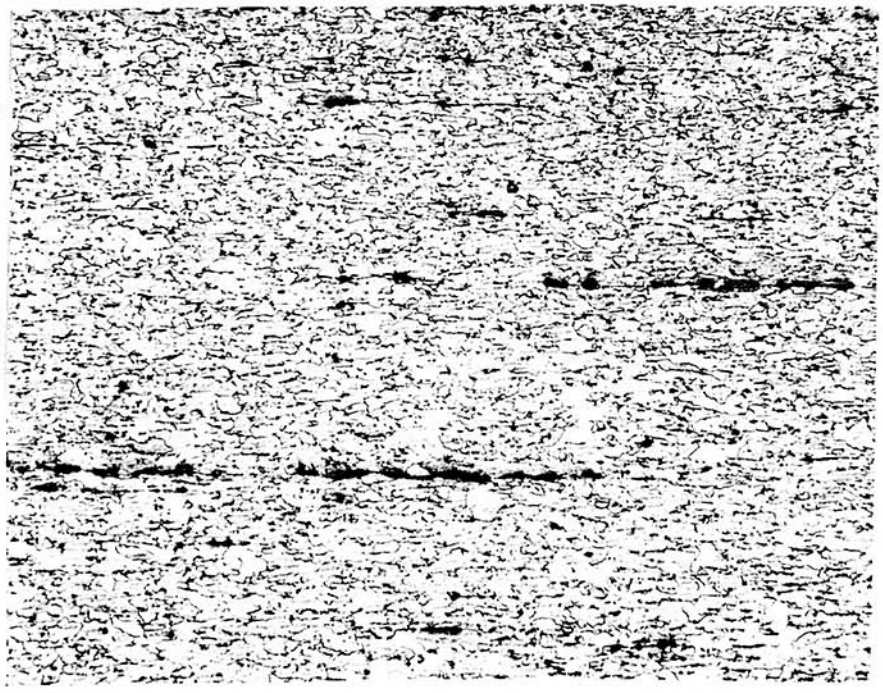
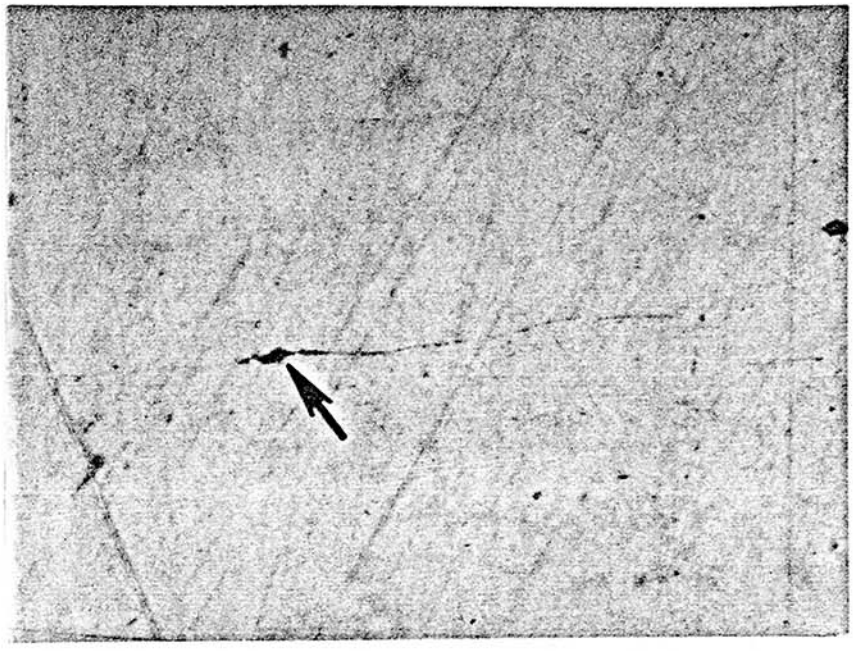
Two of the three M249 receivers experienced breakage of the metal boss which was the mounting location of the handguard. The macroscopic appearance of the fracture was typical of a fatigue failure in a cold-rolled steel. The ferritic grains were elongated and defects and inclusions were oriented in the rolling direction. Since cracks propagate more rapidly through defects and inclusions, the fracture surface had a layered appearance. The fracture surface was more heavily damaged at the rear end (narrow end of the retainer boss), indicating that the fatigue crack propagated from that direction. The least damaged portions of the failure surface showed ductile fracture characteristics, although the existing damage made it difficult to characterize the fracture. The part hardness, HRB 73, corresponded to a tensile strength of approximately 65 kpsi. The micrograph of the longitudinal section showed elongation of ferritic grains due to cold rolling reductions of between 40 and 50%. There were also sulfide stringer inclusions. Examination of an unetched polished section showed that the inclusions were minimal and too small to be characterized by ASTM standards. The material used in the receiver was identified as a high-strength low-alloy (HSLA) steel, SAE 950x grade. The microstructure indicated that the material had a low carbon content.

Part hardness and the microstructure indicated uniform material strength. The surface cracks noted (Fig. 5.3-10) acted as stress risers. The cracks were part of the manufacturing process, since the protective coating applied to the receiver was also applied to the crack surfaces before occurrence of the failures. Figures 5.3-9 through 5.3-14 show various views of the failed parts.

Figure 5.3-9. Right side view of failed retainer boss showing fracture surface with punched stress-relief holes on each and (arrow) (rear end at right).

Figure 5.3-10. Rear end view closeup of retainer boss showing cracks on outside edge of stress-relief hole. Magnification: 6 X.

Figure 5.3-11. Closeup of fracture surface showing layered effect due to preferential cracking. Magnification: 20 X.

Figure 5.3-12. Micrograph of transverse section showing ferritic microstructure. Magnification: 200 X.

Figure 5.3-13. Micrograph of longitudinal section showing elongation of ferritic grains in direction of cold rolling and sulfide inclusions. Magnification: 200 X.

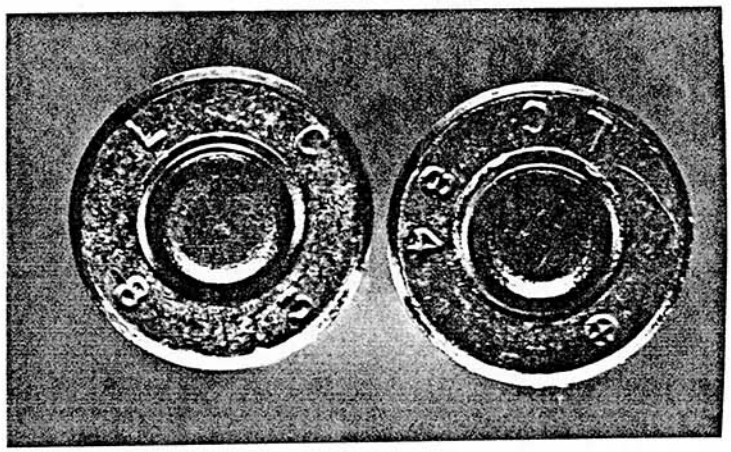
The final documentation of this subtest relates to inspection of the ammunition and fired cases. Figure 5.3-15 shows an incorrect cartridge case on a round of M855 Ball ammunition. Figure 5.3-16 depicts a typical case mouth tear. Folds in the neck of the cartridge case, caused during manufacture, are shown in Figure 5.3-17. These folds could result in splits when the round was fired (Fig. 5.3-18). Another type of case fold in the area of the case shoulder is shown in Figure 5.3-19. A representative example of a pierced primer is displayed in Figure 5.3-20. Table 5.3-8 summarizes the ammunition and fired case inspection performed during this subtest.

Figure 5.3-15. Wrong cartridge (left) discovered during pre-firing inspection.

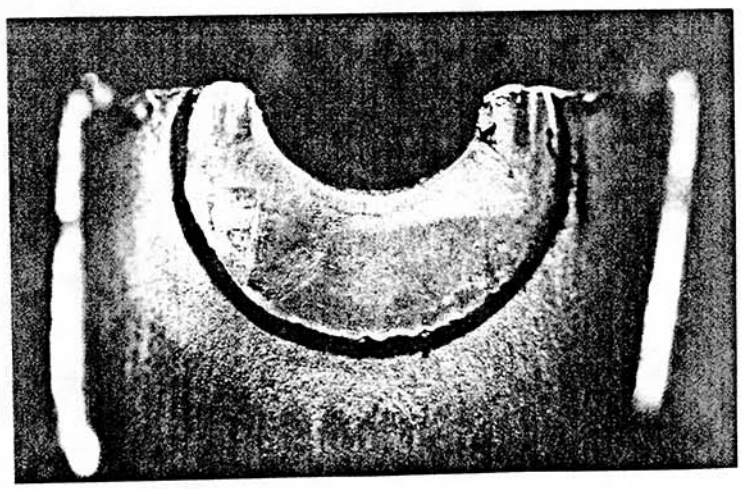
Figure 5.3-16. Inside view of case mouth deformation (typical).

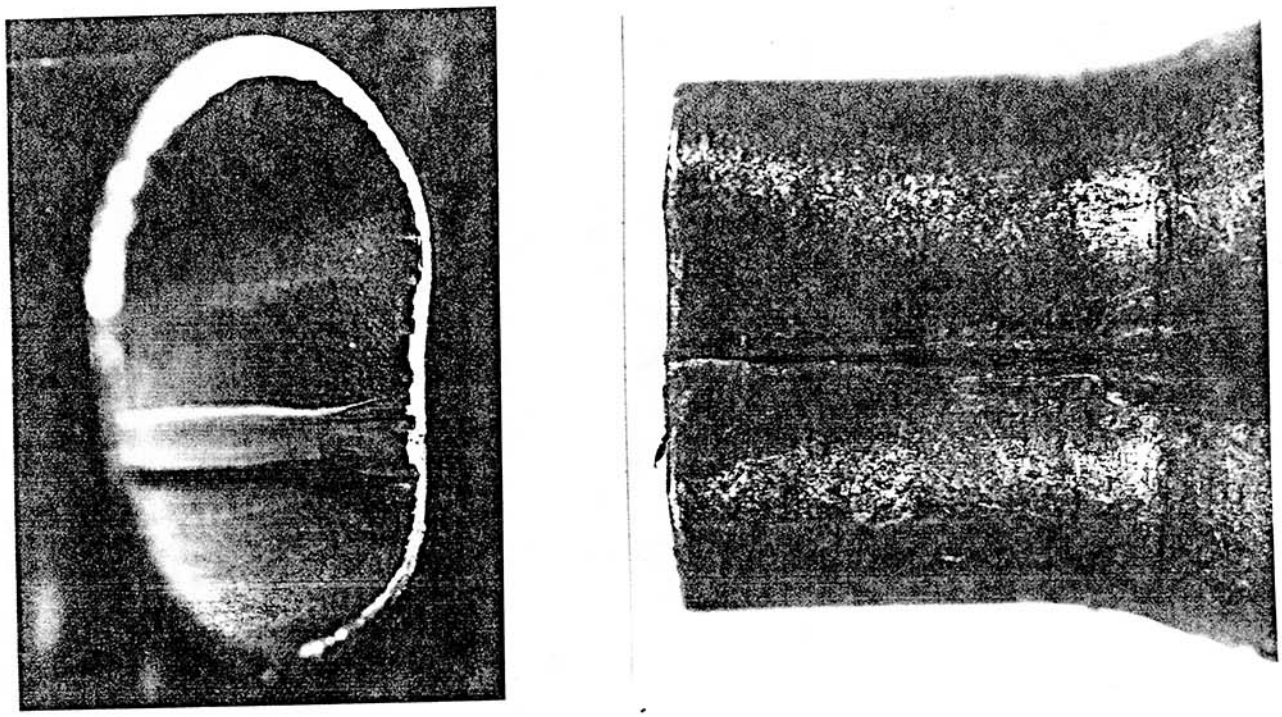
Figure 5.3-17. Showing a typical fold in the case neck.

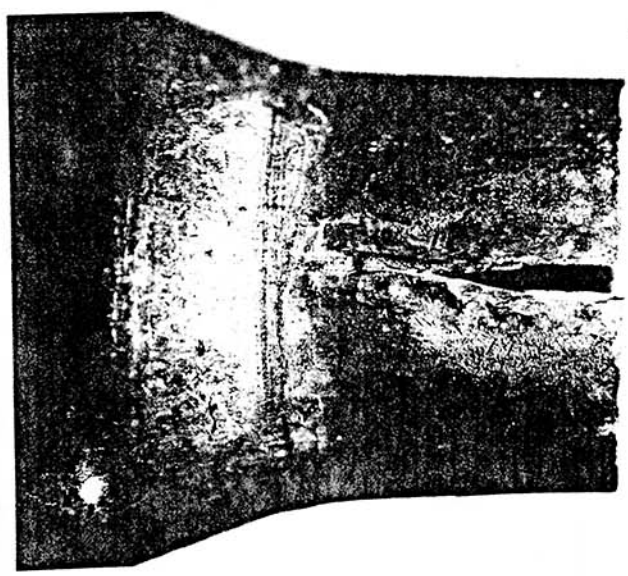
Figure 5.3-18. Typical case split.

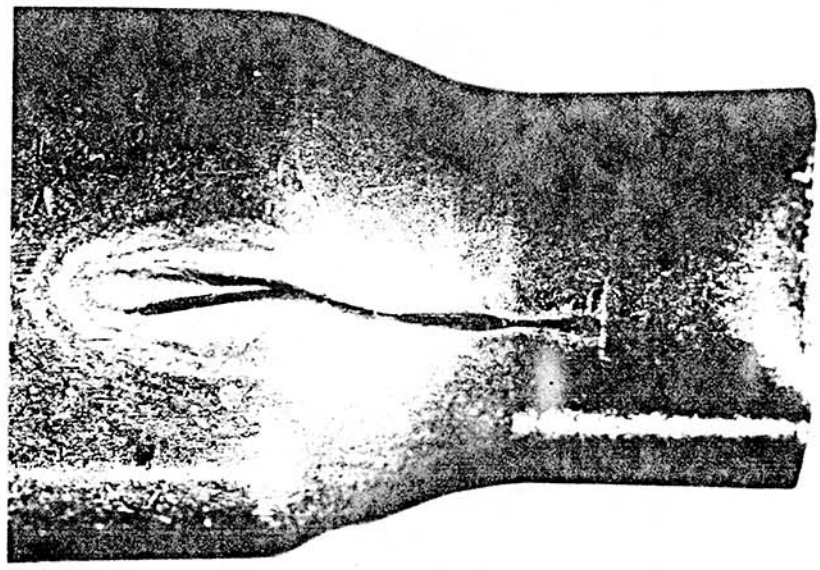
Figure 5.3-19. Typical should fold.

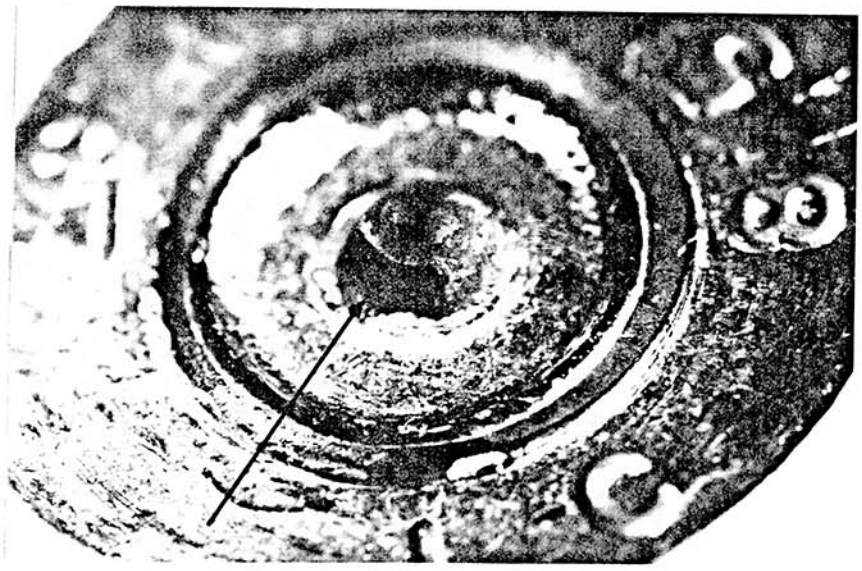
Figure 5.3-20. Typcial pierced primer (arrow).

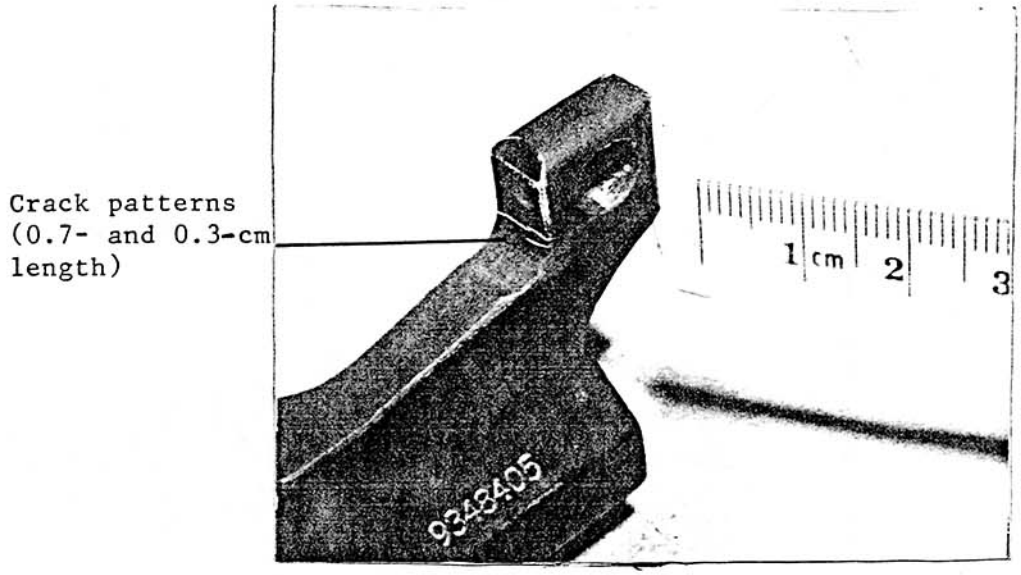
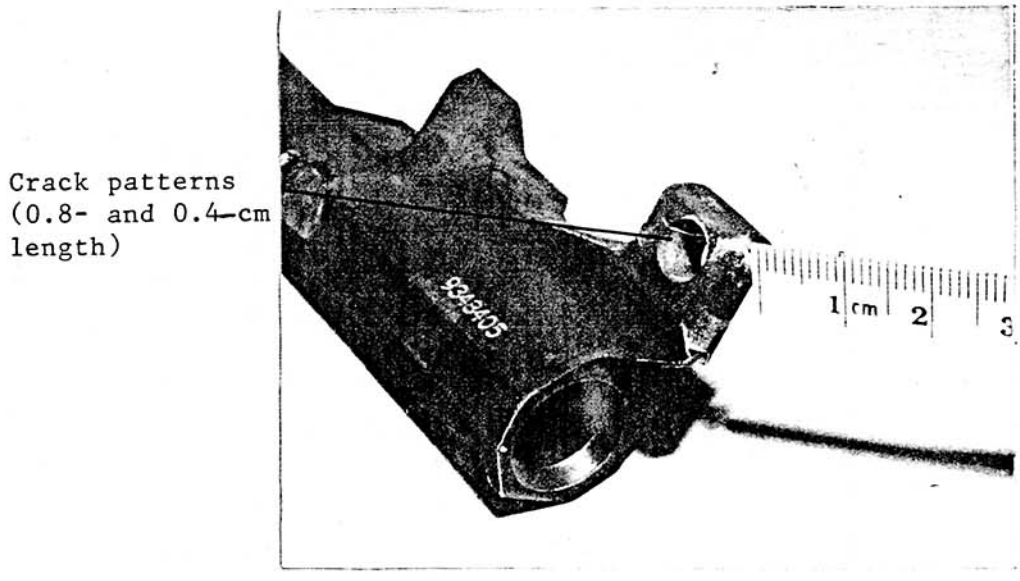
Inspection of the SAWs after the high temperature test revealed that there was no change in existing crack patterns found during initial inspection. The components showing major damage from the cookoff in gun, SN 002437 (Test No. 4) are shown in Figures 5.4-2 and 5.4-3. These parts were replaced before continuing the test. Other components replaced were the bolt, extractor, extractor spring, extractor pin, and feed tray. No damage occurred to the receiver or barrel of this gun. No personnel injury occurred. The primer of the cartridge case that cooked off was securely retained by its crimp. The case showed signs of a lack of support (unlocked breech) (refer to Fig. 5.4-4). Figure 5.4-5 compares the case heads from the cook-off round, a normal fired case, and a case with a blown primer. The increased firing pin indentation in the cook-off primer was due to the setback damage created when the weapon fired while unlocked.

Figure 5.4-2. Piston assembly from M249 SAW, SN 002437. Magnetic particle crack pattern noted after cartridge cookoff in high temperature (+155 °F) environment.

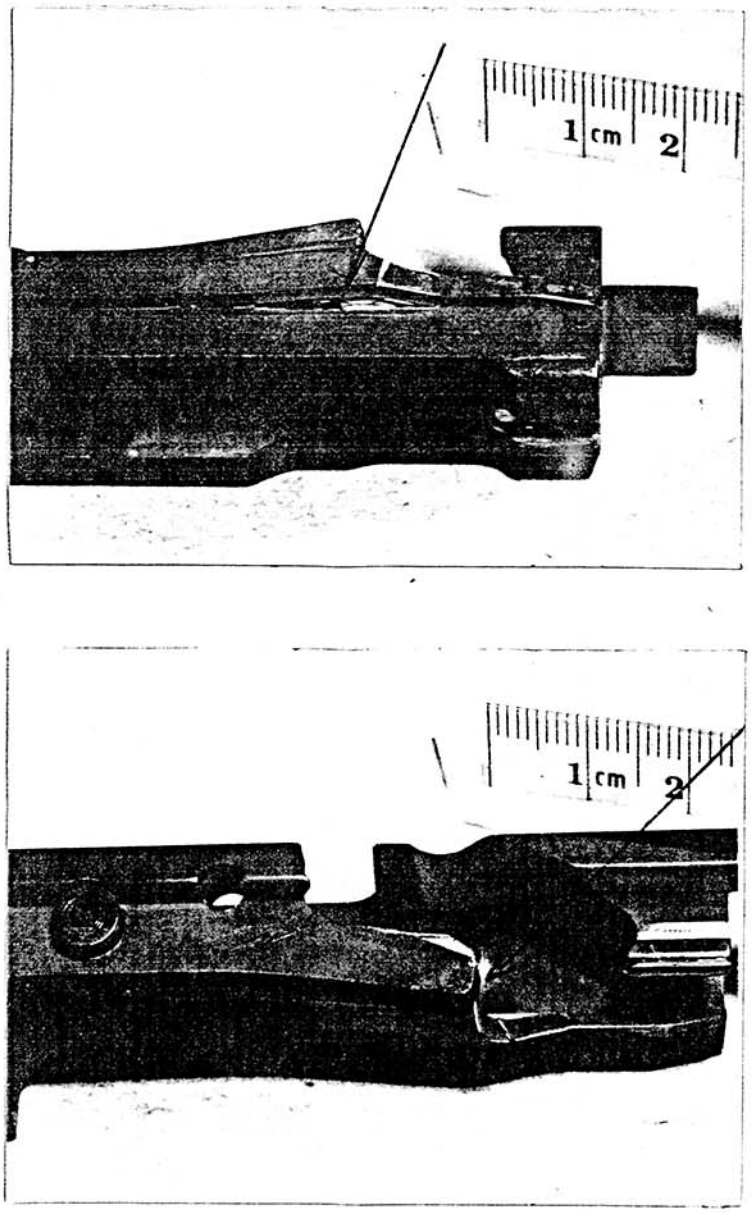
Figure 5.4-3. Bolt carrier from M249 SAW, SN 002437. Through crack noted after cartridge cookoff in high temperature (+155 °F) environment.

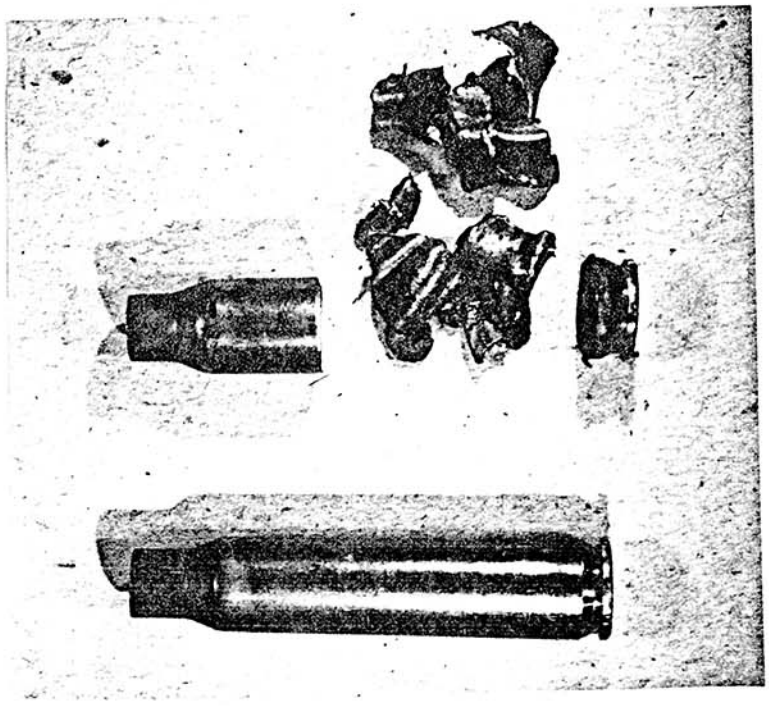
Figure 5.4-4. Cook-off case (top) from the high temperature test compared to an undamaged, fired case (bottom).

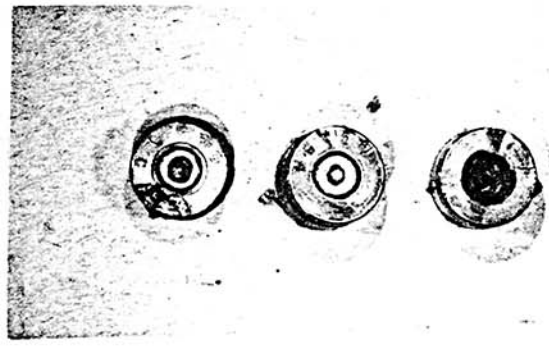
Figure 5.4-5. View of case head from high temperature test cook off (left), normal fired case (center), and blown primer (right).

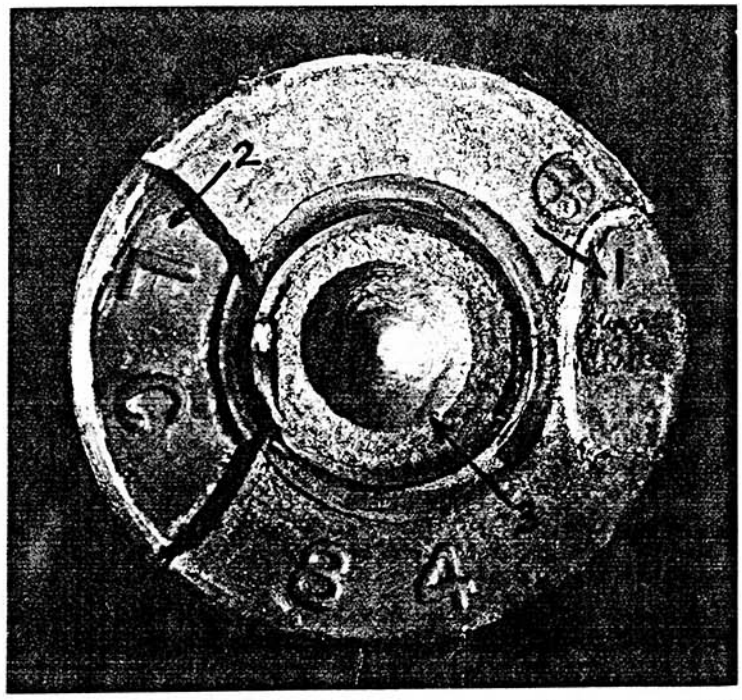
Figure 5.8-1. Typical cook-off round fired case from an M249 SAW showing heavy set back into bolt face (arrow 1 and 2) and protruding primer (arrow 3).

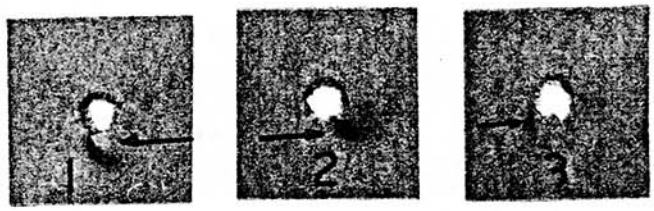
Notes: No projectile yaw in excess of 15° was noted.
Possible bullet jacket separation noted on yaw target with M855 Ball ammunition during high temperature testing. Refer to Figure 5.10-1.

Figure 5.10-1. Bullet signature at high temperature (+155°F). View 1 = rd No. 51; view 2 = rd No. 113, and view 3 = rd No. 187 of the 200-round series. Dark colored semicircular smear (arrows) on the paper target were created during passage of the projectile through the kraft paper target.
