REPORT ON USATECOM PROJECT NO. 8-3-0030-06F
PRODUCT IMPROVEMENT TEST OF BOLT ASSIST DEVICES
FOR RIFLE, CALIBER .223, AR15
REPORT NO. DPS-1120
NOVEMBER 1963

REPORT ON USATECOM PROJECT NO. 8-3-0030-06F
PRODUCT IMPROVEMENT TEST OF BOLT ASSIST DEVICES
FOR RIFLE, CALIBER .223, AR15
REPORT NO. DPS-1120

Test Director: A. Wilson
Infantry and Aircraft Weapons
Division
Development and Proof Services
Aberdeen Proving Ground, Md.

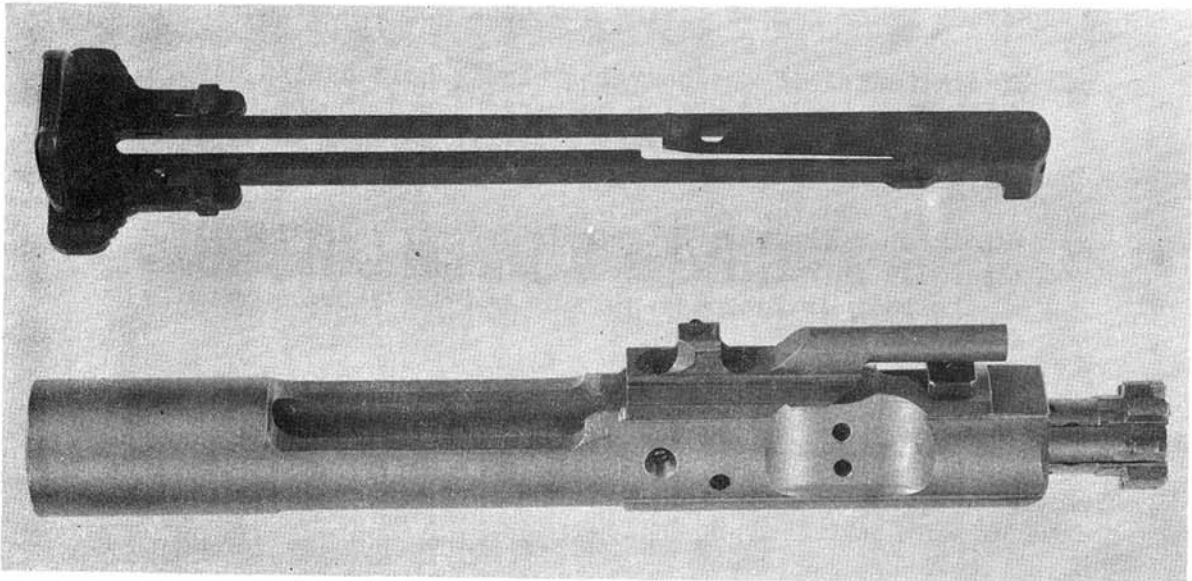
Figure 2: Redesigned Charging Handle with Two Locking Latches, Vertical Pad at Rear End, and Spring at Top Front. Note Plunger Incorporated in Bolt Carrier Key, in Line with Slotted Hole in Charging Handle Spring.

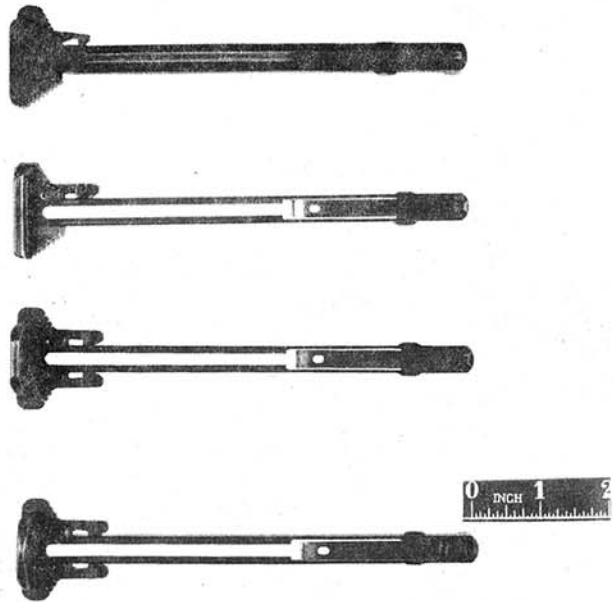
Figure 3: Charging Handle Assemblies. Top to Bottom: Standard Aluminum Model; Redesigned Steel Model with One Latch; Redesigned Steel Model with Two Latches; Redesigned Steel Model with Two Latches and Elongated Carrier Key Channel. Note Length of Channel Compared to Latch Pivot Pins.

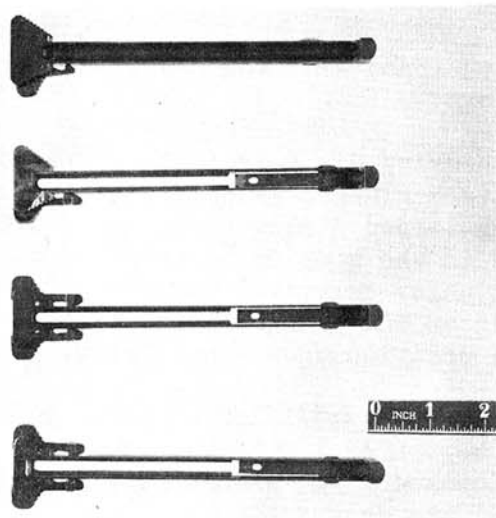
Figure 4: Charging Handle Assemblies, Upside Down View. Top to Bottom: Standard Aluminum Model; Redesigned Steel Model with One Latch; Redesigned Steel Model with Two Latches; Redesigned Steel Model with Two Latches and Elongated Carrier Key Channel. Note Length of Channel Compared to Latch Pivot Pins and Bevel at Rear of Channel.

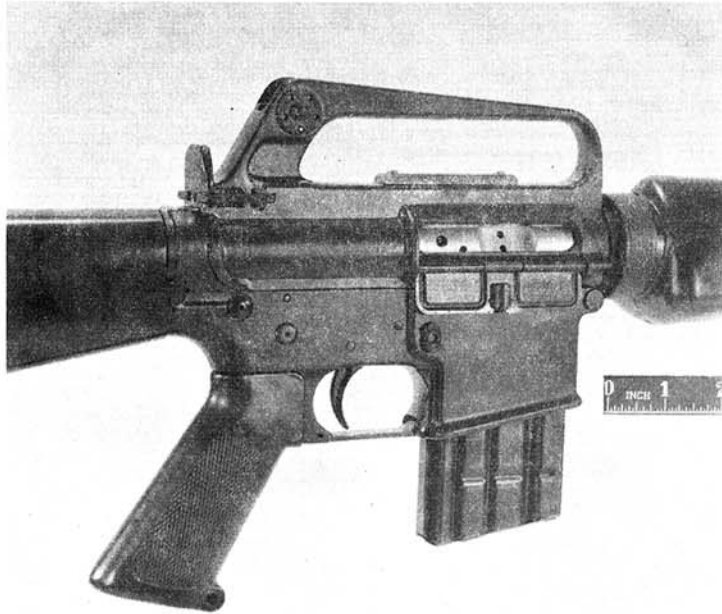
Figure 5: Modified AR15 Rifle. Note Riveted Cam Plate under Carrying Handle and Double Latch Charging Handle with Contact Pad at Rear End to Assist in Bolt Closing and Opening Operations.

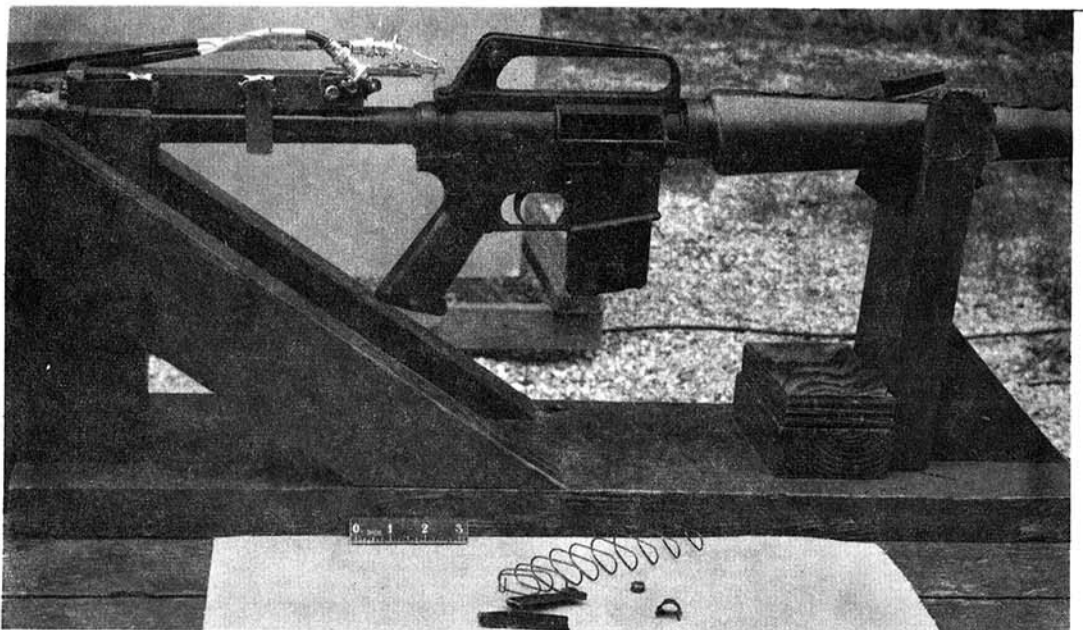
Figure 9: Standard AR15 Rifle (008271) Subjected to Cook-Off.

The standard AR15 rifle upper receiver did not crack in the area below the carrying handle. All the components of the magazine except the tube were blown downward and free of the rifle. No rounds were stored in the magazine at the time of the cook-off. Figures 9, 10, and 11 show the over-all view of the rifle, the damaged bolt and undamaged charging handle, and damaged receiver, respectively.

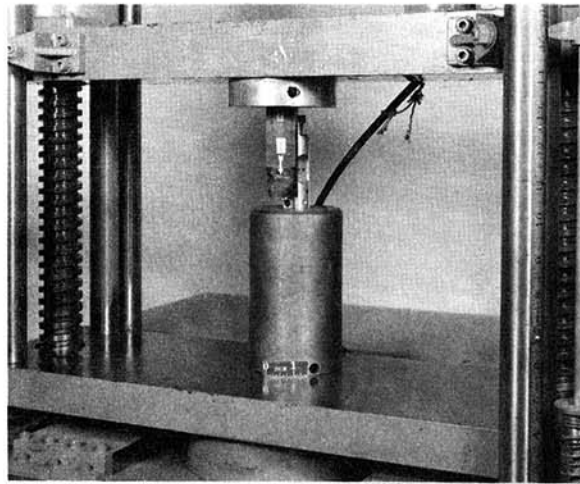
- a. Two early model bolt carrier key plungers failed in shear at loads of 435 and 445 pounds; two of the latest plungers failed at loads of 235 and 240 pounds.
- b. Two charging handle spring tabs failed in tension under loads of 1230 and 1310 pounds.
- c. Each of two double-latch charging handles was subjected to a load of 1650 pounds without failure or disengagement of the latches occurring.

Figure 15: Bolt Carrier Key Plunger Undergoing Shear Test.

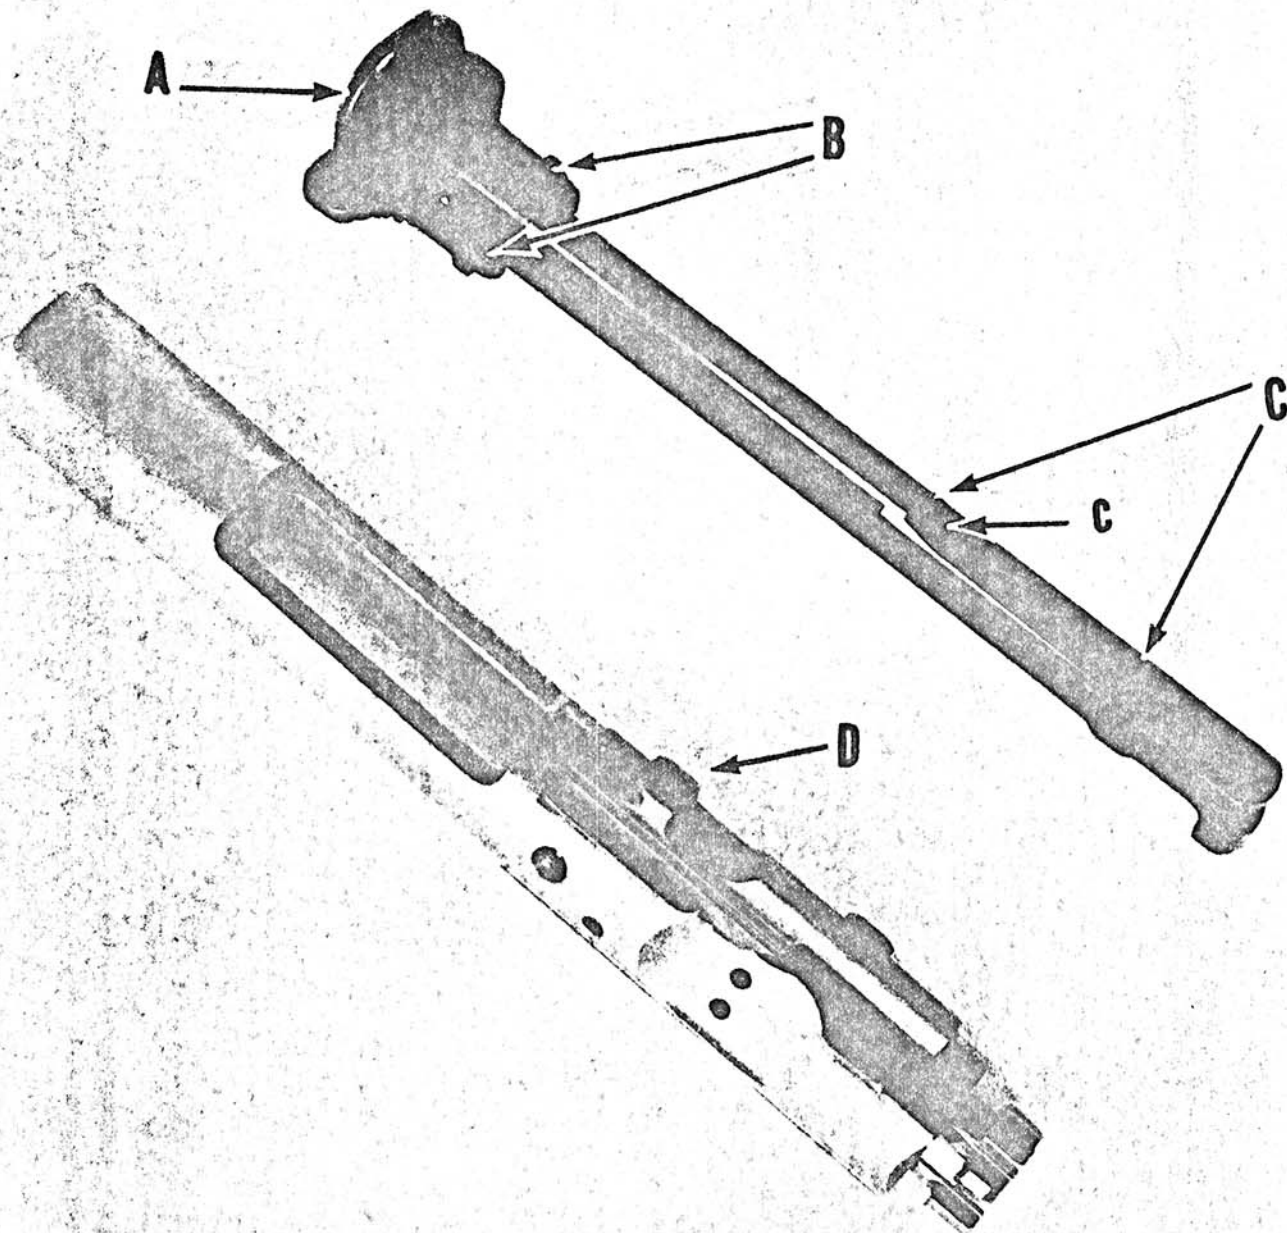
TOP: Modified AR-15 rifle. Note the arrows which point to the protective housing on the top of the receiver. This housing covers the aperture in the top of the receiver which allows the leaf spring in the top of the charging handle to move up when the bolt locks, thus releasing the spring-loaded pin on the bolt carrier.

BOTTOM: A. Darkened spot showing rearmost position reached by the charging handle.
B. Original location of housing for bolt assist device.
C. Ruptured receiver.
