REPORT R-1946

ELIMINATION OF GAS TUBE FOULING IN THE
M16A1 RIFLE WHEN USING THE M200 BLANK CARTRIDGE

BRUCE W. BRODMAN
ANDREW J. GRANDY

February 1970

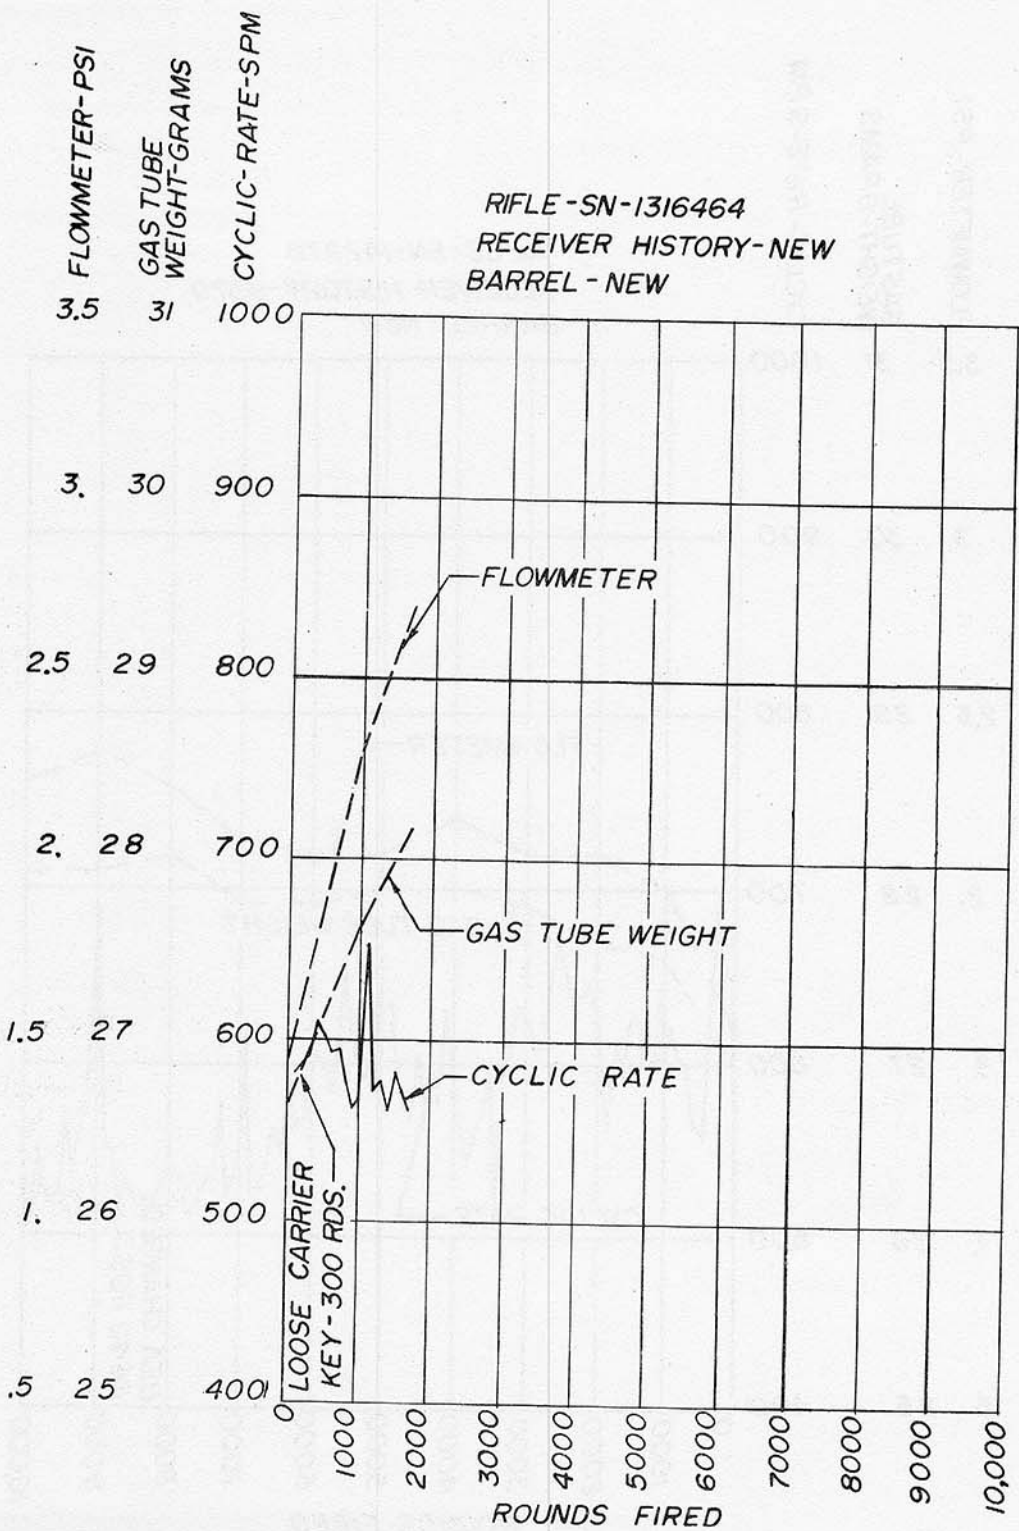
Figure 12. Test Data, Lot A, Shoulder Fired

and normal operation was restored up to 1,700 rounds. At this point the weapon could not be cycled in the automatic mode. Increase in flowmeter reading from 1.45 to 2.70 psi and increase in gas tube weight from 26.6696 to 28.1620 grams verified the existence of a clogged gas tube. Plotted data are shown in Figure 12. Lowest cyclic rate recorded was 562 spm and the highest cyclic rate recorded was 653 spm.

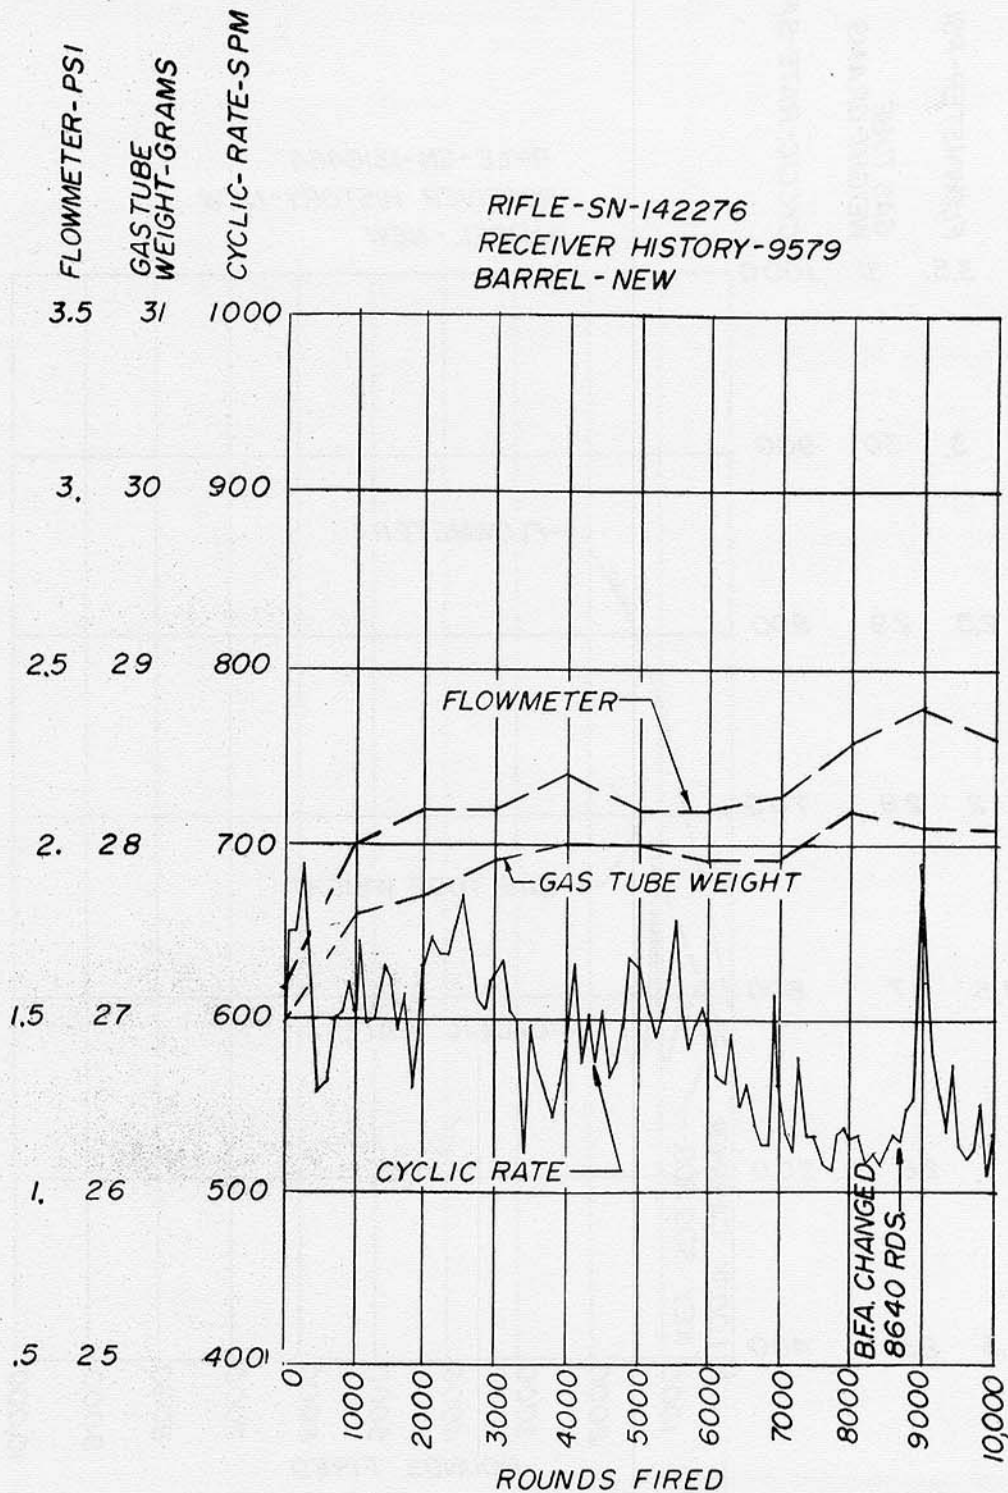
Figure 13. Test Data, Lot B, Mount Fired

The weapon functioned normally up to 8,640 rounds. At this point evidence of insufficient gas energy for bolt operation was observed. This included BOB, FX, and FF-SR type malfunctions. It was evident that the malfunctions could not be attributed to a clogged gas tube since there was no appreciable weight gain or significant flowmeter increase. The magazine was transposed to a control weapon and it functioned satisfactorily. Upon examination of the BFA it was found that gas leakage was occurring around the small diameter of the restrictor tube which seats into the weapon muzzle. Progressive leakage provided a path for solid residue which was deposited on the mating faces of the gun muzzle and the first shoulder on the BFA restrictor tube. Continued firing increased the amount of deposit on the mating faces providing a large area leakage path due to the buildup. This resulted in a progressively lower cyclic rate until 8,640 rounds were fired. At this point the energy loss was sufficient to induce rifle malfunctions. Replacement of the BFA after 8,640 rounds resulted in trouble-free operation of the system. Plotted data are shown in Figure 13. Highest cyclic rate recorded was 689 spm and the lowest cyclic rate was 516 spm.

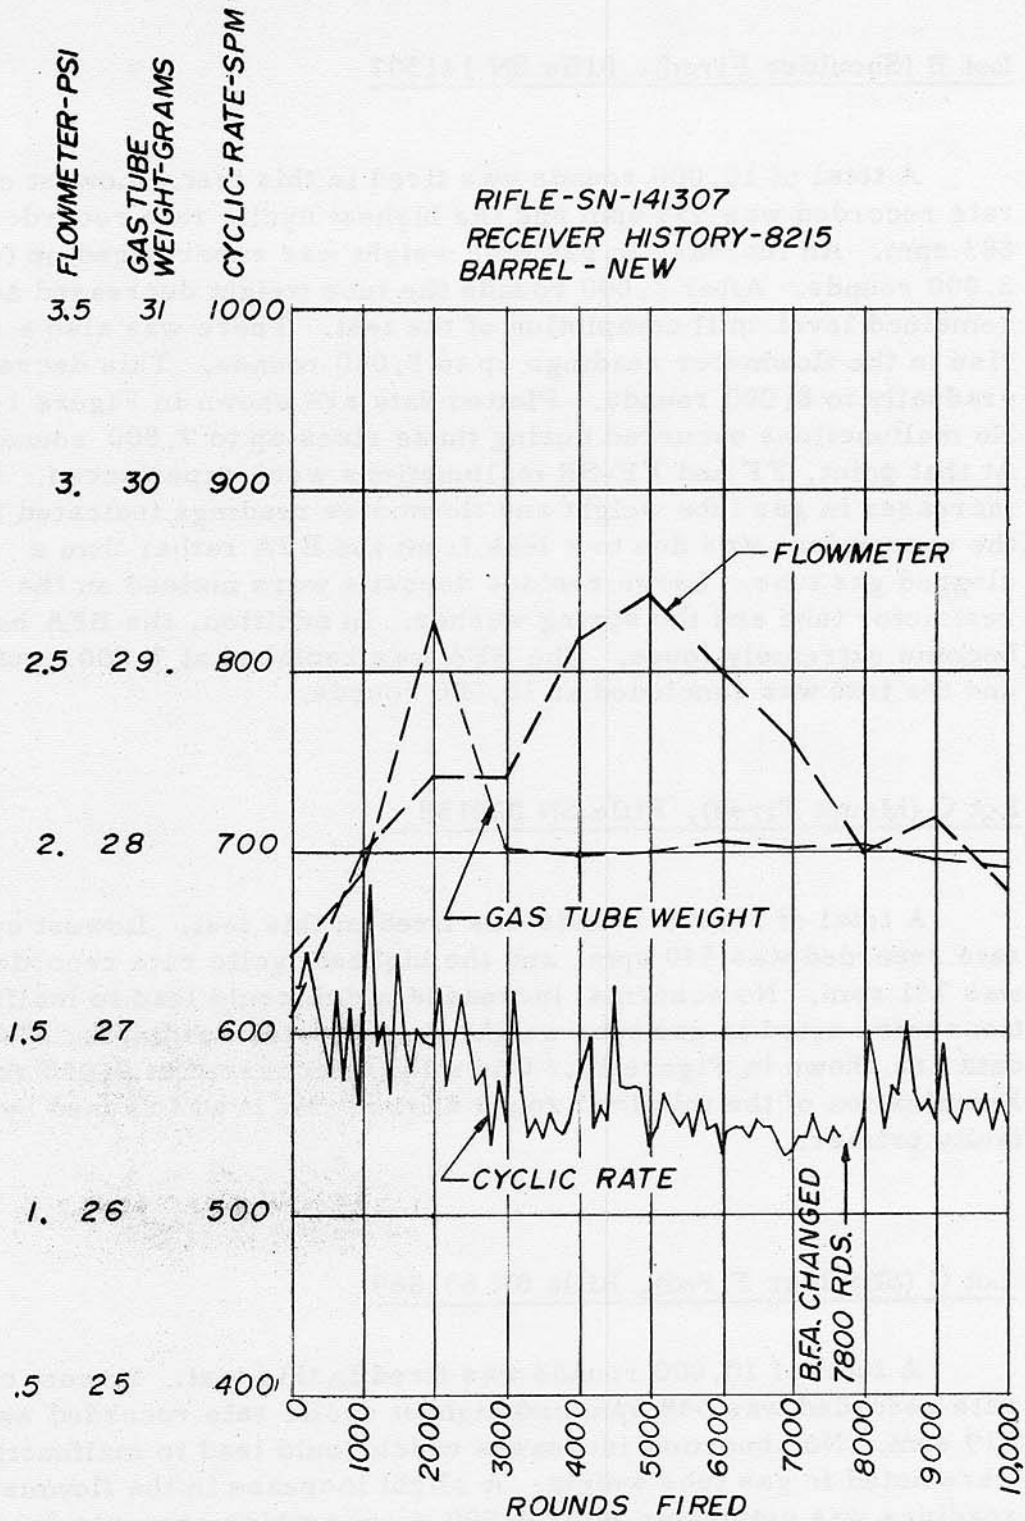
Figure 14. Test Data, Lot B, Shoulder Fired

A total of 10,000 rounds was fired in this test. Lowest cyclic rate recorded was 534 spm and the highest cyclic rate recorded was 683 spm. An increase in gas tube weight was experienced up to 2,000 rounds. After 2,000 rounds the tube weight decreased and remained level until completion of the test. There was also a steady rise in the flowmeter readings up to 5,000 rounds. This decreased gradually to 8,000 rounds. Plotted data are shown in Figure 14. No malfunctions occurred during these rises up to 7,800 rounds. At that point, FF and FF-SR malfunctions were experienced. Small increases in gas tube weight and flowmeter readings indicated that the energy loss was due to a leak from the BFA rather than a clogged gas tube. Large residue deposits were noticed on the restrictor tube and the spring washer. In addition, the BFA had become extremely loose. The BFA was replaced at 7,800 rounds and the test was concluded at 10,000 rounds.

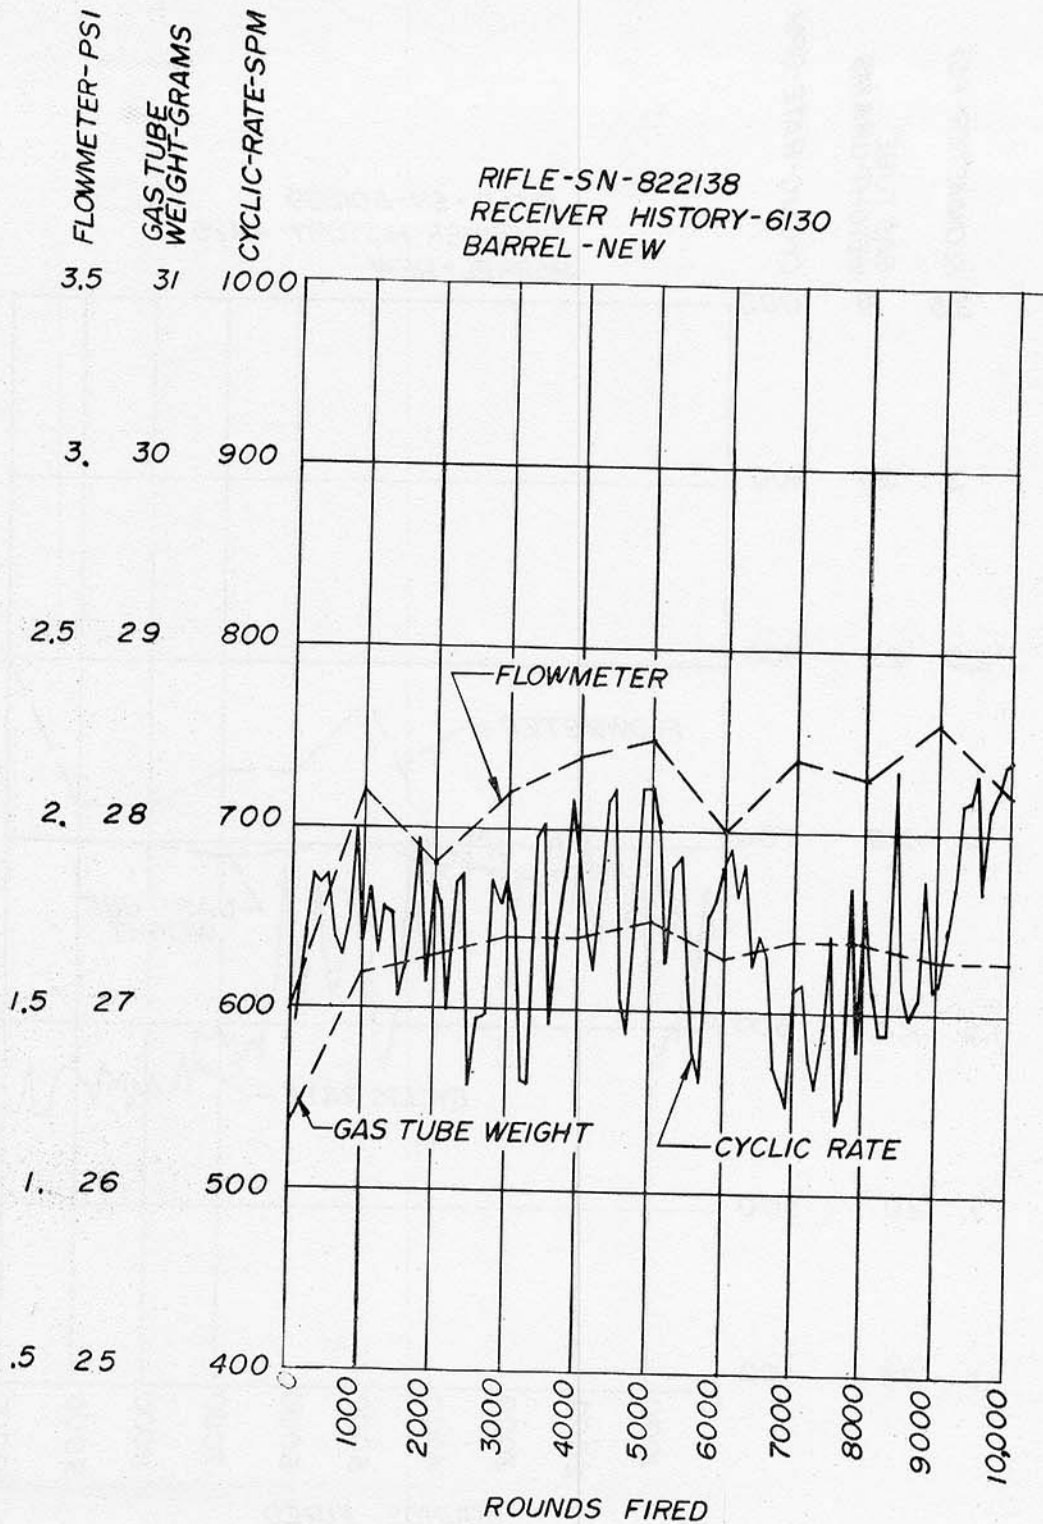
Figure 15. Test Data, Lot C, Mount Fired

A total of 10,000 rounds was fired in this test. Lowest cyclic rate recorded was 540 spm, and the highest cyclic rate recorded was 741 spm. No abnormal increases which could lead to malfunctions were noted in gas tube weight or flowmeter readings. Plotted data are shown in Figure 15. One misfire occurred at 7,000 rounds. Examination of the misfired round showed that it was caused by a faulty primer.

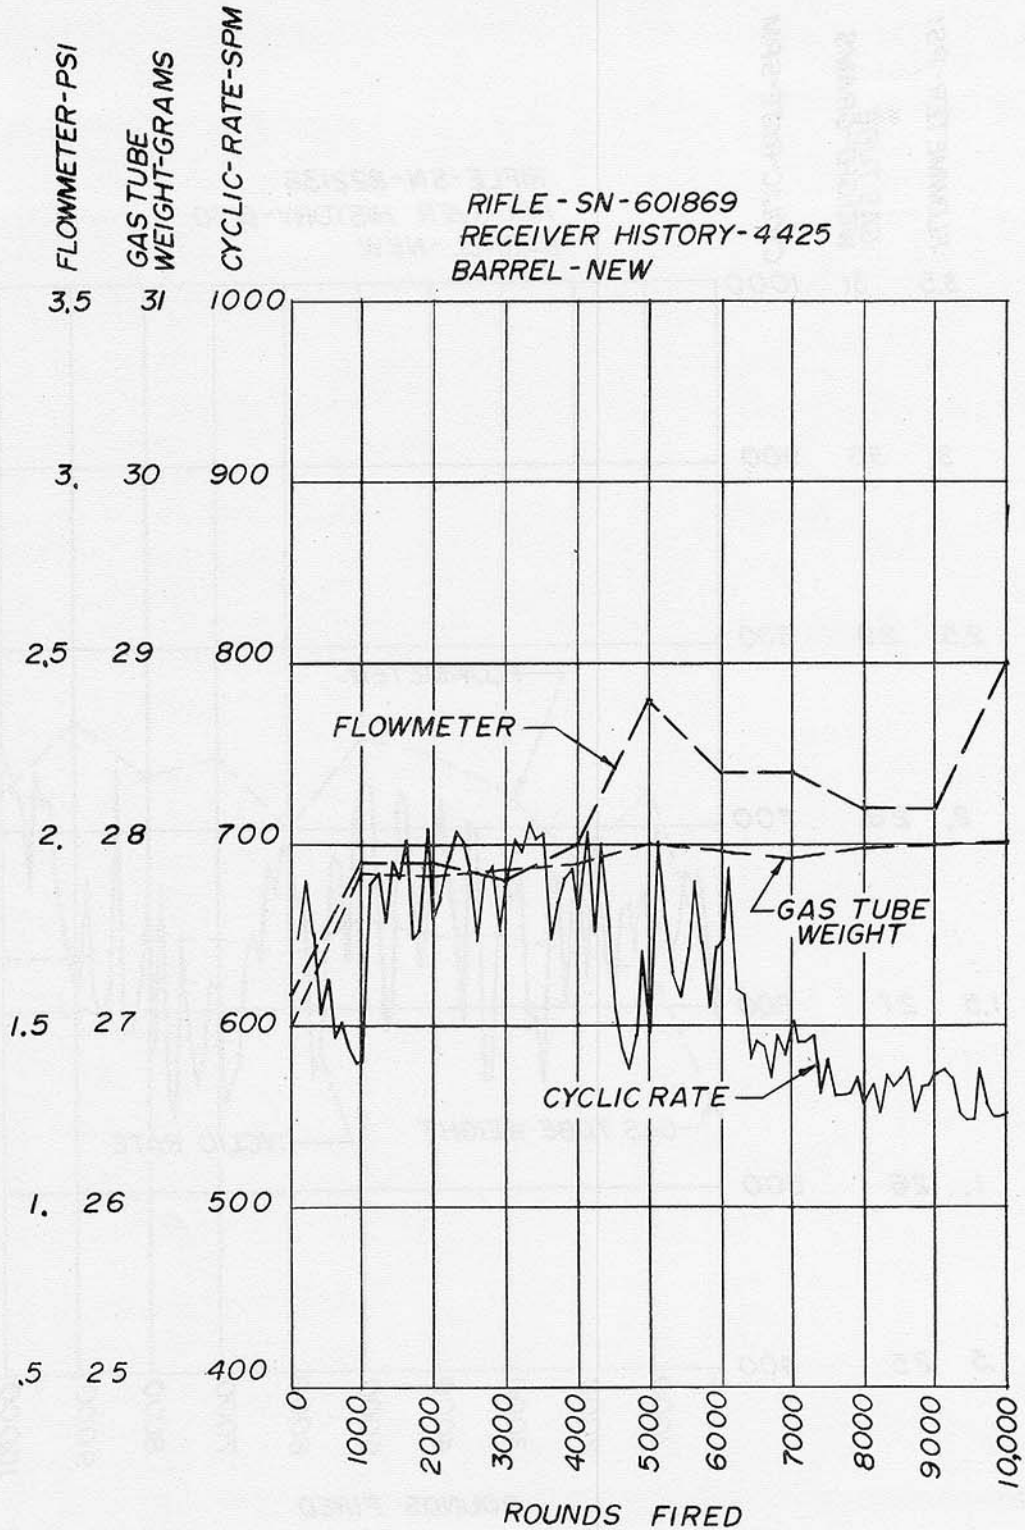
Figure 16. Test Data, Lot C, Shoulder Fired

A total of 10,000 rounds was fired in this test. Lowest cyclic rate recorded was 548 spm and highest cyclic rate recorded was 719 spm. No abnormal increases which could lead to malfunctions were noted in gas tube weight. A slight increase in the flowmeter readings was noticeable after 4,000 rounds which accounts for a gradual decrease in cyclic rate. However, no malfunctions were encountered. Plotted data are shown in Figure 16. The test was concluded at 10,000 rounds.

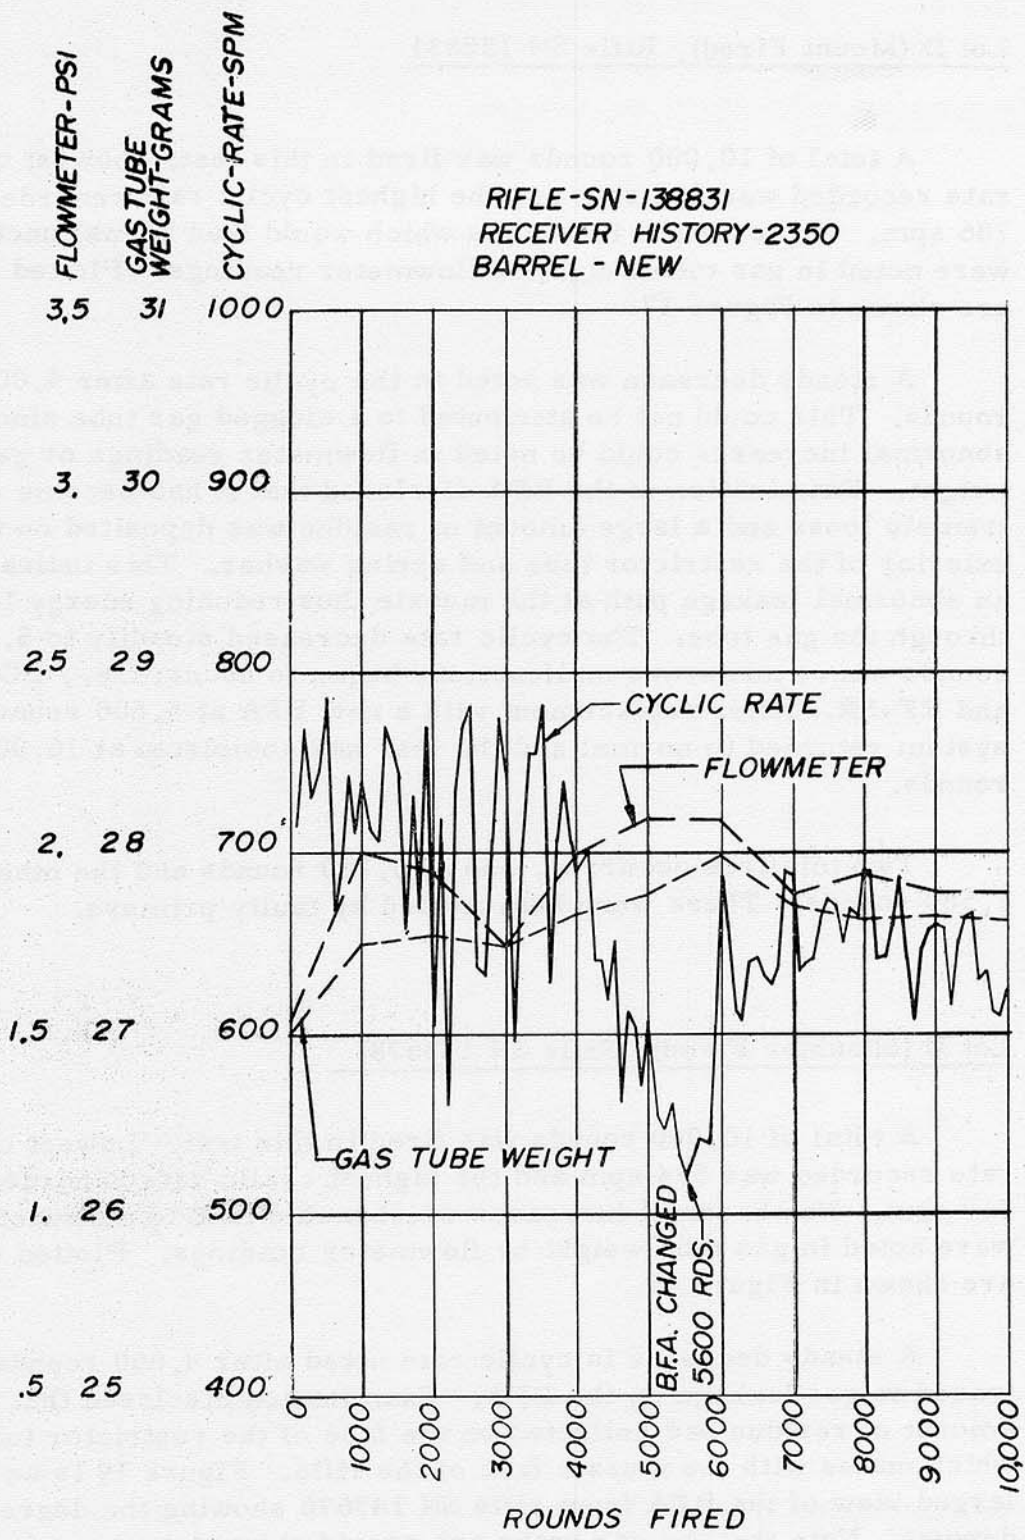
Figure 17. Test Data, Lot D, Mount Fired

A total of 10,000 rounds was fired in this test. Lowest cyclic rate recorded was 519 spm and the highest cyclic rate recorded was 786 spm. No abnormal increases which would lead to malfunctions were noted in gas tube weight or flowmeter readings. Plotted data are shown in Figure 17.

A steady decrease was noted in the cyclic rate after 4,000 rounds. This could not be attributed to a clogged gas tube since no abnormal increases could be noted in flowmeter readings or gas tube weight. Examination of the BFA disclosed that it had become extremely loose and a large amount of residue was deposited on the exterior of the restrictor tube and spring washer. This indicated an abnormal leakage path at the muzzle thus reducing energy level through the gas tube. The cyclic rate decreased steadily to 5,600 rounds where numerous malfunctions began to occur; i. e., BOB, FF, and FF-SR. After replacement with a new BFA at 5,600 rounds the system returned to normal and the test was completed at 10,000 rounds.

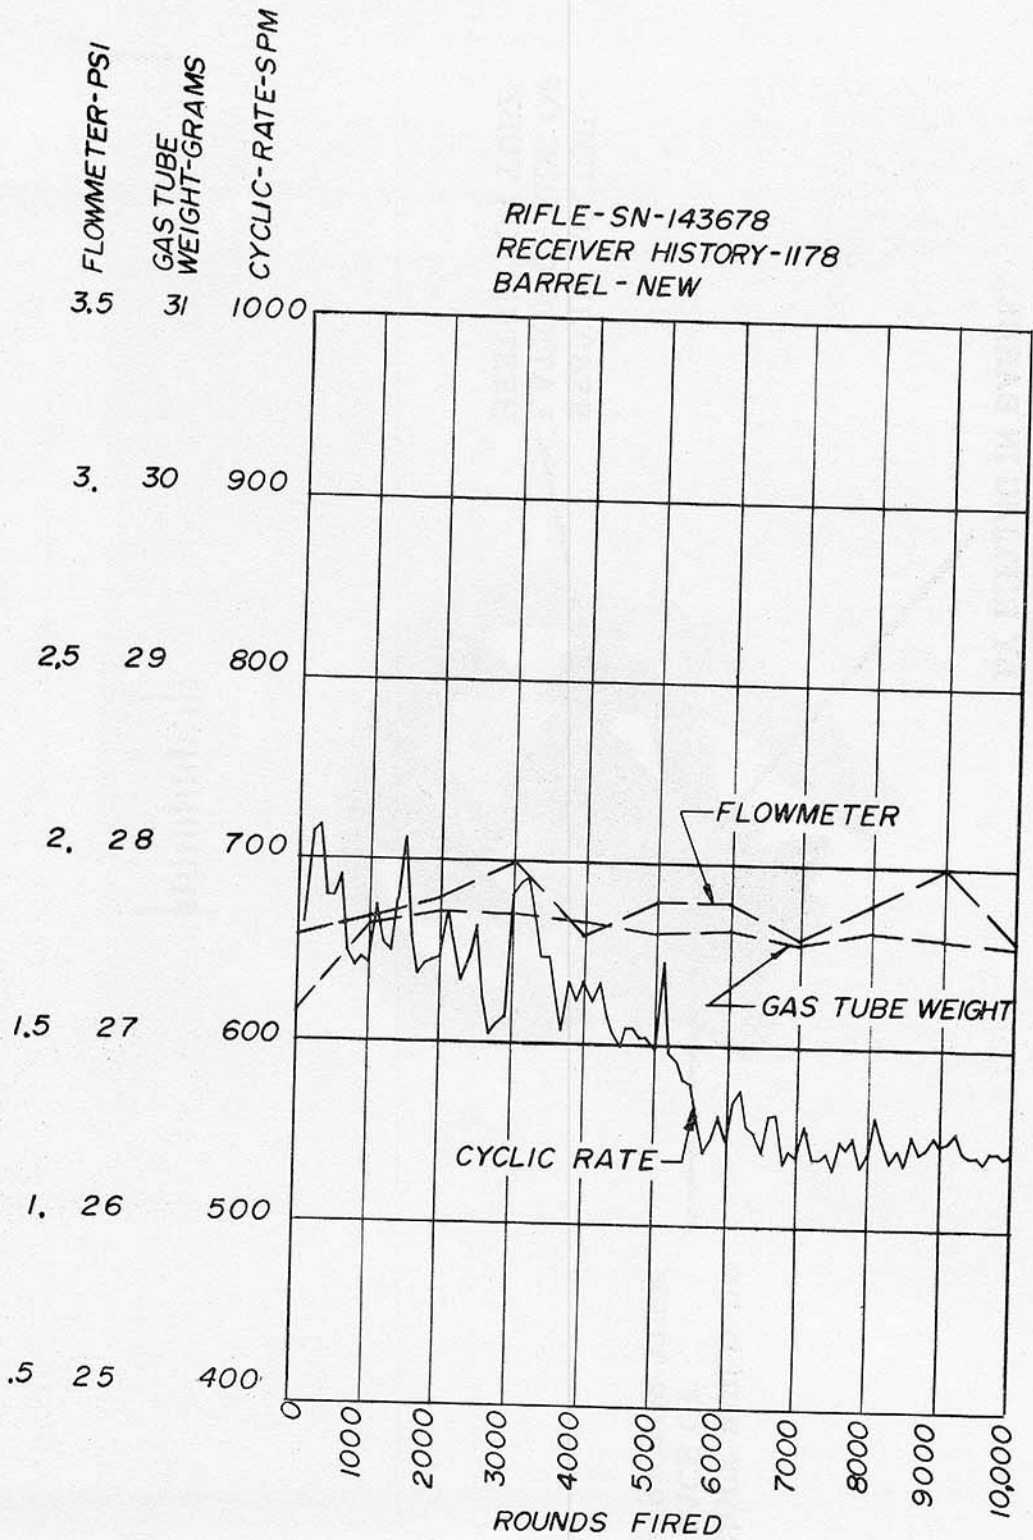
Figure 18. Test Data, Lot D, Shoulder Fired

A total of 10,000 rounds was fired in this test. Lowest cyclic rate recorded was 534 spm and the highest cyclic rate recorded was 719 spm. No abnormal increases which would lead to malfunction were noted in gas tube weight or flowmeter readings. Plotted data are shown in Figure 18.

A steady decrease in cyclic rate noted after 4,000 rounds was traced to gas leakage on the BFA. Examination disclosed that a large amount of residue had collected on the face of the restrictor tube which mates with the muzzle face of the rifle. Figure 19 is an enlarged view of the BFA from rifle SN 143678 showing the degree of deposit. Note that the gas paths are provided by clearances in the rifling groove diameter of the barrel. Clearly defined is the residue at each groove termination on the restrictor tube face.
