REPORT ON USATECOM PROJECT NO. 8-3-0030-06F  
PRODUCT IMPROVEMENT TEST OF BOLT ASSIST DEVICES  
FOR RIFLE, CALIBER .223, AR15  
REPORT NO. DPS-1120  
NOVEMBER 1963

U. S. ARMY  
DEVELOPMENT AND PROOF SERVICES

Three models of charging handle bolt assist devices for the caliber .223 AR15 rifle were evaluated for effectiveness in manual extraction and bolt closure operations. A plunger-type bolt closure device was also evaluated. The devices were tested for operation under various adverse conditions, and other special tests were also conducted. Only the plunger-type bolt closing device provided an effective means for closing the bolt under adverse conditions. The modified charging handle did not provide adequate means for extraction operations under adverse conditions. It is recommended that the charging handle bolt assist device tested not be adopted.

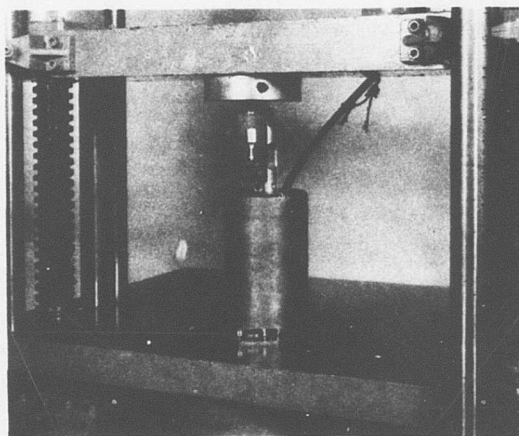
- a. Two early model bolt carrier key plungers failed in shear at loads of 435 and 445 pounds; two of the latest plungers failed at loads of 235 and 240 pounds.
- b. Two charging handle spring tabs failed in tension under loads of 1230 and 1310 pounds.
- c. Each of two double-latch charging handles was subjected to a load of 1650 pounds without failure or disengagement of the latches occurring.

Figure 15: Bolt Carrier Key Plunger Undergoing Shear Test.

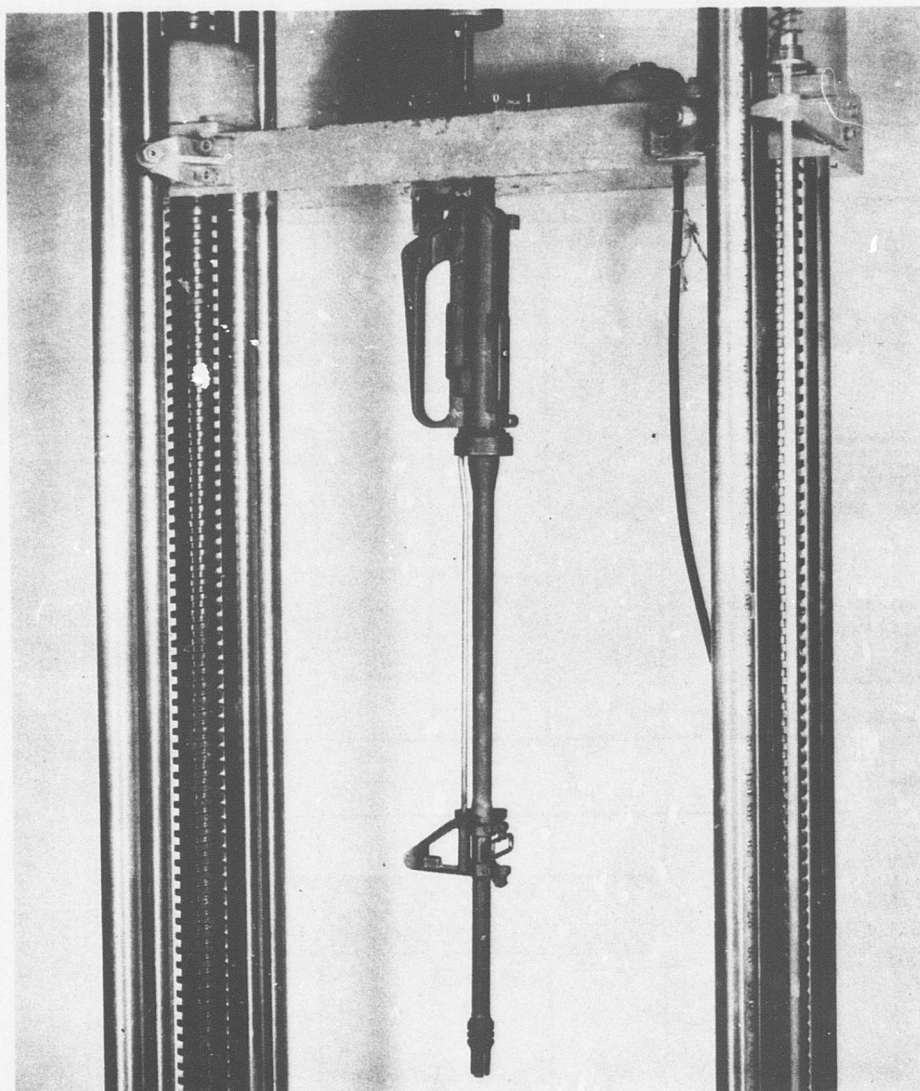
The latches of two charging handles were gradually loaded to 1650 pounds, using the fixtures shown and described in Figures 18 and 19.

Figure 19: Testing Machine Setup for Application of Load to Charging Handle Latches.
