TECOM Project No. 2-MU-001-SAW-001
Report No. USACSTA

PROTOTYPE QUALIFICATION TEST - GOVERNMENT
OF
CONUS-PRODUCED SAW AMMUNITION (M855/M856)

U.S. Army Combat Systems Test Activity
Aberdeen Proving Ground, Maryland 21005-5059

August 1988

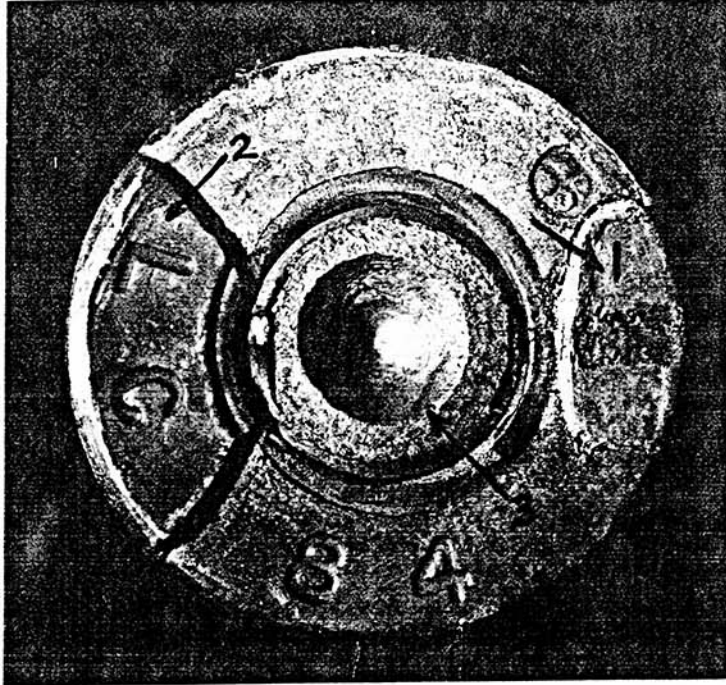
Figure 5.8-1. Typical cook-off round fired case from an M249 SAW showing heavy set back into bolt face (arrow 1 and 2) and protruding primer (arrow 3).

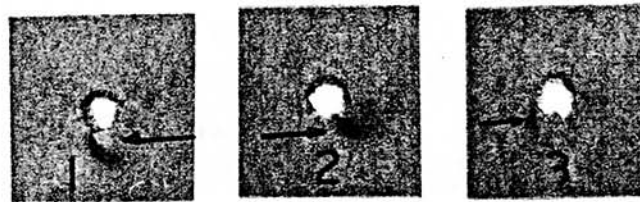
Figure 5.10-1. Bullet signature at high temperature (+155°F). View 1 = rd No. 51; view 2 = rd No. 113, and view 3 = rd No. 187 of the 200-round series. Dark colored semicircular smear (arrows) on the paper target were created during passage of the projectile through the kraft paper target.

Notes: No projectile yaw in excess of 15° was noted.
Possible bullet jacket separation noted on yaw target with M855 Ball ammunition during high temperature testing. Refer to Figure 5.10-1.
